Watchlist

Safety for pedestrians and vehicles using level crossings

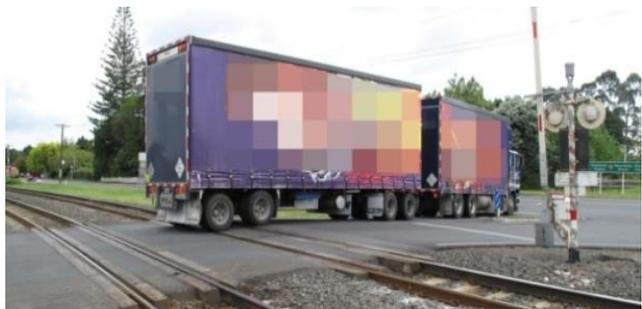
The Commission has investigated several accidents where road-legal vehicles have become stuck on rail level crossings, or have been too long to clear a rail level crossing and then stop, as required, at an adjacent road intersection with the vehicle clear of the rail crossing. There is no routine procedure for measuring the profile or vertical alignment of the road at rail level crossings, which means there could be other level crossings in New Zealand on which low-slung, but nevertheless road-legal vehicles, could become stuck.

About 19% (264) of level crossings on New Zealand's rail network have short stacking distances. At these level crossings a long vehicle, even though it complies with road regulations, is unable to clear the level crossing when stopping at an adjacent road intersection. Similarly, the profile (the change of rate in gradient) of level crossings may not be compatible with vehicles that have low, albeit legal, ground clearance. A train colliding with a heavy vehicle is a serious safety issue.

As a result of its inquiries into a train and truck collision near Rangiriri in 2014³ the Commission recommended that the NZ Transport Agency work with KiwiRail and all road controlling authorities to ensure rail level crossing assessments include a measure of the road profile and compatibility with the allowable dimensions for long and low road vehicles. It was possible that a truck would be unable to complete a successful crossing after stopping at the crossing and confirming it was clear due to permitted train speed and available sight lines. We have made similar recommendations in earlier reports.⁴
