Transport Accident  
Investigation  
Commission

# **Published reports**

***1 July 2024 to 30 June 2025***

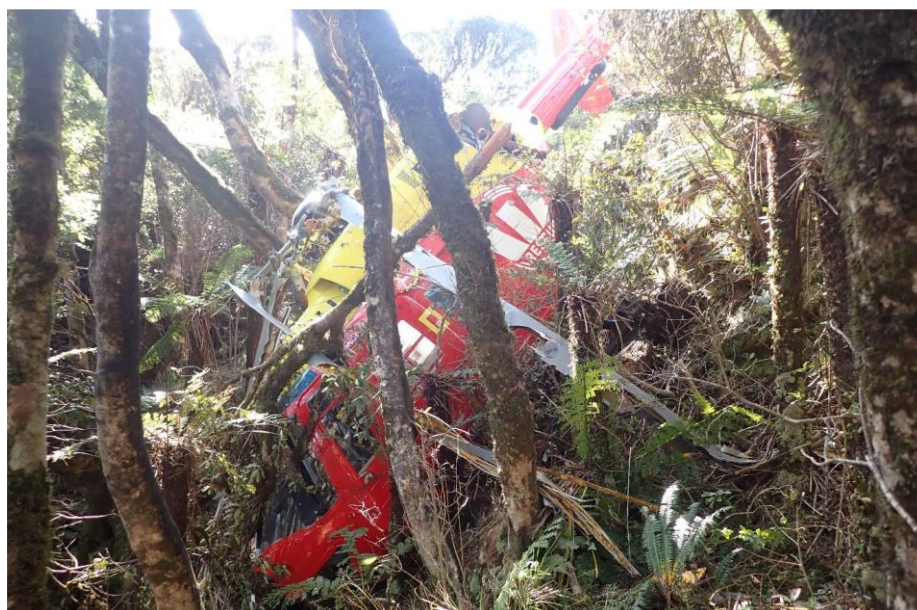
**Figure 6 from the report: Accident scene**

The helicopter was severely damaged. The pilot, crew member and paramedic escaped without injury.

It is **virtually certain** that the helicopter entered Vortex Ring State (VRS) while descending on the windward side of a ridge line to recover the patient. VRS is a hazardous aerodynamic phenomenon that a helicopter can encounter during the descent and landing phases of

During helicopter flight training, pilots receive generic tuition on VRS. The helicopter's Flight Manual did not contain the information necessary for the pilot to identify the flight conditions and parameters for the helicopter type that were conducive to VRS.

On 26 February 2025, the Commission recommended that Kawasaki Heavy Industries revise the Kawasaki BK117 B-2 Flight Manual to include specific data for Vortex Ring State to assist pilots in avoiding this phenomenon. [001/25]

On 26 February 2025, the Commission recommended to the Director of Civil Aviation at the Civil Aviation Authority of New Zealand that they promote, through the appropriate International Civil Aviation Organization (ICAO) forum, consideration for the requirement and implementation for Vortex Ring State alerting systems to be installed in new helicopters. [002/25]

On 26 February 2025, the Commission recommended that the Director of Civil Aviation at the Civil Aviation Authority of New Zealand use the lessons from this report to raise awareness for helicopter pilots of the risks associated with inadvertently entering flight conditions that are conducive to Vortex Ring State. (003/25)

On 26 February 2025, the Commission recommended to the Director of Civil Aviation at the Civil Aviation Authority of New Zealand that they promote, through the appropriate International Civil Aviation Organization (ICAO) forum, the need for additional information to be included in all rotorcraft flight manuals, to assist pilots in avoiding Vortex Ring State. (004/25)

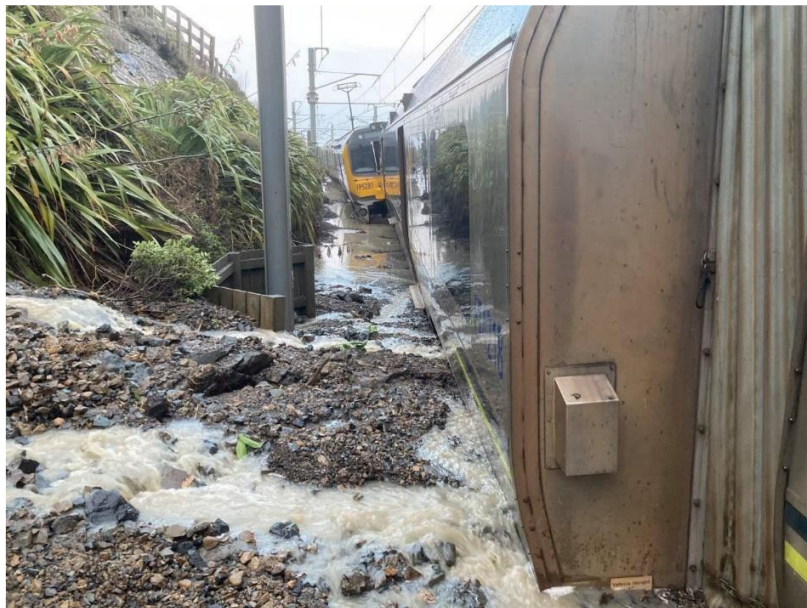
**Figure 5 from the report: Derailed carriage and debris against and under carriage**

On 25 September 2024, the Commission recommended that KiwiRail review the trigger settings of its rainfall-monitoring equipment and weather risk matrix to ensure they can identify and respond to moderate or heavy rainfall that occurs within a short time period. [004/24]

On 25 September 2024, the Commission recommended that Transdev Wellington and Auckland One Rail take action to fit automatic alert systems to emergency brake activations on its passenger train services, to alert train control to an emergency at the earliest possibility. [005/24]

On 25 September 2024, the Commission recommended that Transdev Wellington review and improve the training on the application of the in-cab emergency radio button simultaneously with an emergency brake application. [006/24]

On 25 September 2024, the Commission recommended that Transdev Wellington review the back-up portable radio system, particularly the equipment, coverage and signal strength along the network, to ensure it can transmit clear communication between train crews and train control. [007/24]

On 25 September 2024, the Commission recommended that Transdev Wellington and Auckland One Rail implement regular checks of the onboard radios (both in-cab main radios and in-cab back-up portable radios) in their passenger trains to ensure they can communicate with train control. [008/24]

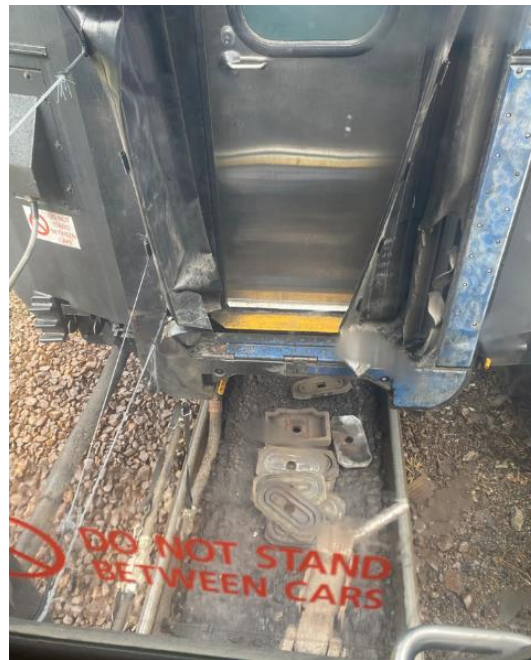
**Figure 11 from the report: Parted gap between first and second carriages**

At approximately 1630 as the train descended into Arthur's Pass station, the locomotive engineer completed several train brake applications. As the train came to a stop at the station's platform, the first two carriages<sup>21</sup> parted<sup>22</sup> by approximately one metre (m), activating the fail-safe braking system<sup>23</sup>.

The broken component had a pre-existing fracture that had not been identified in regular maintenance inspections by KiwiRail.

It is **virtually certain** that the train's configuration of four locomotives<sup>25</sup> operating in throttle position three while applying the train's brakes to their full capability caused the weakened coupler component to break.

On 26 March 2025, the Commission recommended that KiwiRail review and improve the maintenance and inspection of safety-critical components of the carriage-coupler system to ensure they remain safe to operate. [034/25]

On 26 March 2025, the Commission recommended that KiwiRail review and improve the automatic carriage alarm system (TMS) to ensure it alerts the crew to faults. [035/25]

On 26 March 2025, the Commission recommended that KiwiRail include in its Operational Rules the processes and procedures to respond to a train parting because of a mechanical failure, to ensure the risk of injury to rail personnel and damage to rail vehicles is mitigated. [036/25]

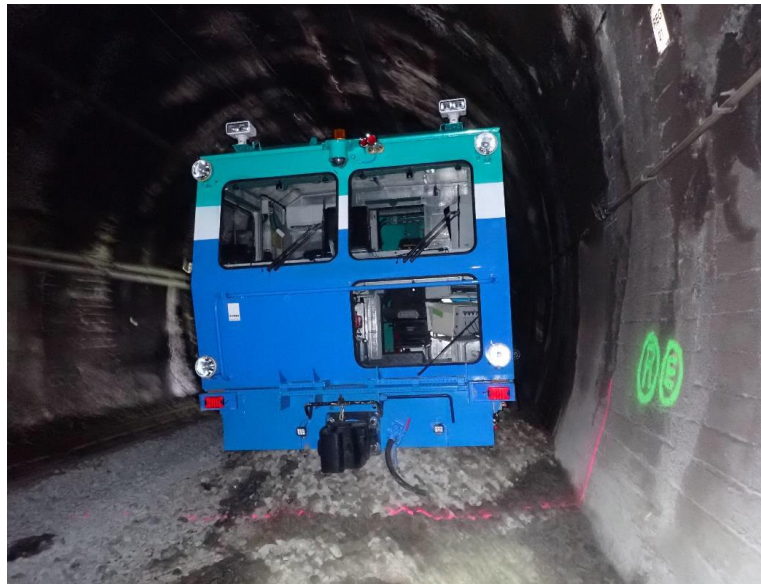
**Figure 1 from the report: Tamper 703 at site of derailment**

When the tamper group entered the tunnel, the operator on Tamper 703 noticed the missing track and applied emergency braking.

None of the four crew was injured, but Tamper 703 was significantly damaged.

On 28 May 2025, the Commission recommended that KiwiRail review and improve its process for authorising rail movements within worksites to ensure the safe movement of all rail traffic and personnel within protected work areas, including the verification of track integrity and the sharing of and access to safety-critical information. [031/25]

On 28 May 2025, the Commission recommended that KiwiRail review and improve its rules and procedures relating to track maintenance work to require additional protection within worksites where the tracks have been made impassable. [032/25]

On 28 May 2025, the Commission recommended that KiwiRail review its national project management structure to ensure there is sufficient oversight of and ongoing support for all project staff at all levels to maintain safe working conditions and manageable workloads. [033/25]

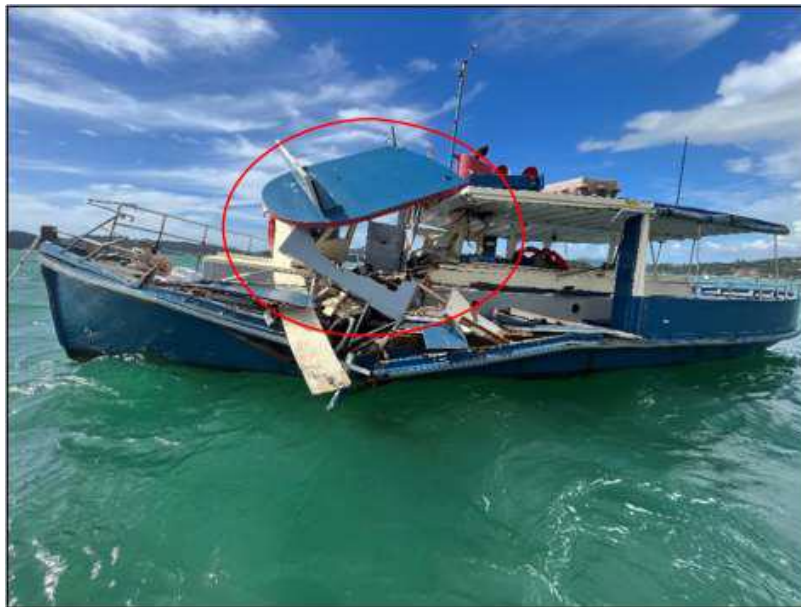
**Figure 6 from the report: The damaged *Waitere* showing the destroyed wheelhouse**  
(Credit: Bay of Islands Coastguard)

The *Waitere* suffered catastrophic damage and eventually sank. The *Onepoto* also sustained some damage but was able to proceed under its own power to a repair berth.

The skipper of the *Onepoto* was navigating the vessel at 20.5 knots (kt). Had it been travelling at a safer speed for the conditions, it is **very likely** that either the collision would have been avoided or the consequences of the collision would have been reduced.

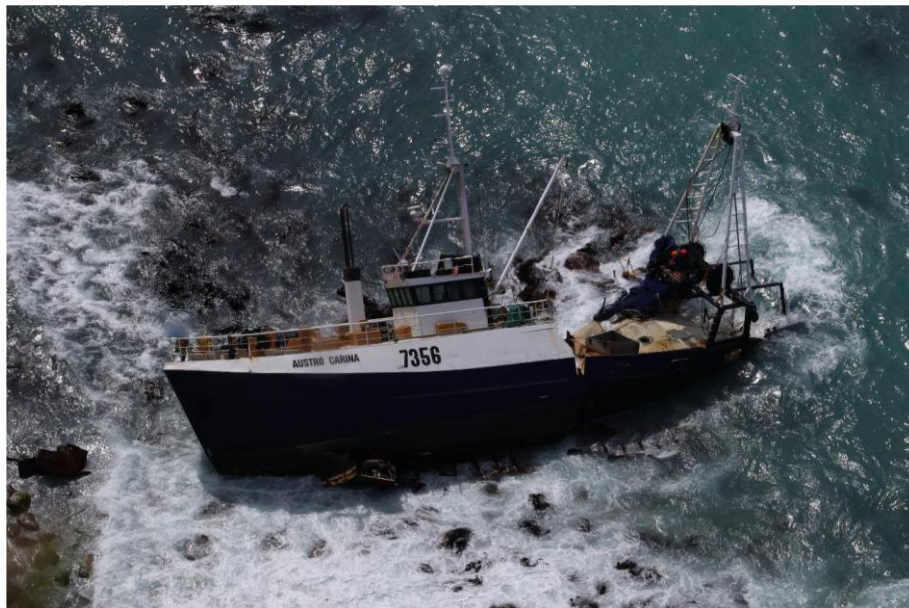
Figure 5 from the report: The stranded *Austro Carina*  
(Credit: Mr G Finlayson)

On 24 September 2023, at about 2137, the *Austro Carina* stranded<sup>46</sup> while fishing at Red Bay, Banks Peninsula. The vessel suffered extensive damage and was unsalvageable. It was subsequently declared a constructive total loss<sup>47</sup> by the insurer.

On 13 March 2025, the Commission recommended that the Director of Maritime New Zealand review their competency frameworks for STCW-F-aligned certificates, to ensure they include the basic principles to be observed in keeping a navigational watch as set out in Chapter IV of the Annex to STCW-F. [029/25]

On 13 March 2025, the Commission recommended that Pegasus Fishing Limited review their safety management system and take steps to ensure safe navigational watchkeeping principles are observed during all phases of the fishing operation. [030/25]

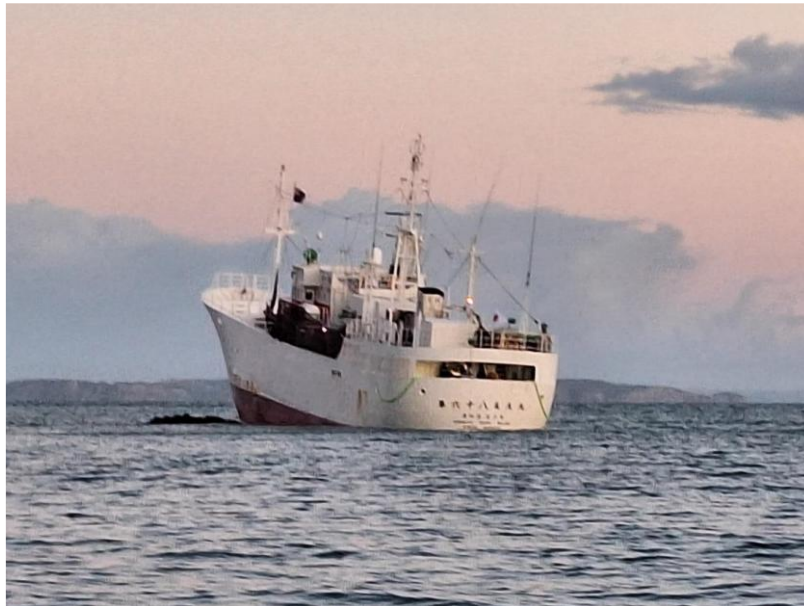
**Figure 1 from the report: Fishing *Chokyu Maru No.68* after grounding**  
(Credit: Auckland harbourmaster)
