Report 00-005

Hughes 369FF

ZK-HJN

wire strike

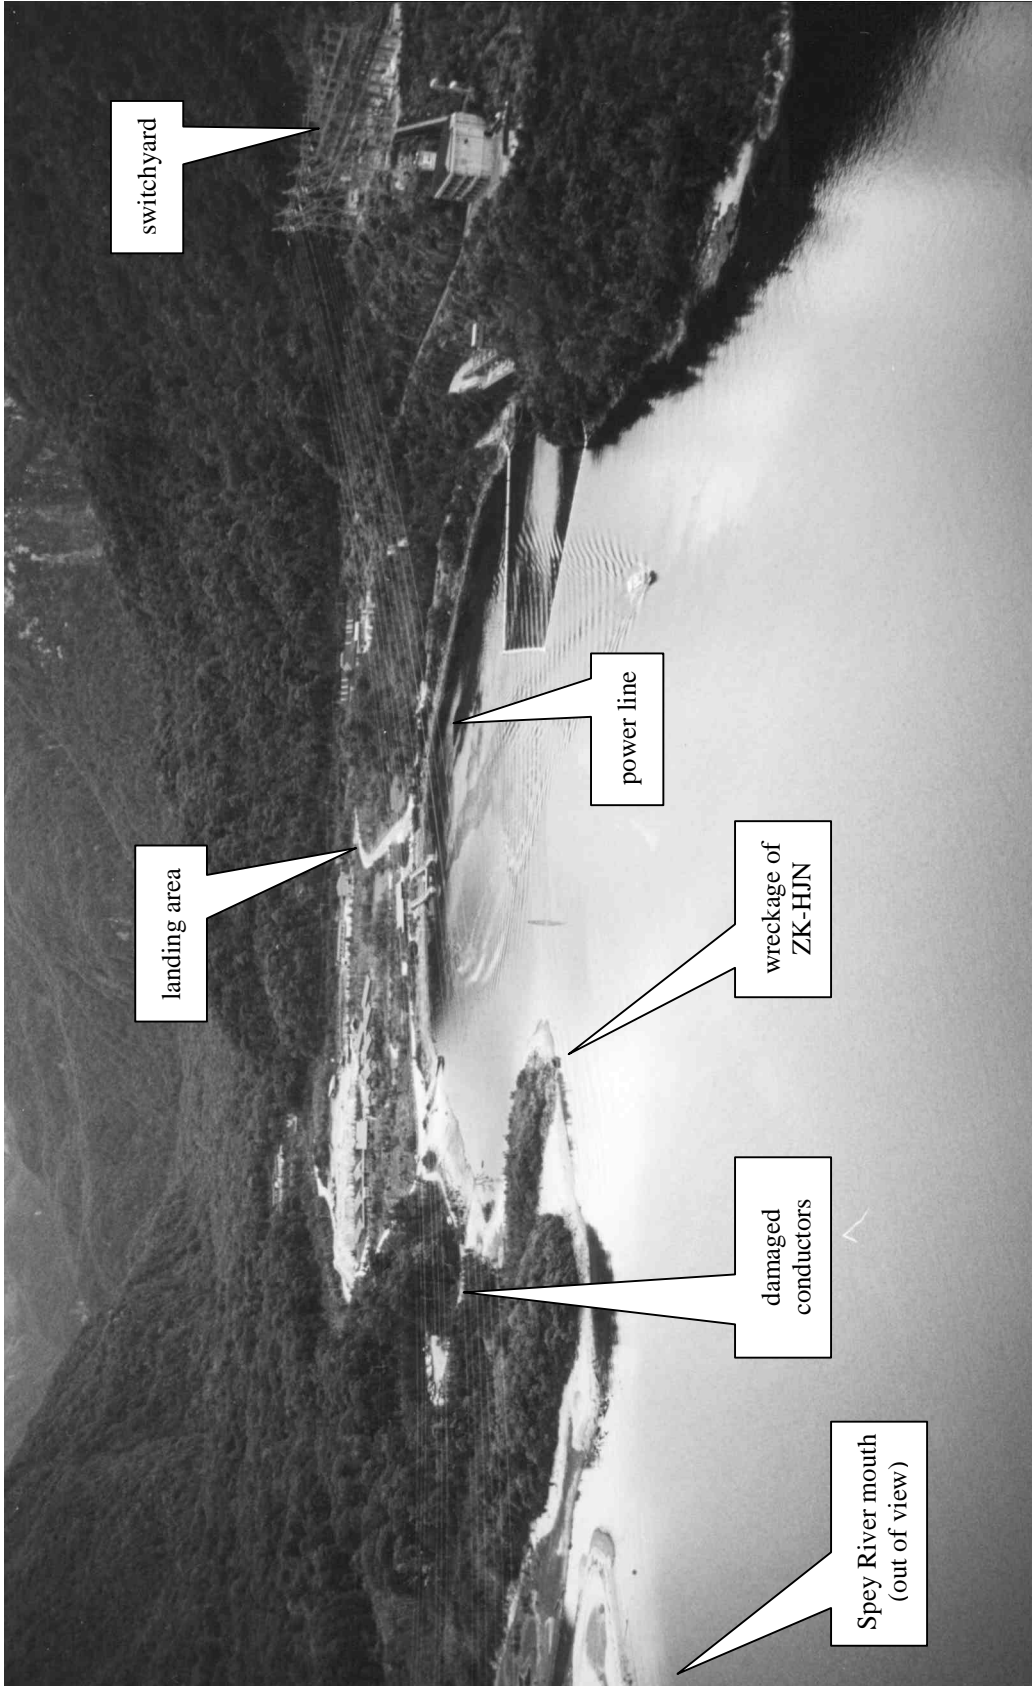
Figure 1
West Arm, Lake Manapouri

- 1.1.2 West Arm was the site of a small settlement at the western end of Lake Manapouri. The settlement supported tour groups travelling by road to Doubtful Sound, and workers at a nearby underground power station. Commissioned in 1969, the power station was located on the northern side of the arm. Above the power station was a switchyard from where power lines, comprising multiple conductors and earthwires, ran south-east across the lake to the southern side of the arm (see Figure 1).

- 1.1.7 As ZK-HJN turned through a northerly heading, the main rotors struck one pair of conductors of the high-tension power lines spanning West Arm. The helicopter then fell, out of control, impacted the ground and rolled down a small bank, coming to rest on its side near the edge of the lake.

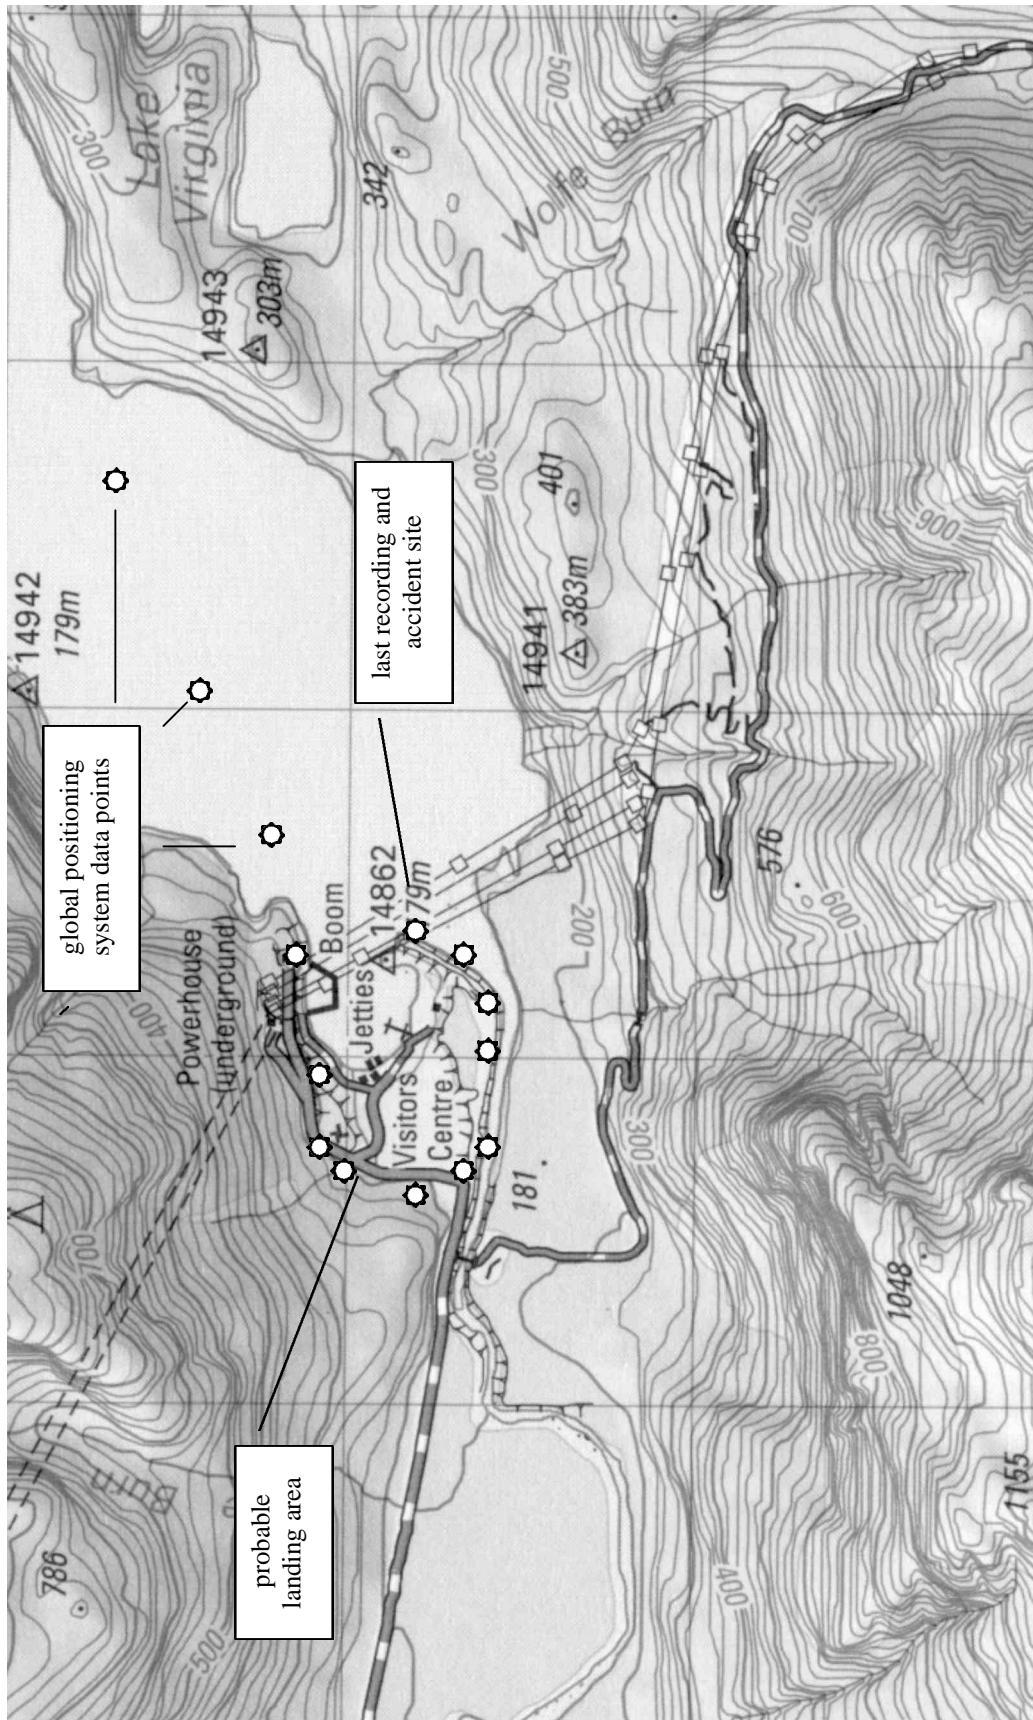
Figure 2
Global positioning system approach track flow by ZK-HJN

- 1.7.7 ZK-HJN flew about overhead the switchyard and continued on a westerly heading for some 500 m (see Figure 2). The helicopter then entered a left turn with a groundspeed of about 85 kts. As the helicopter approached the river, the rate of turn decreased and a short downwind leg of about 8 seconds was then flown. Groundspeed during this segment of the flight was about 80 kts. At about 200 m west of the mouth of the river, the helicopter turned left again and groundspeed continued to decrease to be about 70 kts. The final recording was at 1014 hours and 9 seconds.
