Report 00-012

temporary loss of air traffic control communications system

Christchurch main trunk air traffic services centre

25 October 2000

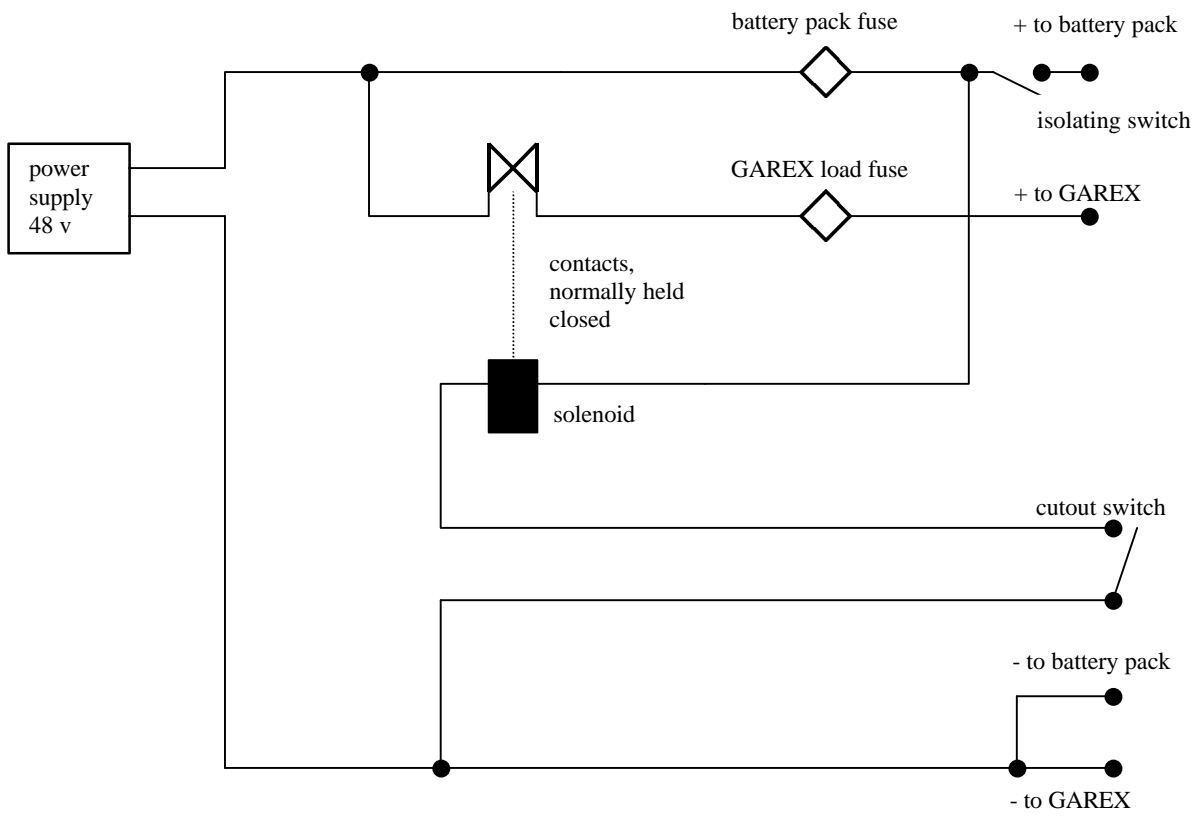
Figure 1
Simplified GAREX power connection diagram

- 1.9 The standby battery power pack fuse was situated in and before the line that supplied main power to the solenoid. The purpose of the fuse was to protect the battery power pack. Once the fuse was removed the main power supply to the solenoid was disrupted, but the solenoid remained powered by the standby battery power pack. When the battery power pack isolating switch was turned off it removed its power supply to the solenoid. The solenoid switch then opened, cutting main power to the GAREX (see Figure 1).

- 1.12 Following the power loss Airways identified a wiring deficiency in the GAREX system circuitry. The deficiency allowed the solenoid to be de-powered if the standby battery power pack fuse was removed, while the standby battery power pack was also disconnected. Airways advised that the solenoid main power supply circuitry would be modified by connecting it before the battery power pack fuse, thereby eliminating the potential for a similar occurrence. Other means of manually shutting off the GAREX from its power sources existed and could also be used to quickly turn off power to the system.

- 2.2 Although the GAREX system had several layers of power supply redundancy, there was a single failure point latent in the system because of a design deficiency. The failure point was not obvious and had not previously been identified. During normal operation a complete power loss was unlikely. In this instance the power loss was induced by the non-routine maintenance. Although a scenario analysis had been carried out before undertaking the non-routine maintenance, the single failure point was undetected. The subsequent action taken by Airways to eliminate the failure point should enhance the reliability of the system’s power supply redundancy and prevent a similar occurrence.
