Report 00-104
express freight Train 326
derailment
Pukekohe
6 April 2000

Abstract

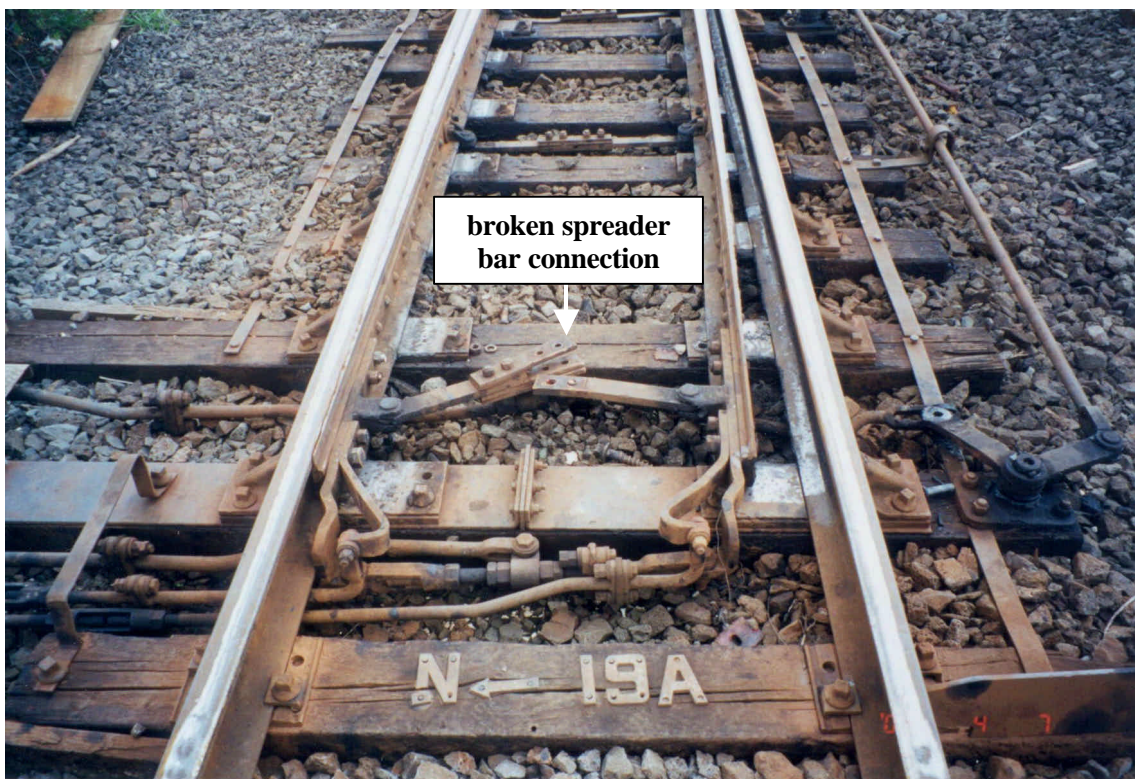
- 1.1.1 On Thursday, 6 April 2000, express freight Train 326 was travelling between Te Rapa and Auckland. The train consist was locomotives DX 5039 and DFT 7307 and 47 bogie wagons, with a gross weight of 1800 t and a length of 792 m.
- 1.1.2 At about 0942 hours as the train was passing through Pukekohe at 628.412 km NIMT the leading end of dragging brake rigging on the trailing bogie of wagon UK 14035 (the 19th wagon in the consist) impacted on the spreader bar of the up main line to loop turnout at the south end of Pukekohe.
- 1.1.3 The impact broke the spreader bar connecting the switch rails, causing the left-hand switch rail to be pulled away from the stock rail. Figure 1 shows the broken spreader bar connection.

Figure 1
Looking north at the up main to loop points following the derailment

- 1.1.4 The gap between the stock rail and the dislodged switch blade allowed the wheels of following wagons to take 2 roads simultaneously, resulting in 13 wagons derailing.

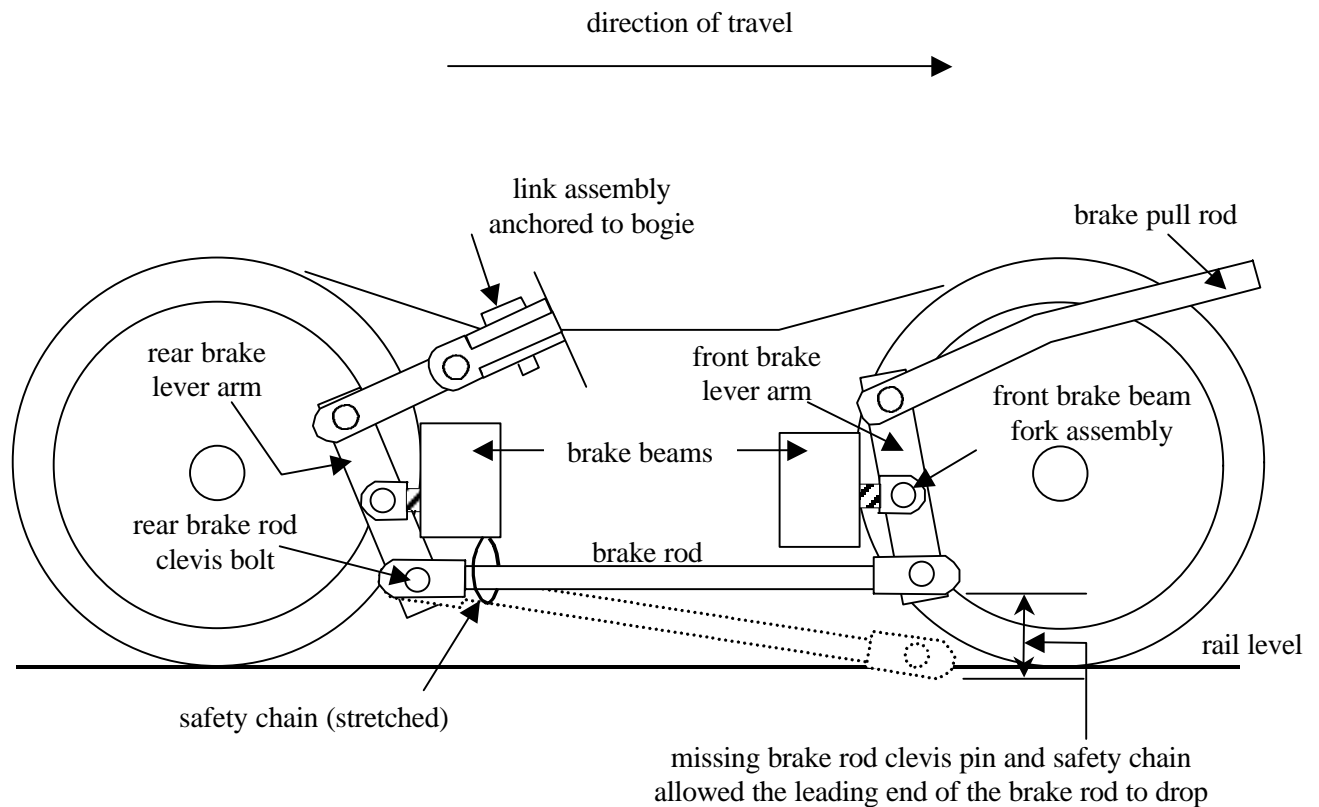
1.3.1 Wagon UK 14035 was the last wagon remaining on the track on the front portion of the train. Inspection showed the trailing bogie brake rod was fractured. The leading end of the fractured brake rod was found imbedded below the first sleeper past the broken spreader bar on the south end turnout. The trailing end was still attached to the wagon.

Figure 2
Diagrammatic section of the trailing bogie showing the brake gear

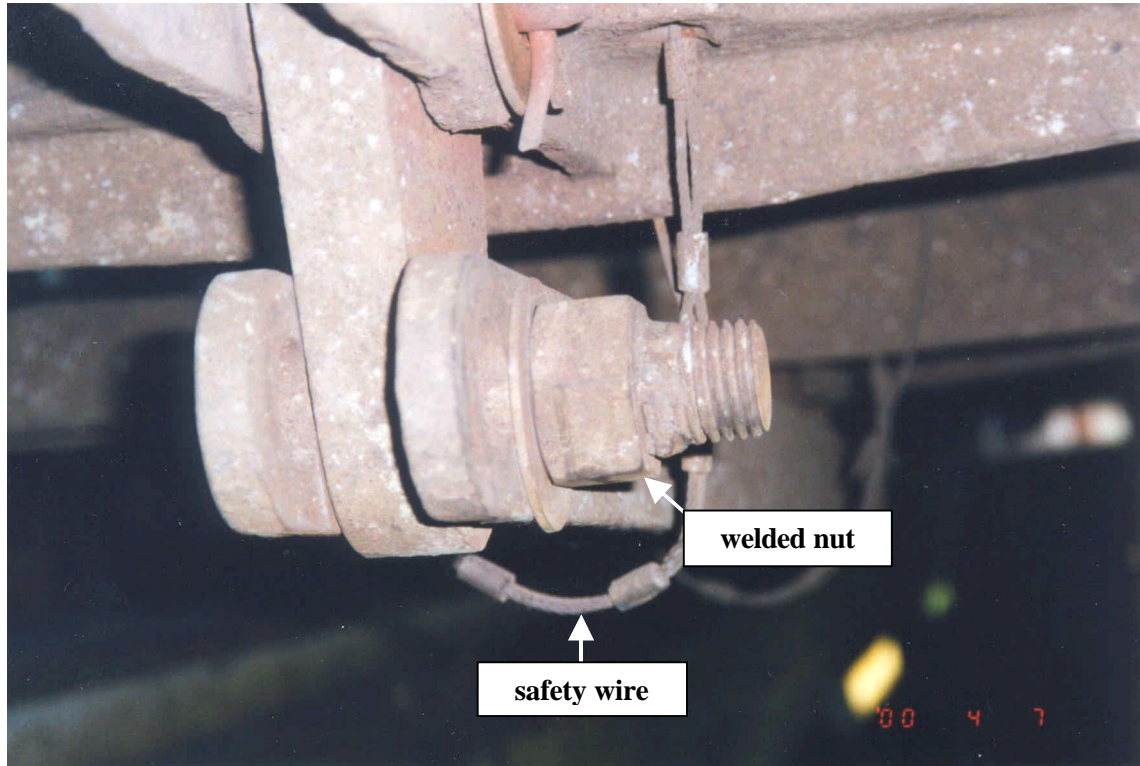
1.3.3 On UK 14035 the brake rod ends had been fixed by a clevis² pin and retaining split pin, with a safety chain at each end to retain a dragging rod. The more recent design used a bolt and welded nut connection instead of a clevis pin and split pin, in some cases with safety wires instead of safety chains. Figure 3 shows a typical installation of this type.

Figure 3
A typical modified support with bolt and welded nut, and safety wires

4.2 On 18 July 2000 Tranz Rail issued Field Modification Instructions MW 3024 which dealt comprehensively with the issues identified by:

- consolidating earlier Field Modification Instructions
- requiring replacement of fulcrum pins as well as clevis pins with a bolt and welded nut
- requiring replacement of safety chains with safety wires
- making these two modifications compulsory for all wagons which entered a depot
- requiring B checks outside depots to identify, and either action or specifically programme, wagons requiring pin modification, and to identify and action worn chains.

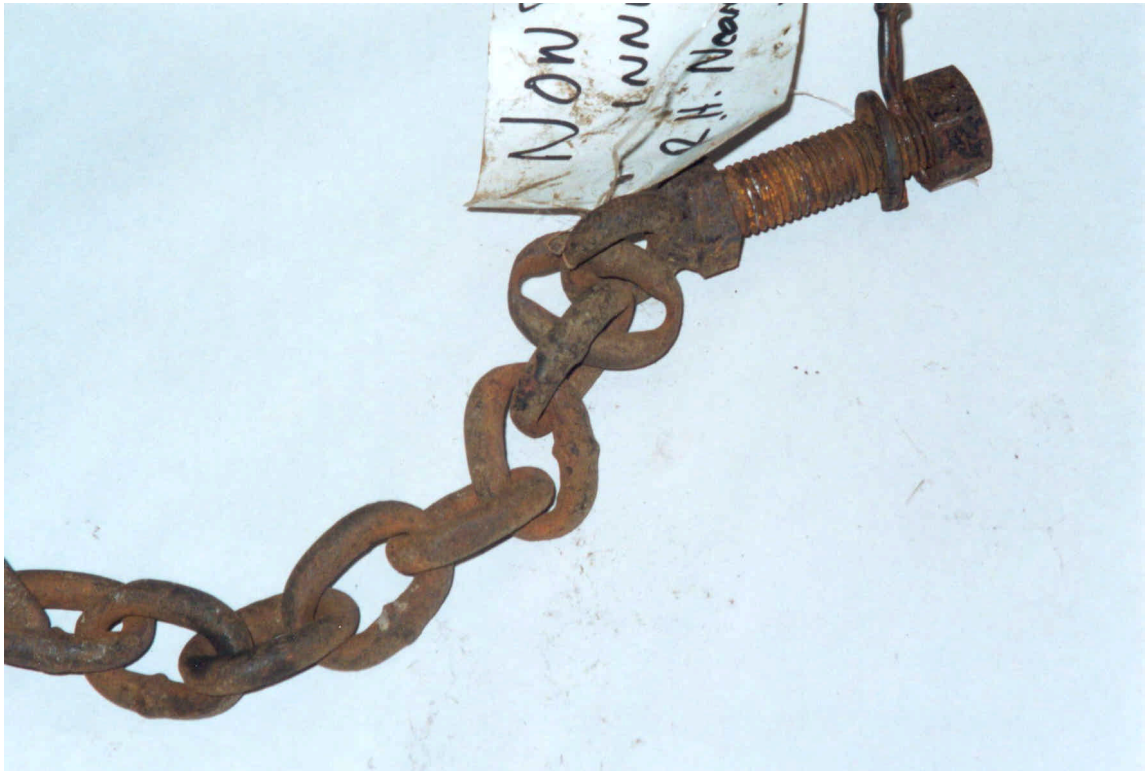
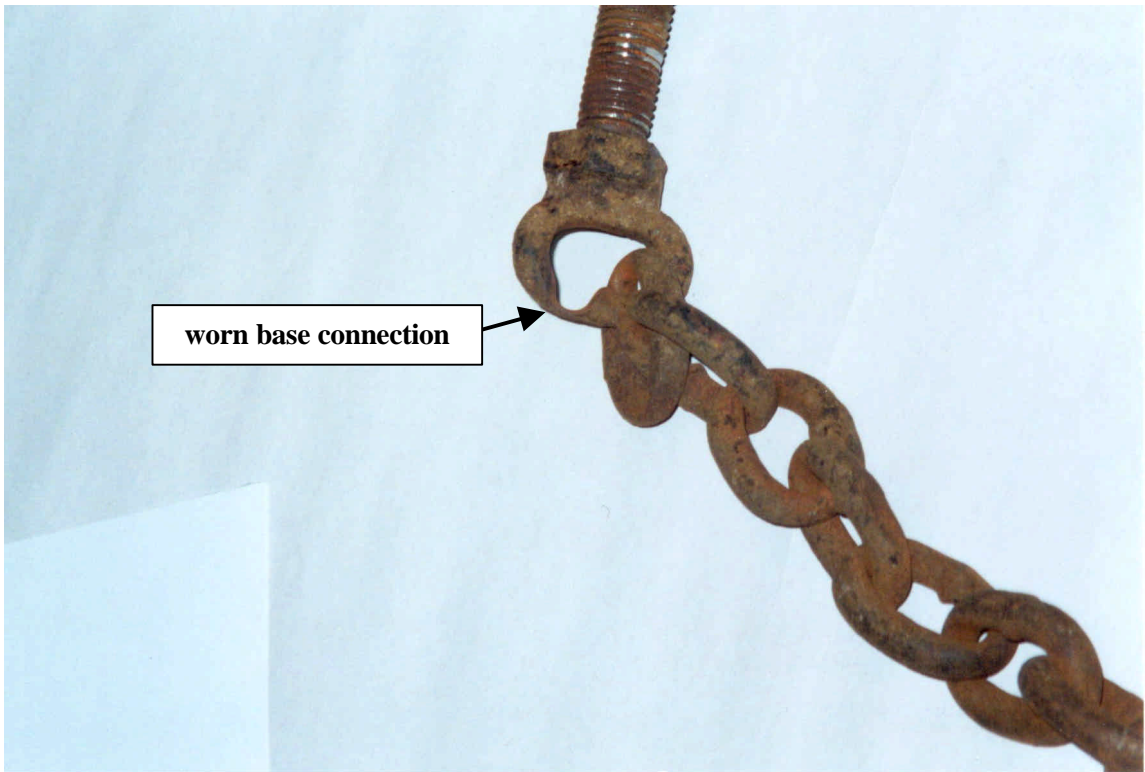
- 1.3.6 The 2 bolts fixing the leading-end safety chain to the wagon frame were in position. In each case the chain connection was worn and had failed. One connection failure looked aged, but the other connection failure looked recent, showing a shiny metal surface. Figure 4 shows typical wear in a safety chain and connecting bolts. This particular chain was supporting the leading bogie brake rod and was not affected by the derailment. The bottom of this safety chain was hanging 12 mm above rail level.

Figure 4
Worn connections from a safety chain under the leading bogie brake rod

2.3 The safety chains were intended to restrain the brake rod following such failures, until the failure was detected and repaired. It is unlikely that the leading safety chain was present when the brake rod dropped, and even if it had been, immediate chain failure was likely based on the worn condition of the other 3 safety chains on the wagon, and the worn condition of the bolt chain connections for the missing chain.

2.4 The wear of the safety chains had developed over years and would have been present at B check inspections for some time. These inspections failed to detect this defective safety critical component, despite the clear warning given by the Hapuku derailment and the action it should have generated. Inspection and assessment of safety chains was not being effectively actioned and this deficiency has been dealt with.
