## **Report 00-118**

express freight Train 520, Te Wera, 5 December 2000  
express freight Train 920, Pareora, 6 December 2000  
express freight Train 922, Shag Point, 6 December 2000  
express passenger Train 601, Opapa, 8 December 2000  
express freight Train 729, Ward, 14 February 2001  
express freight Train 234, Te Kawa, 2 March 2001

### **derailments or near-derailments due to heat buckles 2000/2001**

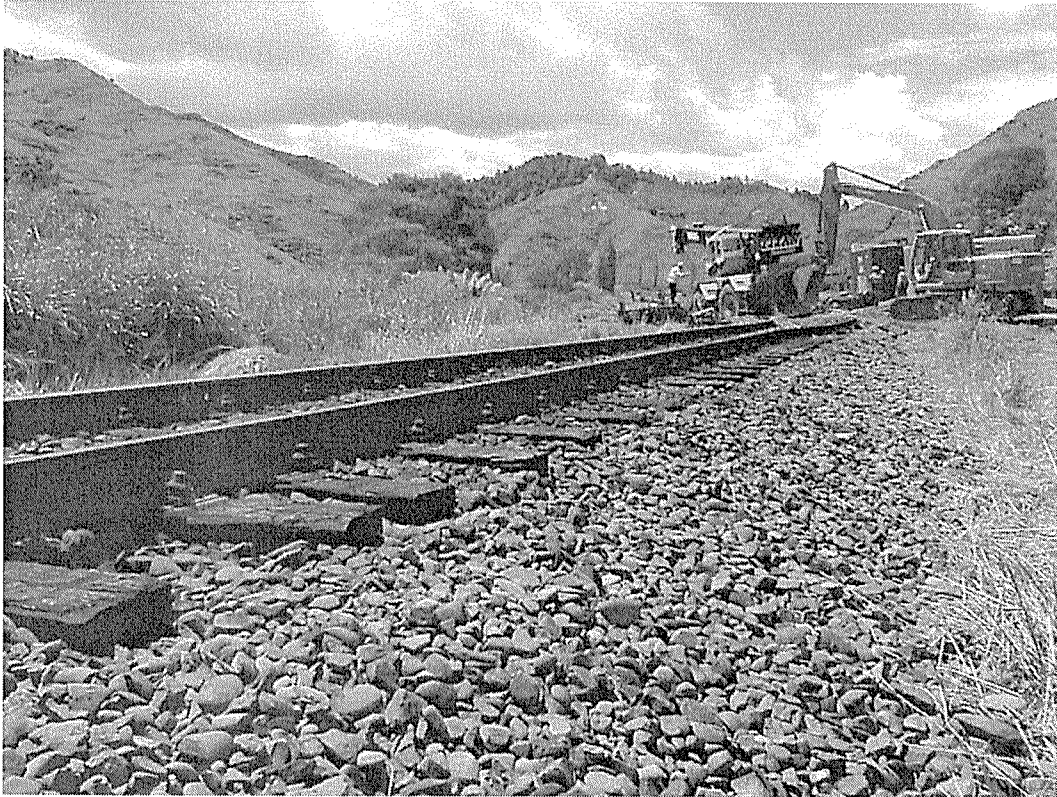
**Figure 1**  
**Typical ballast profile at 47.35 km SOL**

- 2.1.6 The CWR track consisted of 1962, 91 lb/yd rail on 1977 treated pinus radiata (TPR) sleepers and rail anchored every fourth sleeper. All fastenings were tight. The ballast section was of clean crushed metal with a depth of approximately 250 mm below the sleepers. The ballast shoulders on both sides of the track in the area of the derailment extended up to about half the depth of the sleeper as shown in Figure 1. Evidence in the ballast section indicated that the sleepers had moved approximately 100 mm to the right at the point of derailment (POD) at 47.35 km SOL and 250 mm to the right at 4 m after the POD.

- 2.1.7 The minimum new ballast section for CWR track, as stipulated in Tranz Rail's Code supplement CSP/55, for curves under 400 m radius was for the ballast shoulder to be heaped up 100 mm above the sleeper top for 450 mm outside the end of the sleeper and a minimum depth of 225 mm below the sleeper. Tranz Rail advised that the ballast profile, as distinct from the ballast depth, was also a minimum standard for maintaining existing track.

2.2.1 The likely cause of this buckle was the passage of the train triggering lateral movement due to the substandard ballast profile providing insufficient lateral resistance.
