## Report

### *Huka Jet 1*

**engine failure and collision with riverbank**

**16 June 2000**

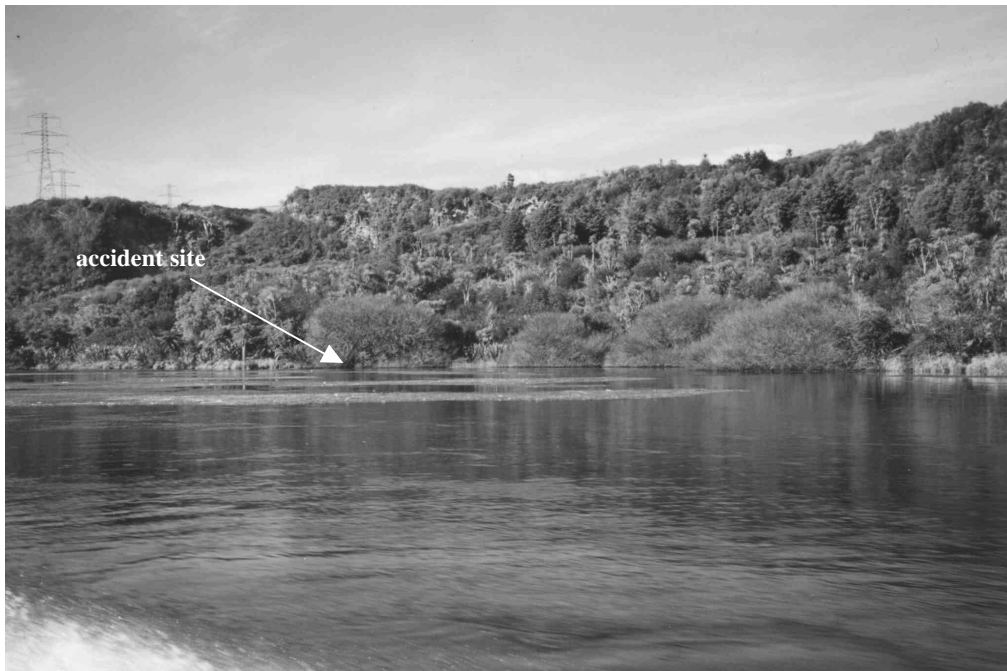
**Figure 2**  
**Accident site in “First Shallows”**

- 1.1.11 Three to four minutes later the driver landed his colleague on the riverbank track close upstream of the accident site and then proceeded downstream, where he manoeuvred his boat as close as possible alongside *Huka Jet 1*.
- 1.1.12 The passengers were transferred into *Huka Jet 3* and were taken back to the base. The 2 injured passengers were taken to a medical centre for treatment, while the others were given some refreshments. *Huka Jet 1* was recovered later and towed back to the base.

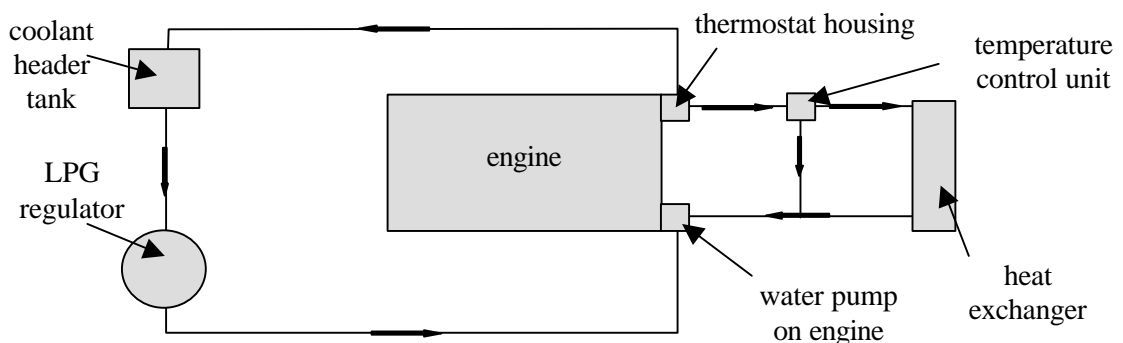
**Figure 4**  
Simplified diagram of engine coolant system

- 1.3.5 The engine was fuelled by LPG that reached the engine via a regulator, which reduced the pressure of the LPG as it left the fuel tank. The regulator caused the liquid, at a pressure of approximately 100 psi, to become a gas at approximately zero psi. Such a pressure drop would normally cause LPG to freeze, but this was prevented by warming the regulator using the circulating engine water coolant.

- 2.21 The replacement header tank was larger than that previously fitted, resulting in the top of the tank being sited lower than previously and subsequently lower than the regulator. Therefore the new arrangement did not comply with New Zealand Standard NZS 5422 as required by Maritime Rule Part 80.

- 2.22 The overflow reservoir was removed as part of the fleet standardisation modification but with the header tank and regulator being close to level, a small loss of coolant probably resulted in an air lock in the regulator. A clear plastic overflow reservoir, marked to show the desired level of coolant when the engine was cold, would enable the person carrying out the daily boat check to see if there was any leakage.

- 4.3 Before putting *Huka Jet 1* back into service, new brackets were fitted in the engine bay and the replacement header tank was raised so that it was at least level with the LPG regulator.

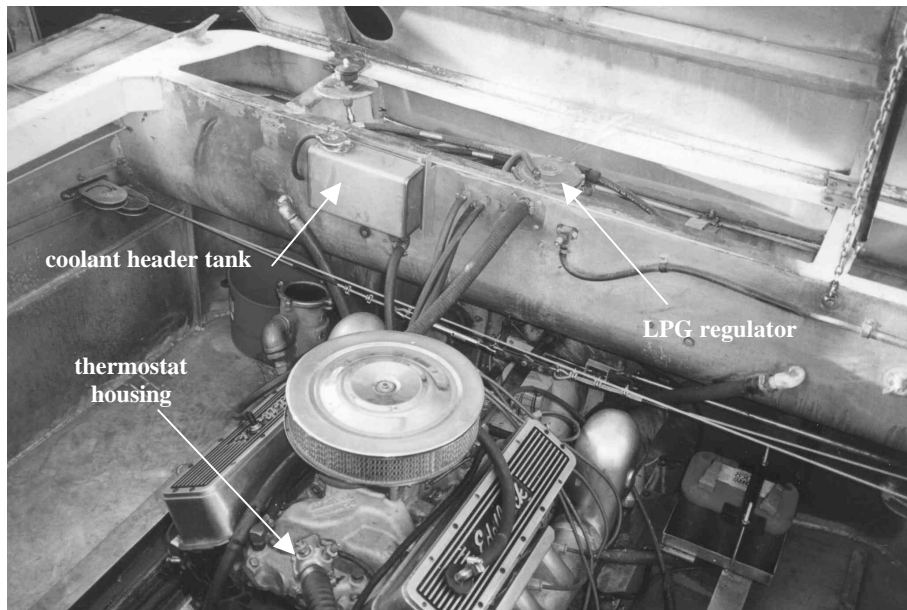
**Figure 5**  
**Engine bay of *Huka Jet 1***

1.4.2 The modifications consisted of replacing the water coolant hose connection where it exited the engine with an elbow that allowed the fitting of a thermostat and a coolant low level sensor, both of which had previously been situated low down in the coolant system. The replacement part was one of a consignment thought to be manufactured by General Motors of Canada and supplied to Shotover Jet Limited (Shotover Jet) in Queenstown. The technical services manager, who assisted the mechanic with the modifications, brought 2 housings with him from Queenstown.

- 1.4.3 At the same time, the water coolant header tank was renewed and the coolant overflow reservoir removed. The new header tank was larger than that previously fitted but was situated slightly lower.
- 1.4.4 The modifications were intended to give a greater volume of water coolant within the system and to give an earlier warning of coolant loss. The coolant overflow reservoir was not considered to be necessary with the increased volume of the new header tank.

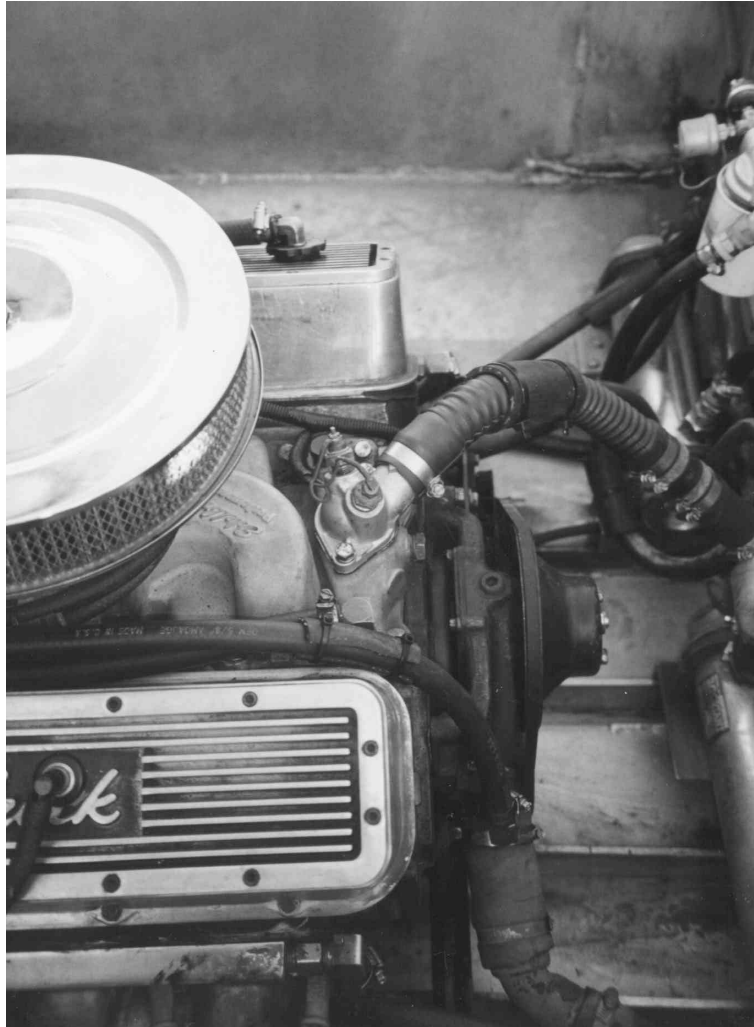
**Figure 6**  
**Thermostat housing and associated plumbing**

- 2.14 The thermostat housing that was fitted during the modification was cracked on its underside and would have been leaking during the 22 hours' running since fitting. The leak would have further reduced the volume of water within the cooling system.

- 2.15 With the water level reduced by normal running and also from the leaking thermostat housing, air probably entered the system and would have naturally progressed to the LPG regulator; the highest point in the system. The air would then have been trapped in the regulator and would slowly increase each time the boat was run with a lower than normal water level.

- 4.1 The cracked thermostat housing was replaced immediately after the accident.
- 4.2 Shotover Jet sent a service bulletin to all its subsidiary operators requiring that any thermostat housings similar to the one that failed on *Huka Jet 1* were to be specifically inspected for signs of cracking. No cracks were found.

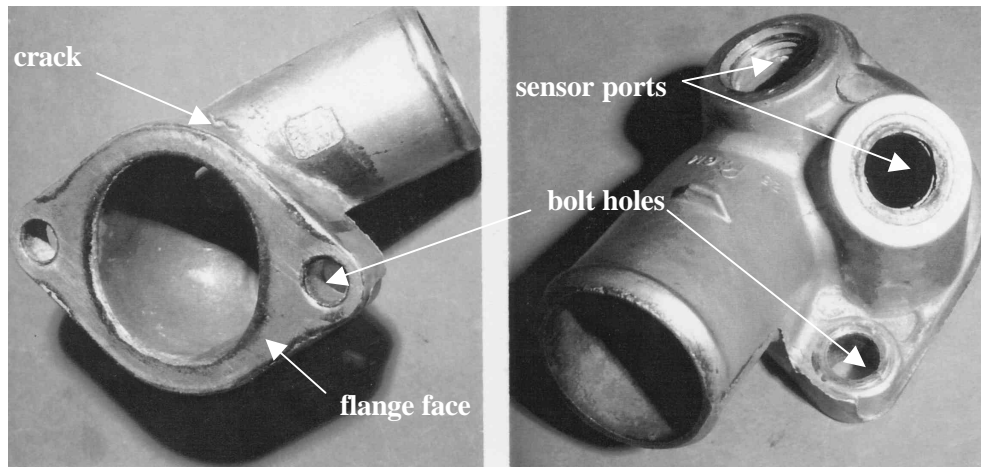
**Figure 7**  
**Thermostat housing**

- No evidence of any gross manufacturing defects was present.
- It [the fracture surface] was not typical of a fatigue fracture or stress corrosion crack.
- The thermostat housing failed as a result of overload

- The fracture surface was ultrasonically cleaned and examination in a scanning electron microscope (SEM) revealed the surface was corroded.
- The surface of the housing was a dull grey colour and was not typical of a brand new item.

- On the side of the housing, an area of about 30 x 30 mm appeared to be covered with a metallic coppery brown paint. A sample was analysed in an SEM using an energy dispersive X-ray analyser. This revealed that the sample was typical of a polymeric material but it was rich in copper, aluminium and silicon. These elements could be present in a metallic paint. They are not typical of being in an oil or grease.
- It is highly unlikely that the overload of the housing occurred in the boat during normal operation.
- The thermostat housing had been installed 7 days before the accident. The flange face had been scraped and the area around the bolt holes was scored due to nuts being tightened more than once.

- 2.25 Both metallurgists who examined the failed housing agreed that it had failed in overload and that, because of the corrosion at the fracture surfaces, it had been cracked for some time before the accident.

- 2.26 The corrosion products present in the crack were both aluminium, which would occur after a fracture, and red oxide, probably deposited from the cooling water as it leaked through the crack.

- 2.27 The position in which the housing was sited meant that the crack was unlikely to have occurred during operation. The crack was on the underside of the housing and would have required an upward force to start it. The newly fitted plumbing was of a flexible nature and would not have exerted undue force on the housing.

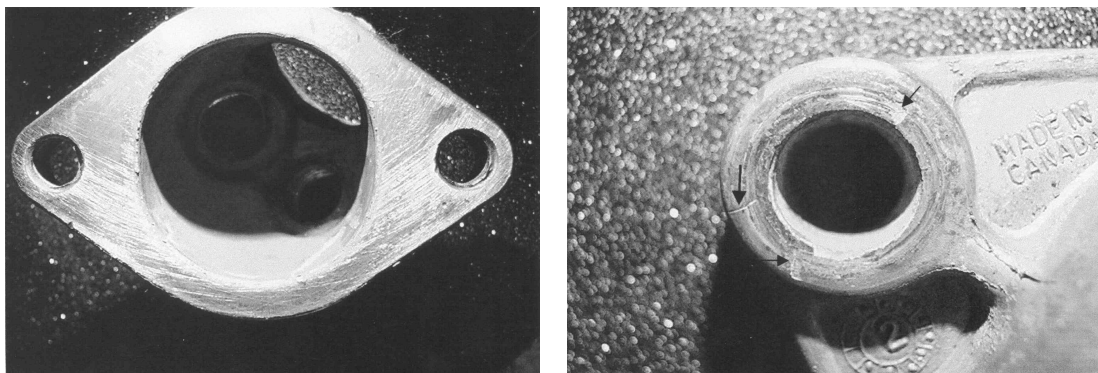
**Figure 8**  
**Scrape marks on flange face (left) and scoring on bolt holes (right)**

- The possibility that the housing had previously been installed in a metallic coppery brown vehicle cannot be discounted.
- It is possible that the housing was cracked before it was installed in [*Huka Jet 1*] and that the leak rate was sufficiently low to allow the engine unit to run for 22 hours before the LPG unit froze, especially if the water system had been topped up. If the housing had been previously cracked, the corrosion of the fracture surface may have assisted in stopping the leakage through the crack.

- The markings on the boss of the attachment holes, where even the un-used part has damage, are due apparently to the broaching tool used to clean the flash from the slightly misplaced jointing line between the two halves of the die cavity.

- 2.28 The metallurgists who examined the housing held differing views on the origin of the crack. One maintained that the housing had been in prior service and might have been damaged by an impact during fitting or removal. This contention was based on the marks found on the securing bolt holes, the scrape marks on the flange face, a partial covering of "paint" and its dull colour.

- 2.29 The first metallurgist later conceded that the marks on the housing could have been caused when the mechanic changed the gasket during initial investigations and that although his analysis of the "paint" was typical of paint, it could also have been the jointing compound used on the gasket. The dull colour of the housing could be explained by it having been in service on *Huka Jet 1* for 22 hours. He found no evidence of any gross manufacturing defects and the theory that the housing had been damaged during prior service could not be fully discounted.
