Report 00-209

fishing charter vessel

La Nina

grounding and foundering

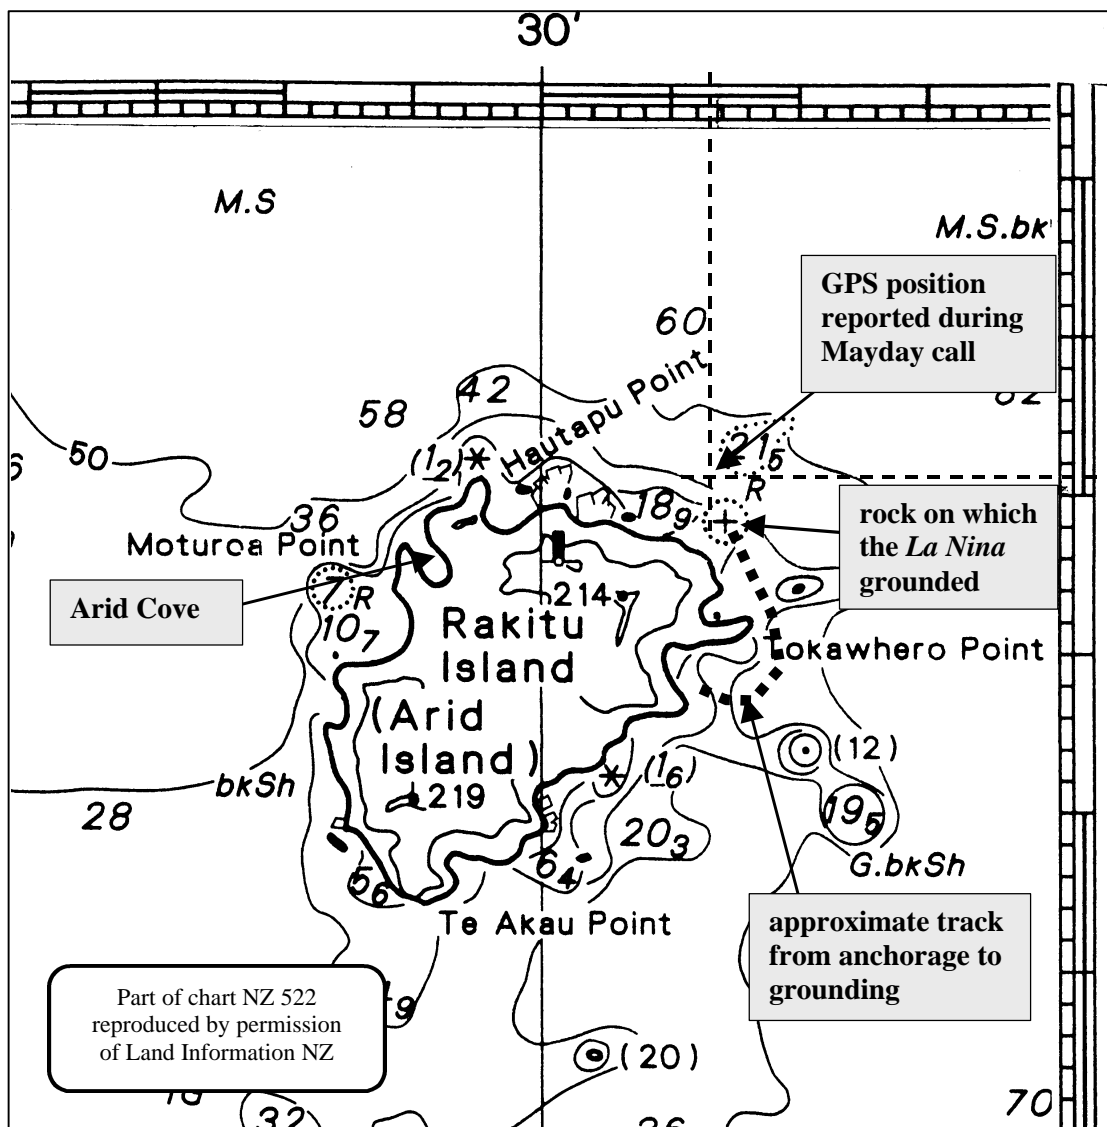
Figure 2
Part of chart NZ 522 showing approximate track to grounding

- 1.1.22 About 2 minutes later, just as he had found his pen, the *La Nina* hit an underwater rock. The boat slowed almost to a stop and began to settle by the stern. The skipper immediately took the engines out of gear. He called Great Barrier Radio on VHF radio and advised them of the grounding. His call was timed at 1843. He told the radio operator his approximate position and that the boat was taking on water. He said that he would call back in about 5 minutes to give an update.

- 1.1.25 It was apparent that the *La Nina* was not stuck fast, but had passed over the rock and was drifting to the north-east. The skipper had tried to get the engines back into gear without success. The boat was settling rapidly by the stern although not listing. He sent a Mayday to Great Barrier Radio on VHF radio, timed at 1844, and confirmed that they were abandoning the *La Nina*. When asked for a position he gave the latitude and longitude showing on the GPS plotter, which was 36° 06.947' S 175° 30.678' E.
