**Report 01-002**

**Fairchild SA227-AC Metro III**

**ZK-RCA**

**bird strike and loss of both engines**

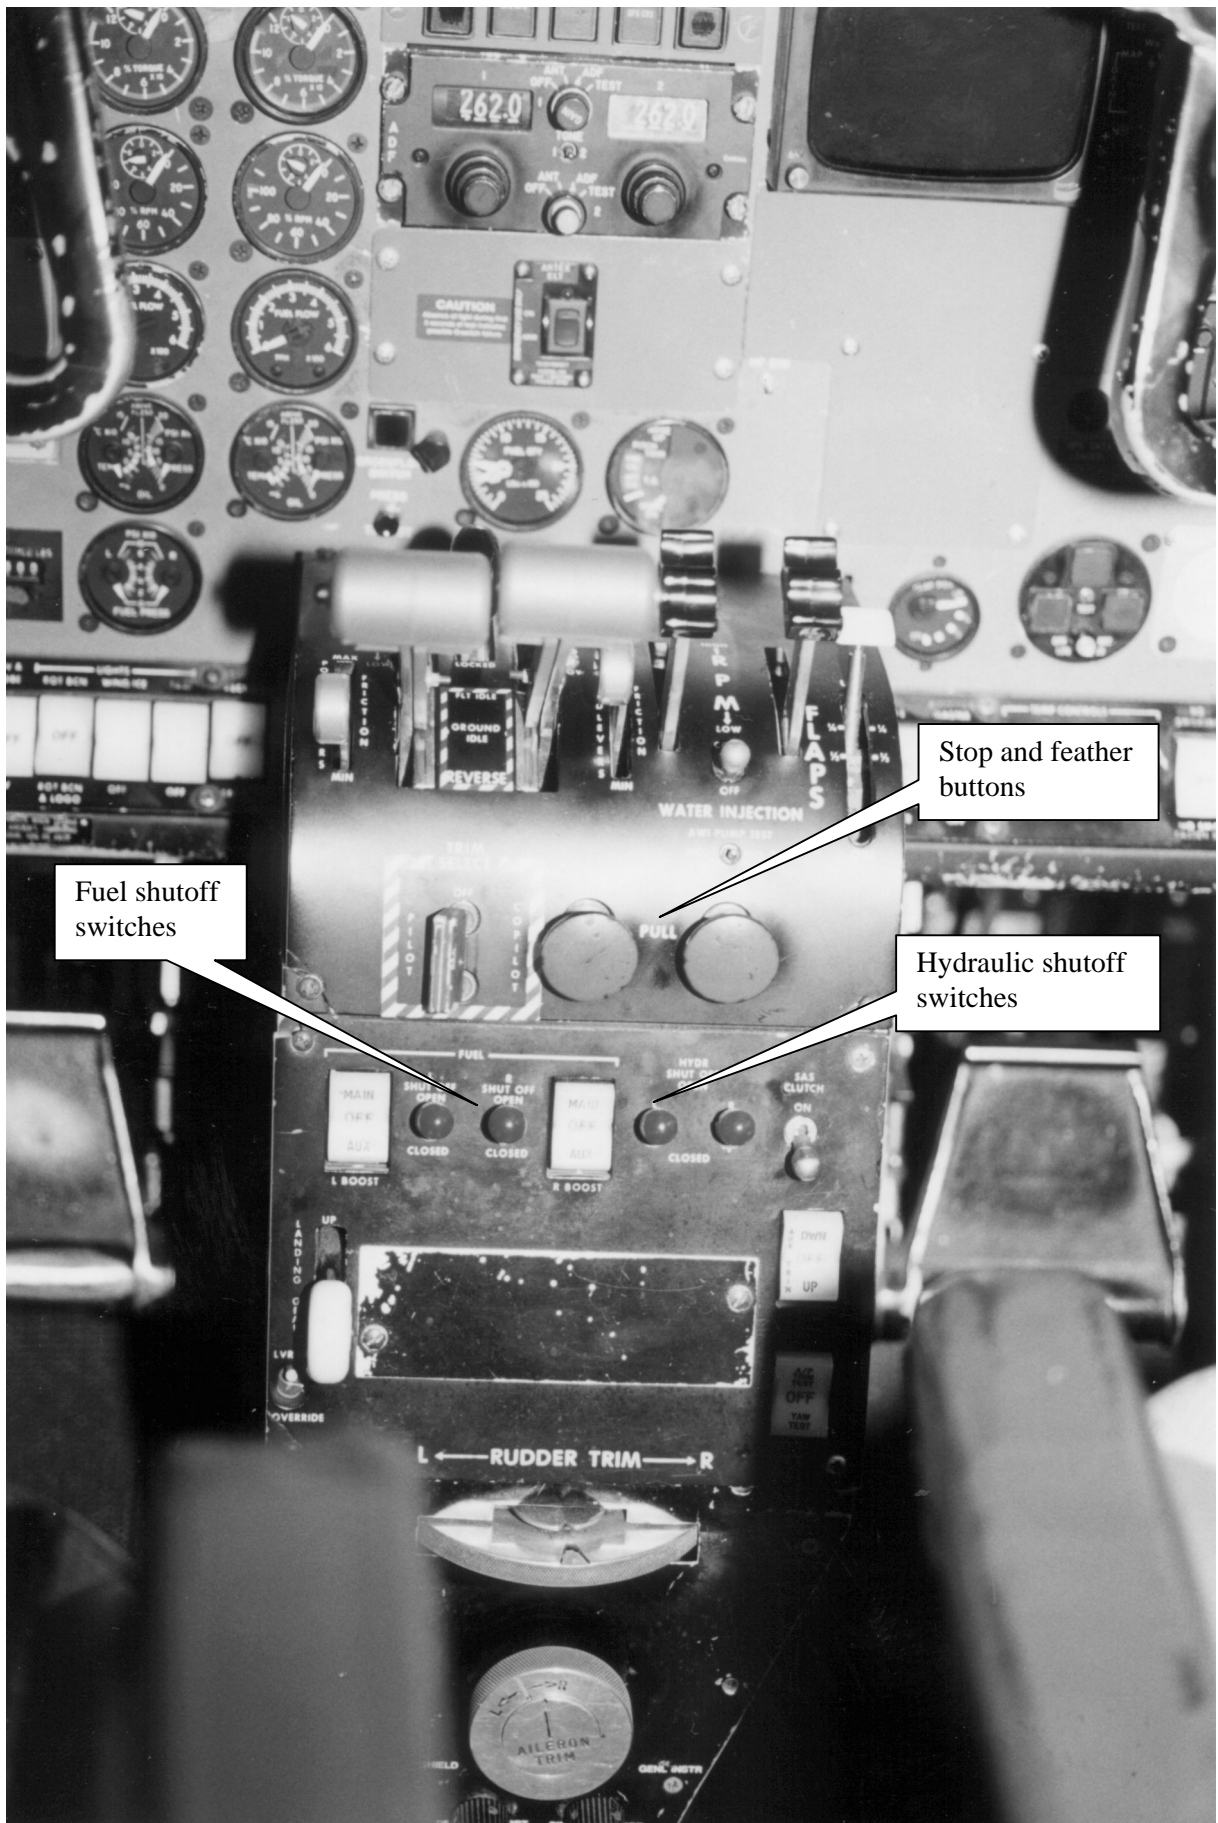
**Figure 1**  
**Aircraft instrument panel for the Fairchild SA227 Metro**

- 1.5.4 The aircraft instrument panel for the Fairchild SA227 Metro followed conventional methodology, with separate flight instruments for the captain and first officer (see Figure 1). The layout of the engine performance instruments was also conventional with the instruments for the left-hand engine in a vertical row to the left of the instruments for the right-hand engine. On the central pedestal, engine control levers and switches were also divided to the left and right, generally in pairs going down the pedestal, except the fuel and hydraulic shutoff switches; which were identical and in a single row across the pedestal. The 2 sets of switches were separated in the centre by a fuel boost switch, with the 2 fuel switches to the left of the boost switch and 2 hydraulic switches to the right. With the left ENGINE STOP AND FEATHER button pulled, it was difficult to see and identify the 2 HYDR (hydraulic) SHUTOFF switches from the left-hand seat.

- 2.9 The positioning of the fuel and hydraulic shutoff switches across the centre pedestal, instead of down the pedestal in pairs, predisposed them to misidentification. This was further compounded by the 2 sets of switches being identical. Ideally, either the fuel and hydraulic switches, or the left and right switches for each, should have varied in their design or perhaps colour.

- 2.10 With the captain's hand on the left-hand fuel shutoff switch and the left-hand feather and stop button pulled, the wording for the switches would have been partly obscured from him. The next item after selecting the left-hand fuel shutoff closed was to select the left-hand hydraulic switch to closed. With the wording partly obscured the captain would have needed to fully remove his hand to correctly identify the left-hand hydraulic switch. It would have, however, been easier to simply slide the hand across to the next switch to be moved. The next switch across being the right-hand fuel shutoff switch.

- 3.6 The captain probably selected the fuel shutoff switch for the right-hand engine instead of the hydraulic shutoff switch for the left-hand engine, an action not detected by the first officer.

- 3.7 The ergonomics of the switches on the central pedestal predisposed them to misidentification.
- 3.8 The incidence of bird strikes and near strikes by spur-winged plovers has increased significantly since their arrival in New Zealand, and they now pose the largest single wildlife threat to aviation safety.
