Report 01-003

Hughes 369D

ZK-HMN

in-flight engine flameout

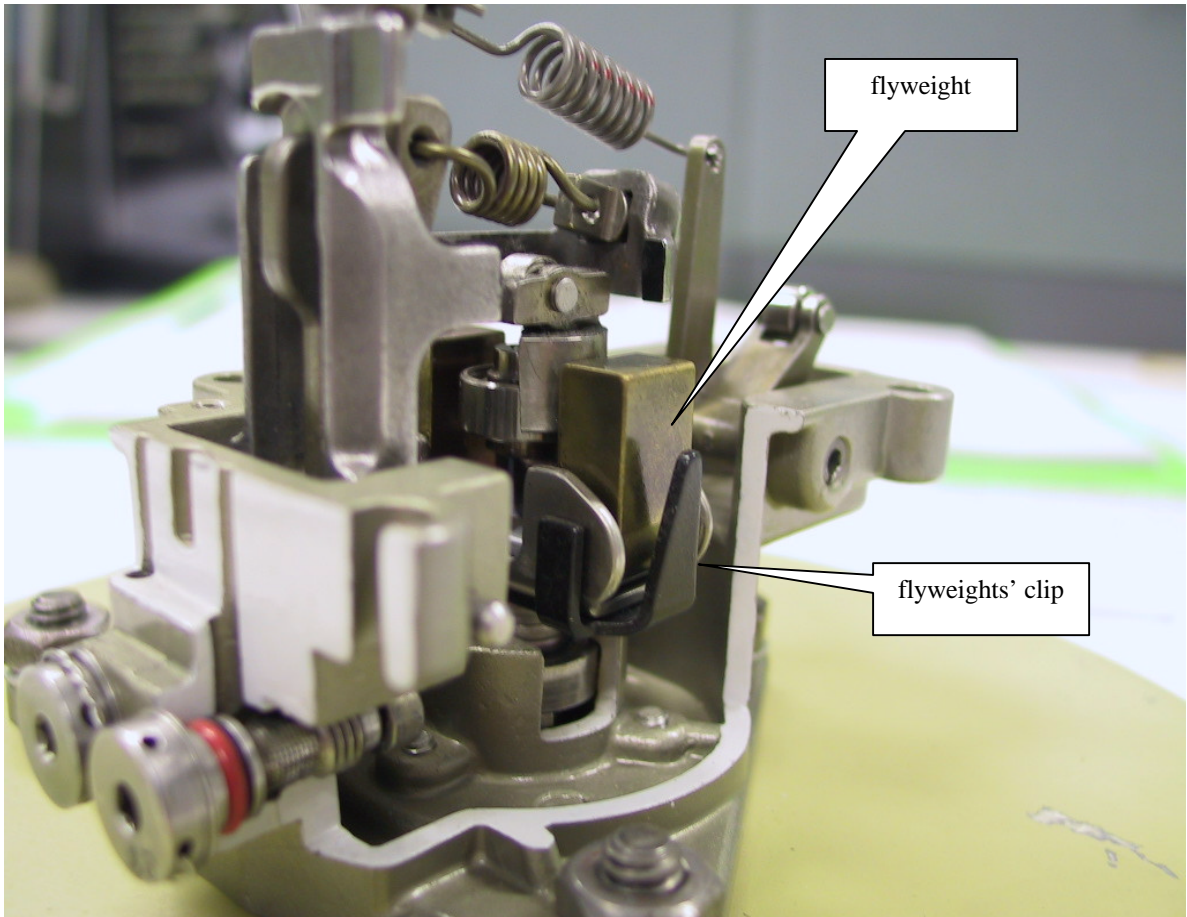
Figure 1
Cut-away view of a model FCU drive body

- 1.5.13 The FCU was fitted to a test bench for a "run as received" test in accordance with the manufacturer's specifications. A direct telephone communication link with the manufacturer was established for the testing. The necessary test requirements under test points 9 (maximum governor spring setting) could not be achieved. Following various checks the ambient air pressure vent screen was removed to allow viewing of the flyweights. The flyweights' clip weight stops were observed to be set incorrectly, thus restricting the flyweights' travel. Removal of the drive shaft assembly and subsequent measurement of the flyweights' clip showed the weight stops were set to allow one flyweight to travel 0.042 inches (1.067 mm) and the other 0.044 inches (1.118 mm). The clip should have been set to allow the flyweights to travel 0.100 to 0.105 inches (2.540 to 2.667 mm). (See Figure 1.)

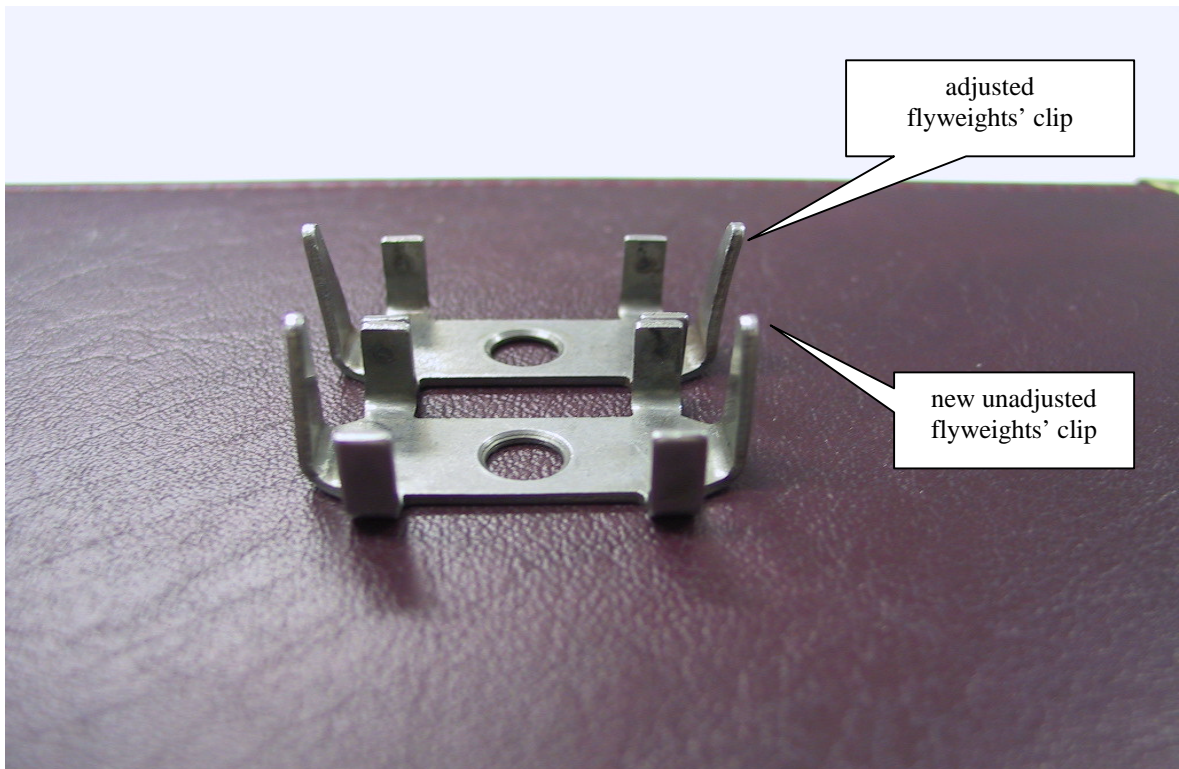
Figure 2
FCU flyweights' clips

- 1.5.14 Examination of a new unadjusted flyweights' clip from the manufacturer showed it would restrict the flyweights' travel, similar to that found on the faulty FCU. (See Figure 2.)

- 2.3 Two main problems were found in the FCU. One was the condition of the P_X (P_C to P_X) air bleed restrictor orifice, which was deformed and enlarged. The other was the incorrect setting of the flyweights' clip, which restricted the flyweights' travel to less than half the required distance.

- 2.7 Because the FCU flyweights' clip restricted the flyweights' travel to less than half the required distance, the FCU could not adequately control any tendency for engine N_1 overspeeding. Any N_1 increase would cause the N_2 to increase. N_2 was controlled by the PTG, which was effective from 98% N_1 . The PTG, therefore, had limited effect and was not able to fully govern N_2 and adequately control rotor speed.

- 2.11 The FCU overhaul and repair records did not show that the flyweights' clip had been replaced. However, the clip was probably replaced with a new item during the repair and not adjusted and recorded. The clip weight stops were near perpendicular, similar to an unadjusted new item. Both the overhaul and repair records' data entries recorded the clip weight stop adjustments as being appropriate. Since the dial test indicator was correctly calibrated, this suggests either the data was entered on the repair documents without the appropriate measurement check being completed, or the check was inadequate.

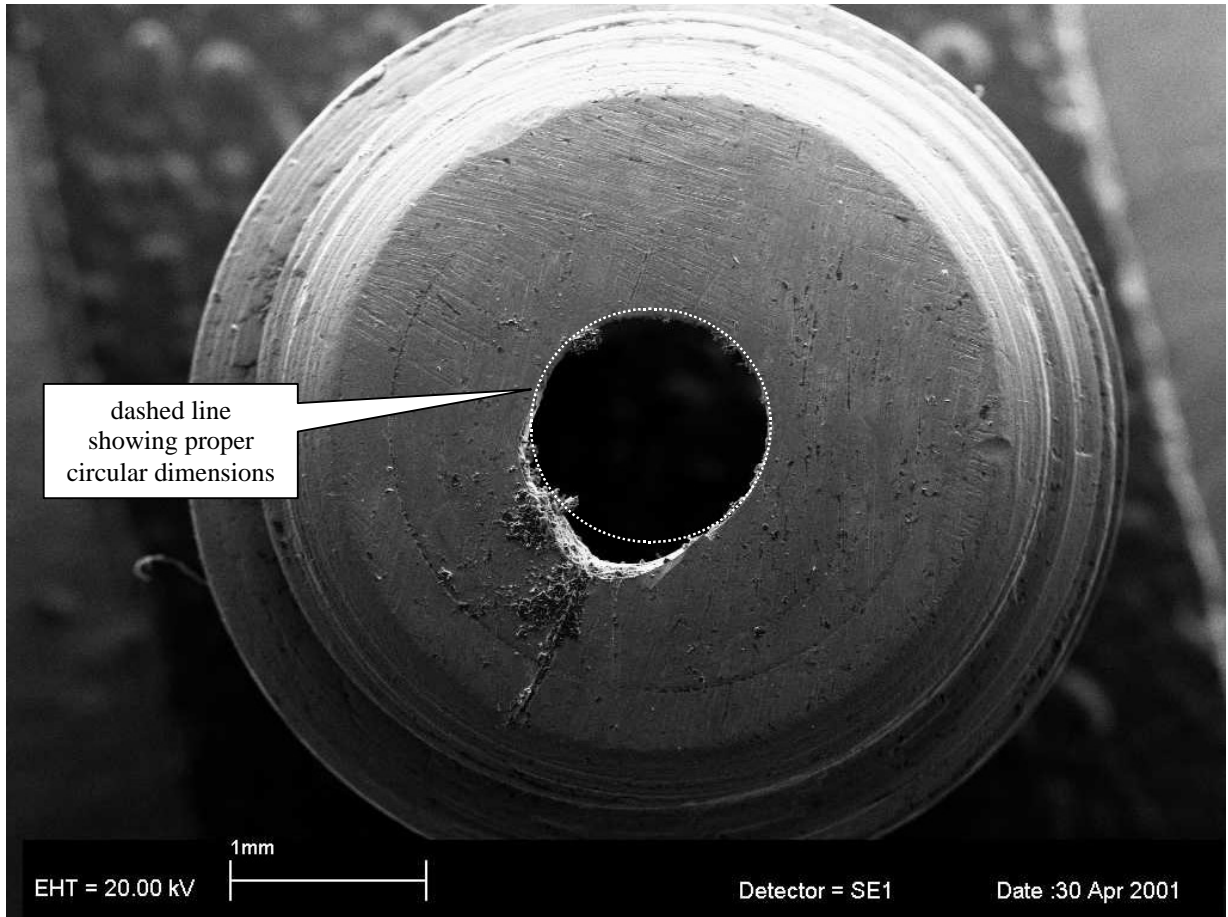
Figure 3
P_x air bleed restrictor orifice

- 1.5.16 The FCU was disassembled in stages and examined. The P_X (P_C to P_X) air bleed restrictor was examined and viewed under a 40-power microscope. The P_X air bleed restrictor orifice was enlarged on one end and misshapen, resembling an egg-shape. Two prominent score marks (like cracks) resembling a "V" shaped groove emanated from the orifice at the misshapen end. The surface around the orifice was scratched. A screwdriver slot on the opposite end of the restrictor, to allow for its assembly to and disassembly from the FCU, was deformed significantly.

- 1.5.22 The P_X air bleed restrictor was further examined under a scanning electron microscope, and compared with another used P_X air bleed. The orifice was not circular but had been enlarged on one end. Close examination revealed a round object had enlarged the orifice. Debris consisting of oil and dirt was present adjacent to the enlarged end of the orifice. A “V” shaped groove ran in a radial direction from the enlarged end of the orifice and was aligned with the centre of the enlarged orifice. Two score marks defined the edges of the “V”. There were no cracks. At the enlarged end of the orifice, the side of the orifice was not perpendicular to the axis of the P_X air bleed restrictor, but at an angle to the axis. Marks present on the face of the enlarged end of the orifice showed a round object had probably been pushed into the orifice at an angle to the axis. Two separate indents were present, showing the round object had probably been pushed into the orifice on more than one occasion. Numerous grinding or polishing marks were present on the face around the orifice (see Figure 3).

- 2.4 When the damage to the P_X air bleed restrictor orifice occurred could not be established. A circular object pushed through the P_X bleed orifice probably domed the base of the P_X bleed around the orifice. The "V" shaped groove in the base of the P_X air bleed was probably formed as a result of restraightening the base after it was domed. Although the manufacturer's tests showed the orifice's condition would not have caused any major anomalies, the manufacturer said it should not have been installed in the FCU in that condition.
