Report 01-004

Boeing 767-319

ZK-NCH

failure of flap deflection control track

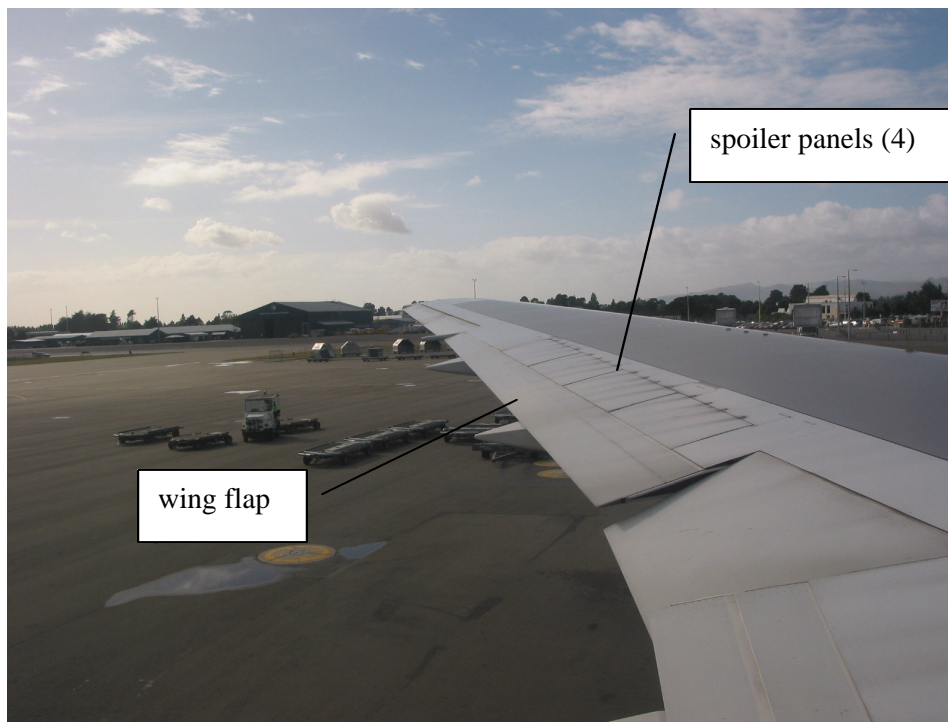
- 1.1.2 Shortly before landing and as the last increments of flap were lowered, the couple saw something suddenly flick out from under the outer edge of “the outboard spoiler” and stick up into the airflow. They estimated the object was about 50 cm or more in length, black in colour and, while firmly attached, did move around a lot. The flap remained in position and did not seem affected by the movement of the object. The couple noticed no similar protuberance on the right wing. The object disappeared into the wing when the flaps were retracted after landing and while the aircraft was slowing to taxi speed. The flap and spoiler sat flush with the wing at this time.

Figure 1
View from row 26 of left wing of Boeing 767-319 (same model as ZK-NCH)

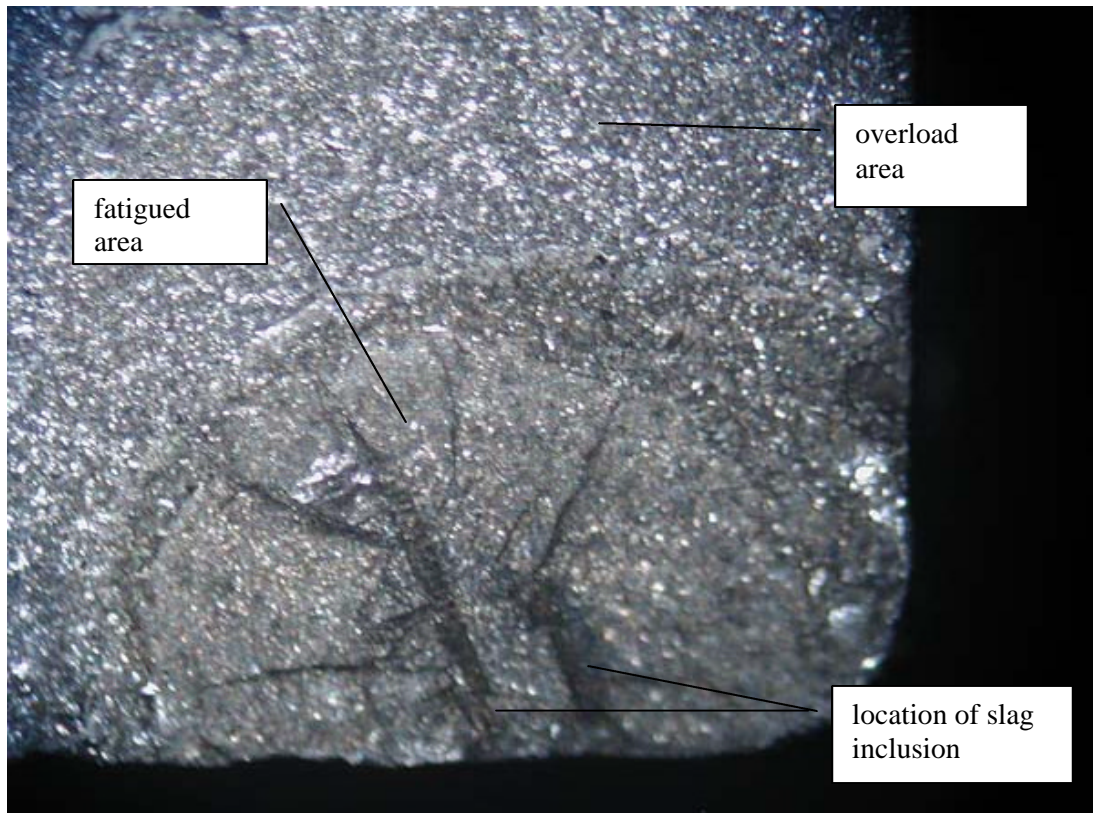
- 1.8.1 The 2 sections of the flap control track were subjected to independent metallurgy testing (see Figures 4 and 5). The report on the testing is summarised as follows:

The fracture resulted from fatigue initiated at a casting defect (slag inclusion) at the surface of the tension face of the guide fillet, which had subsequently developed fatigue cracking. The fatigue crack had grown to a size (approximately 4 mm wide by 2.7 mm

deep) such that, at the applied stress level at the instant of failure, the part had fractured by a cleavage (fast, brittle) mechanism initiating at the fatigue cracking.

The casting defect was of the nature of an extrinsic (chance) defect resulting from the incorporation of a small amount of manganese-silicate slag into the liquid metal stream when the part was being poured, which had become trapped near the surface of the casting in this critical area of the structure.

Figure 5
Fracture surface (close-up)
