# AVIATION OCCURRENCE REPORT

01-005R Bell UH-1H Iroquois ZK-HJH, in-flight break-up, Taumarunui

4 June 2001

**Report 01-005R  
(Resumed investigation)**

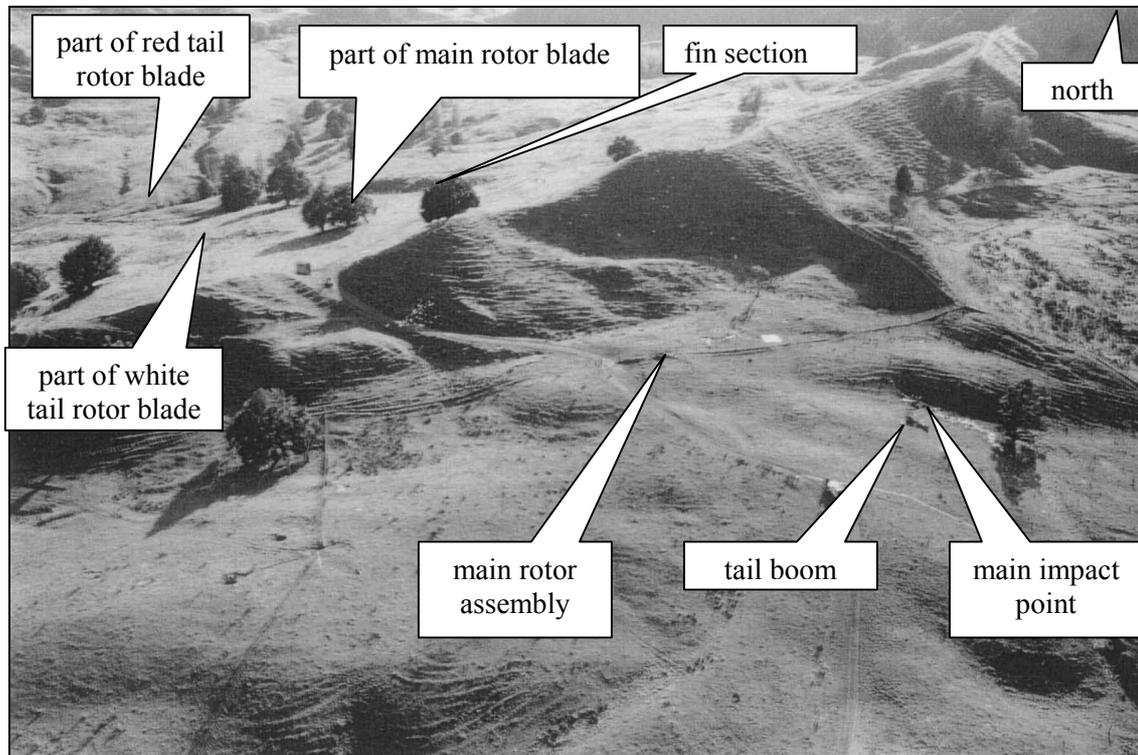
**Figure 1**  
**Accident site**

- 1.9.1 The accident site was on the northern side of Echolands Valley, on hilly farm land about 300 m north of Echolands Road and about 5 km east of Taumarunui. The elevation of the accident site was about 800 feet above mean sea level (amsl).
- 1.9.2 The wreckage of ZK-HJH that was found was spread over a distance of about 450 m along a slight curve to the right. The bearing from the first item of wreckage located to the main impact point was 099° magnetic (see Figure 1).

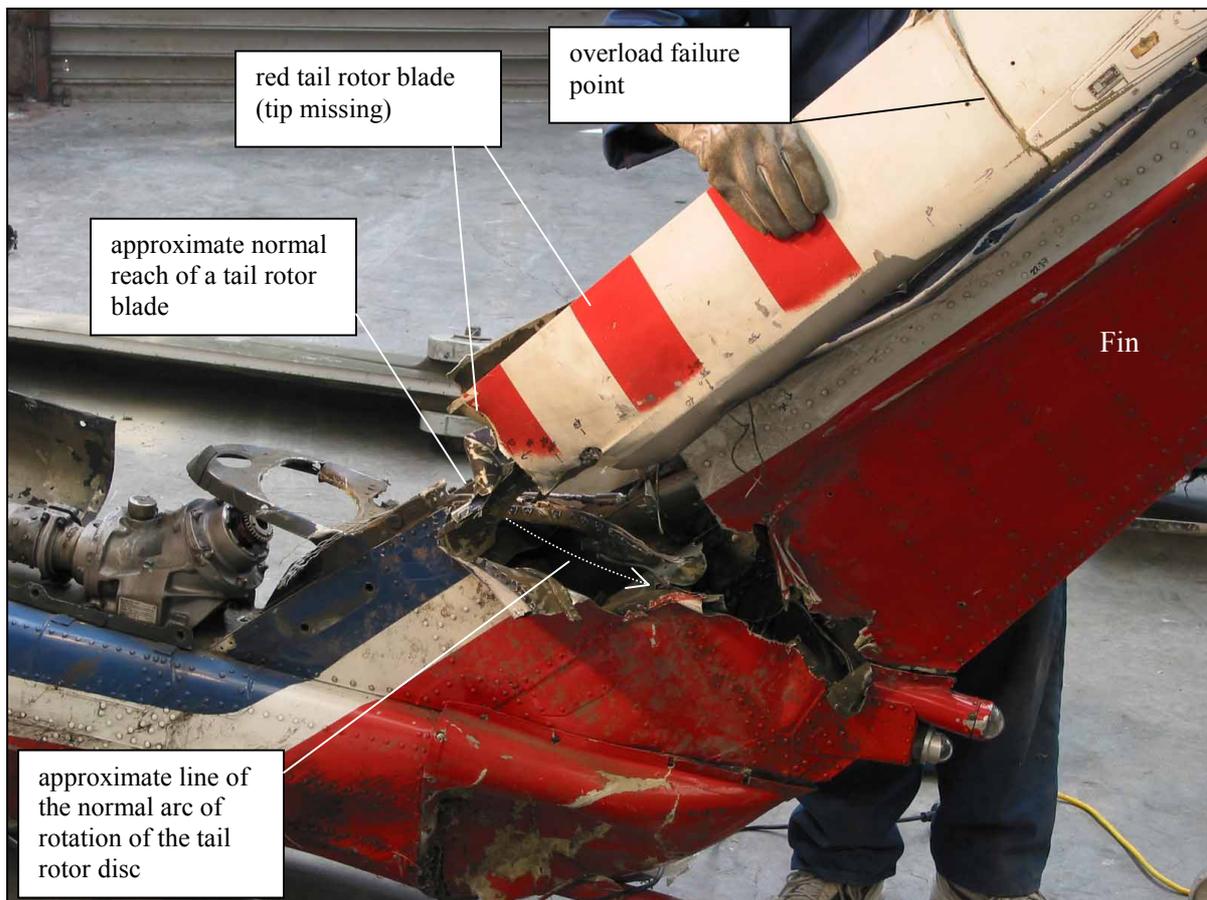
**Figure 3**  
**Red tail rotor blade strike on the fin of ZK-HJH**

- 1.13.24 Examination of the fin showed that a tail rotor blade had struck it on its left side, and further examination showed that it was the red tail rotor blade (see Figure 3). The blade had struck the left spar of the fin, cutting it and bending it backwards in the direction of normal blade travel. Measurement showed the position where the blade had struck the spar corresponded to the extent of the normal arc of rotation of the tail rotor blade. The line of the fin damage aft of the spar coincided closely with the normal arc of rotation of the blade. The left spar had been severed, and the fin had failed to the right with its right spar having failed in overload.

- 1.13.25 The leading edge of the outer portion of the red tail rotor blade was found to be extensively damaged, with its tip missing (see Figure 3). A small section of the outer leading edge of the red blade and its tip block had been found at the start of the wreckage trail. Examination of the blade, including paint transfer evidence, showed the damage was consistent with it having struck the fin while being driven under power.

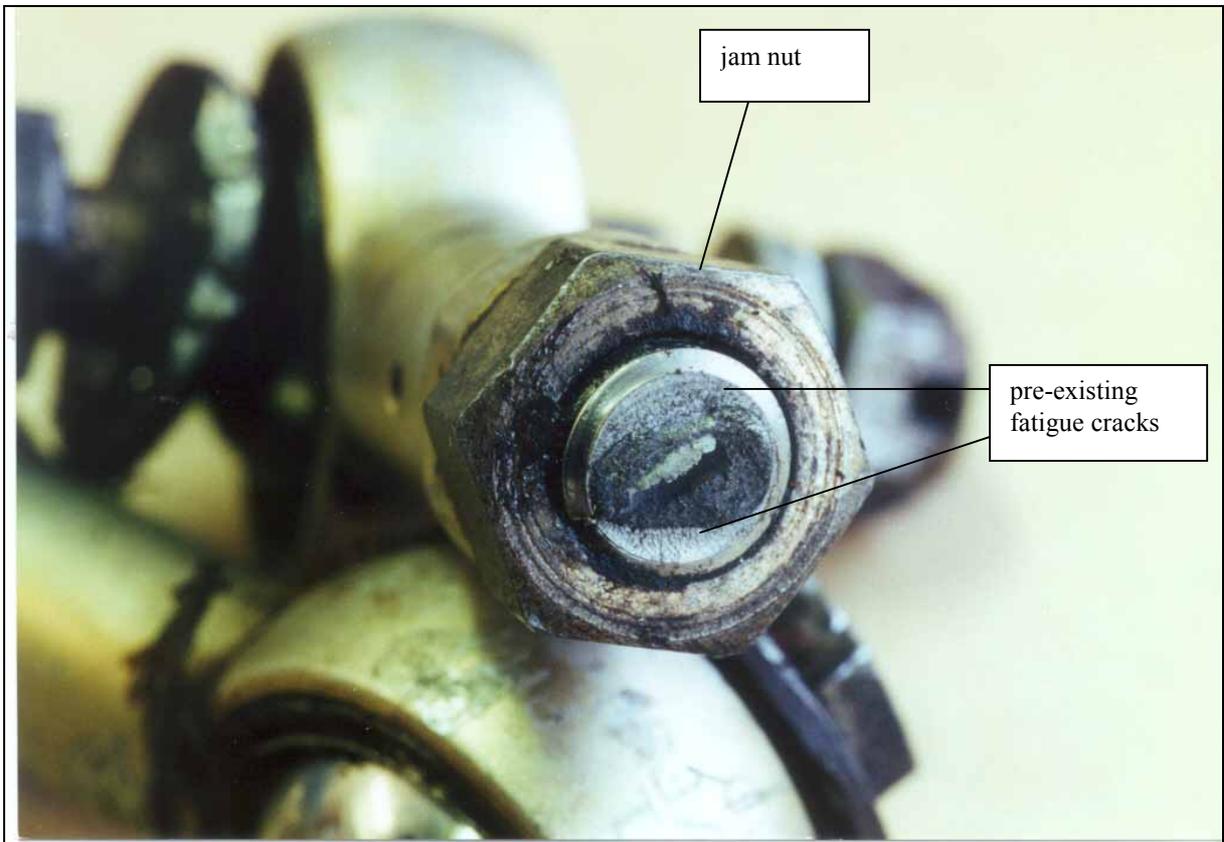
**Figure 5**  
**Broken white tail rotor blade pitch link from ZK-HJH**

- 1.13.28 The outer section of the white tail rotor blade had a tear in its inboard side near the tip. As documented previously, an NAS 1304-20 bolt and AN960 washer had been found embedded in the skin of the blade in the area of the tear, and had been identified as being a crosshead bolt and washer. There were some blue paint smears on the blade leading edge that matched the paint on the fin, some chord-wise gouges near the tip, and some minor indentations on the leading edge. A broken section of the white tail rotor blade pitch link was attached to the tail rotor blade pitch change horn (item 14 Figure 2, and Figure 5). The pitch link had fractured outboard of the jam nut where the link attached to the horn. The outer section of the link was not found, nor was the crosshead to which it attached.

- 1.13.29 Independent metallurgical examination and analysis was carried out, using scanning electron microscopy, of the fracture surface of the failed white tail rotor blade pitch link. The link material was consistent with the correct alloy used to manufacture the links. The fracture surface of the link exhibited 2 pre-existing cracks that featured beach marks typical of fatigue crack propagation (see Figure 5). The position of the cracks indicated in general that the loading action had been reverse bending, and that the cracks had initiated because of this reverse bending. There was evidence of link deformation immediately adjacent to the fracture in the threaded portion of the link outboard of the jam nut. Laboratory tests showed that, for this deformation to occur, the bend was present before cracking. The angular deformation in the first thread was approximately  $5^\circ$  (see Figure 6). Because the rest of the link was not found, it was not possible to determine the degree of any bending beyond what was measured. The 2 fatigue cracks penetrated approximately 35% of the link cross-section, and the remaining cross-section had failed through overload.

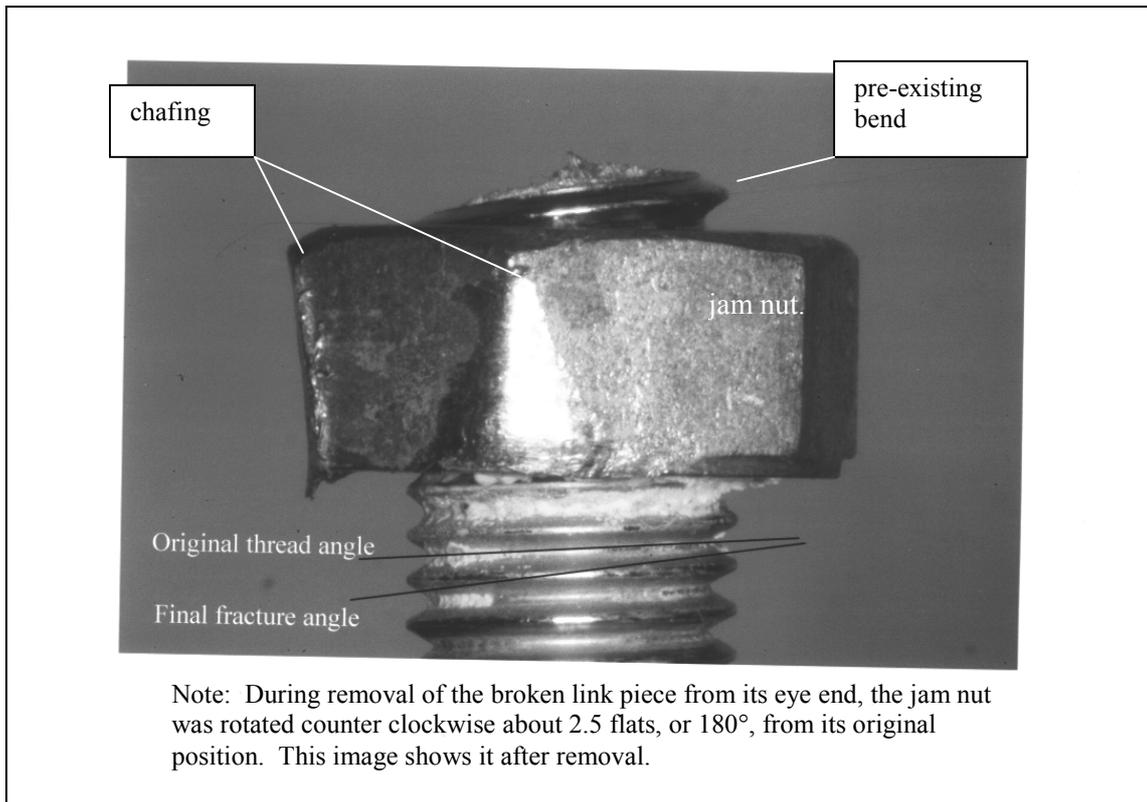
**Figure 6**  
**Fractured white tail rotor blade pitch link showing bend**

- 1.13.30 Examination at high scanning electron microscopy magnification showed that much of the surface of the more heavily burnished crack had been damaged by contact with its mating fracture surface. However, sufficient detail existed to identify fatigue crack growth striations<sup>13</sup> typical of fatigue. The striations were relatively regular, indicating that the crack had been growing in response to regular constant amplitude load cycles. The second crack clearly exhibited evidence of fatigue crack propagation. The fracture mode had grown increasingly more ductile as the crack became deeper. Towards the crack tip the cracking was more ductile, indicating that the crack growth had been relatively fast. The evidence on the fracture surface indicated a rapidly rising cyclic stress amplitude that led to failure as soon as the residual material had been unable to sustain the in-service loads.

- 1.13.36 The metallurgical examinations found that the reason for the fatigue cracks could be some unexplained loading event that was sufficient to induce yielding in the thread root stress concentration, but not sufficient to cause a fracture. Such an event could cause link deformation and possibly in-flight tail rotor vibration, and high fatigue loads in the link. Another possibility was a defect from manufacture during the thread forming process, but cracks of this type were not evident elsewhere in the link screw threads and normal operational loads would not have been sufficient to bend the link even with any small cracks present. There was no evidence that any small manufacturing defects arising from the thread forming process contributed to the link failure.

- 1.13.37 The metallurgical examinations found an unknown, but significant, period (probably some minutes) of flight had led to the fatigue crack growth in the white tail rotor blade pitch link. Examination of the tail rotor hub showed that the white tail rotor blade pitch link jam nut had been held against the hub, and chafed for a period before it finally failed (see Figure 7). Comparative analysis with a bent pitch link from one of the accident helicopters previously mentioned showed that for this to occur, the pitch link would have had to bend to about 45°. The possibility was considered that the chafing between the pitch link jam nut and the hub occurred after the fracture of the pitch link. However, the chafing on the hub was only present at the point where contact would occur with a bent but intact pitch link. A broken pitch link, on the other hand, would have been free to flail and thus only chafe lightly against the hub at random locations, but there was no evidence of this.

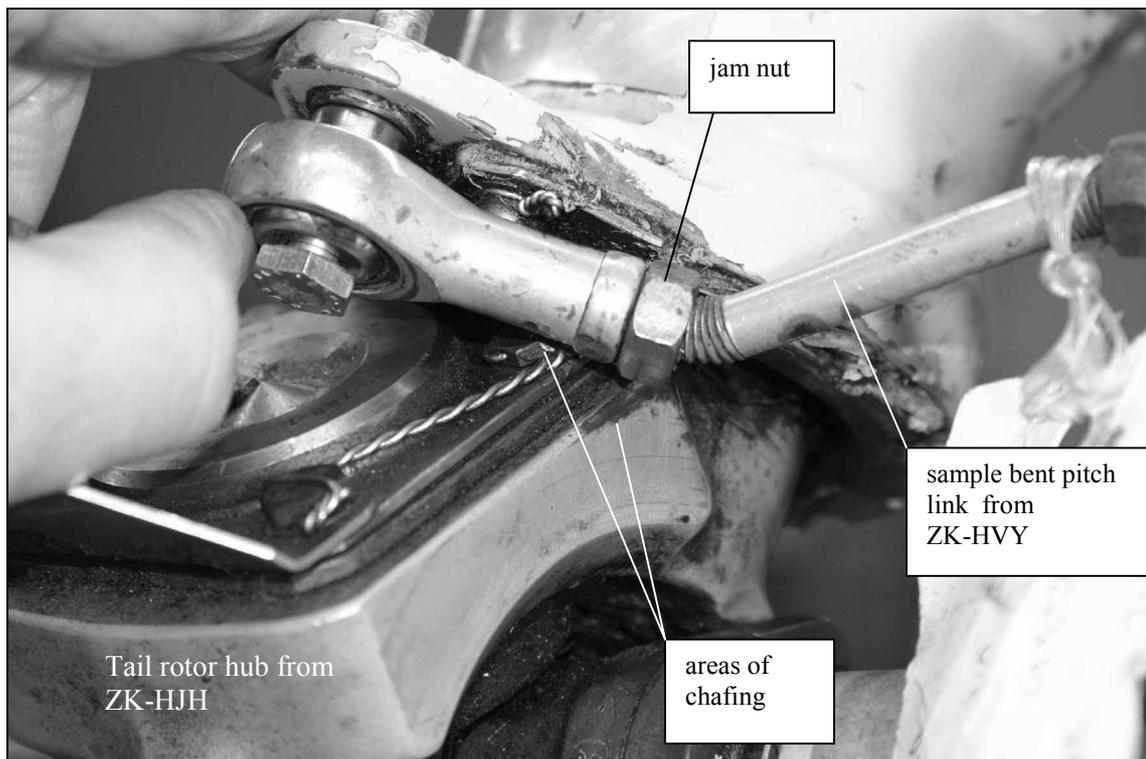
**Figure 7**  
**Illustration of bent white tail rotor blade pitch link contacting tail rotor hub**

- 1.13.38 Another metallurgist in an overseas laboratory examined the fractured white tail rotor blade pitch link using scanning electron microscopy, and reached the same conclusions as the first examination analysis. In addition, the fracture surface of the link was subject to examination and a detailed striation count using transmission electron microscopy. That examination and striation count revealed low-cycle<sup>14</sup> bending fatigue and 8000 striations. The striations showed the growth of the cracks after they had formed. Taking the more likely situation of one striation per cycle of tail rotor blade rotation, or the less likely situation of 2 per rotation, the result showed that the cracks in the link had been propagating because of reverse bending fatigue for a few minutes before the link failed.

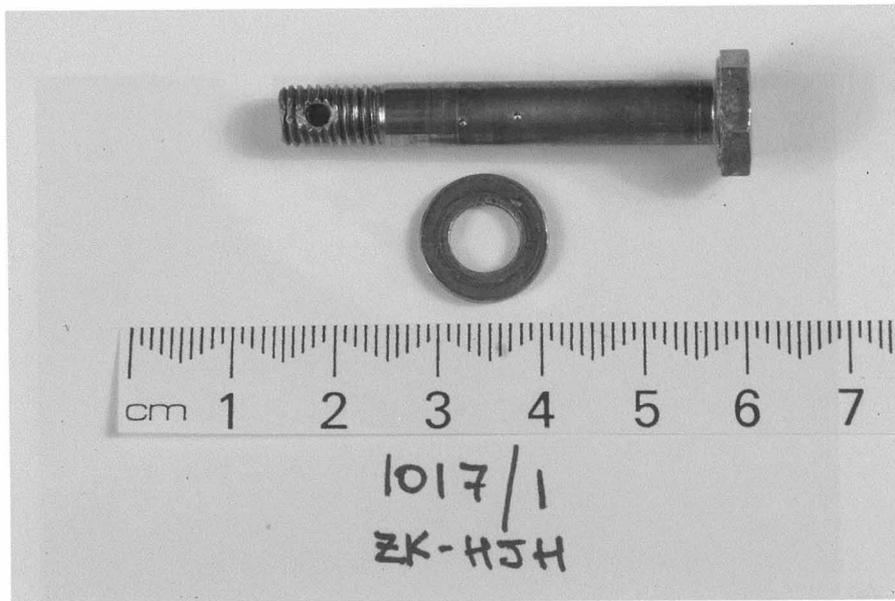
- 1.13.4 The bolt appeared straight and the threads were intact, although exhibiting some deformation. The hole in the bolt for the split pin was empty. The shank of the bolt displayed a slight wear shadow. The shadow was about 24 mm long, when measured from the washer, flat against the underside of the bolt head, towards the thread.

General view of the tail rotor crosshead bolt from ZK-HJH.

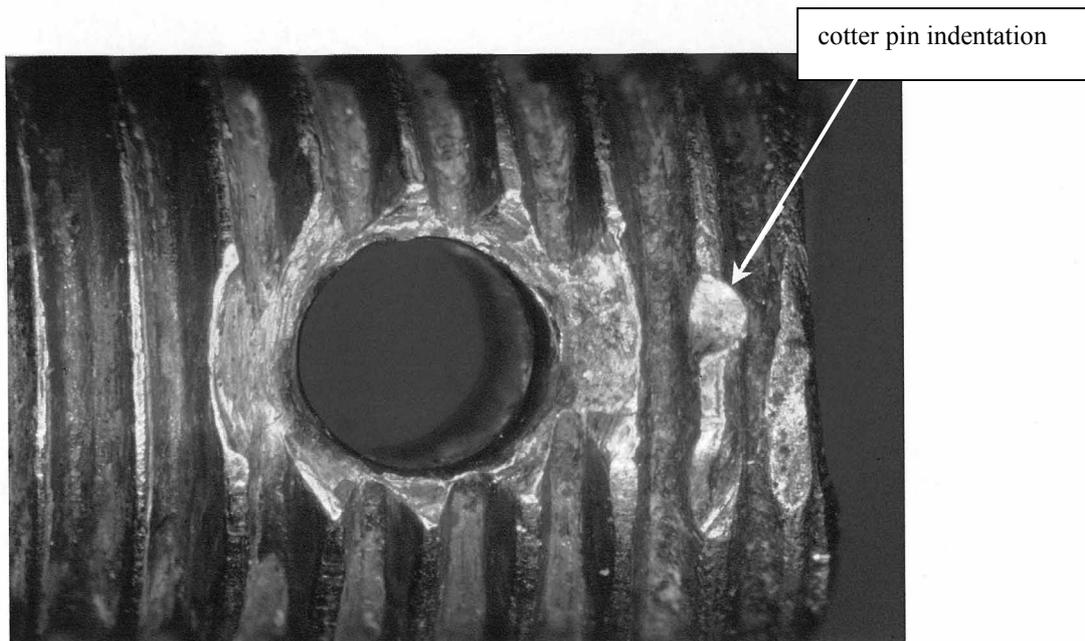
**Figure 8**  
**ZK-HJH crosshead bolt thread damage**

Close-up view of the area around the split pin hole of the bolt from ZK-HJH. Note the deformation and scoring of some of the threads and the indentations.

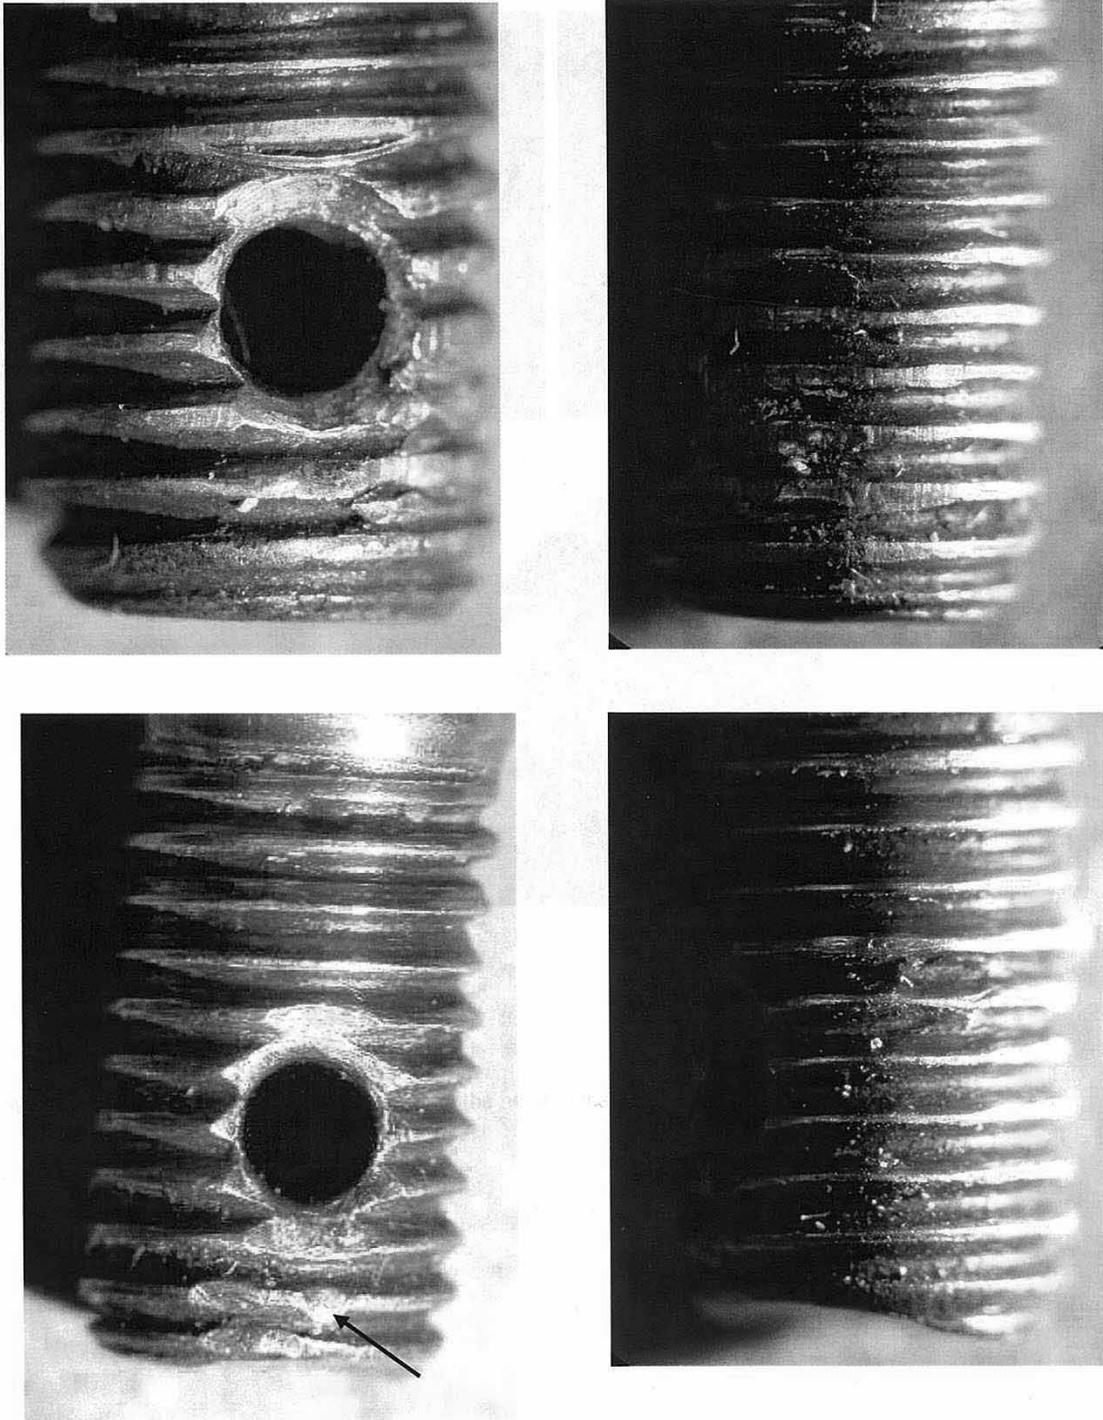
**Figure 9**  
**ZK-HJH crosshead bolt thread damage**

The bolt from ZK-HJH viewed every 90 degree around it showing the deformation to the crests of the threads and longitudinal score marks along the crests of some of the threads. A mark where the head of the split pin was probably pushed into the threads during the failure is arrowed.

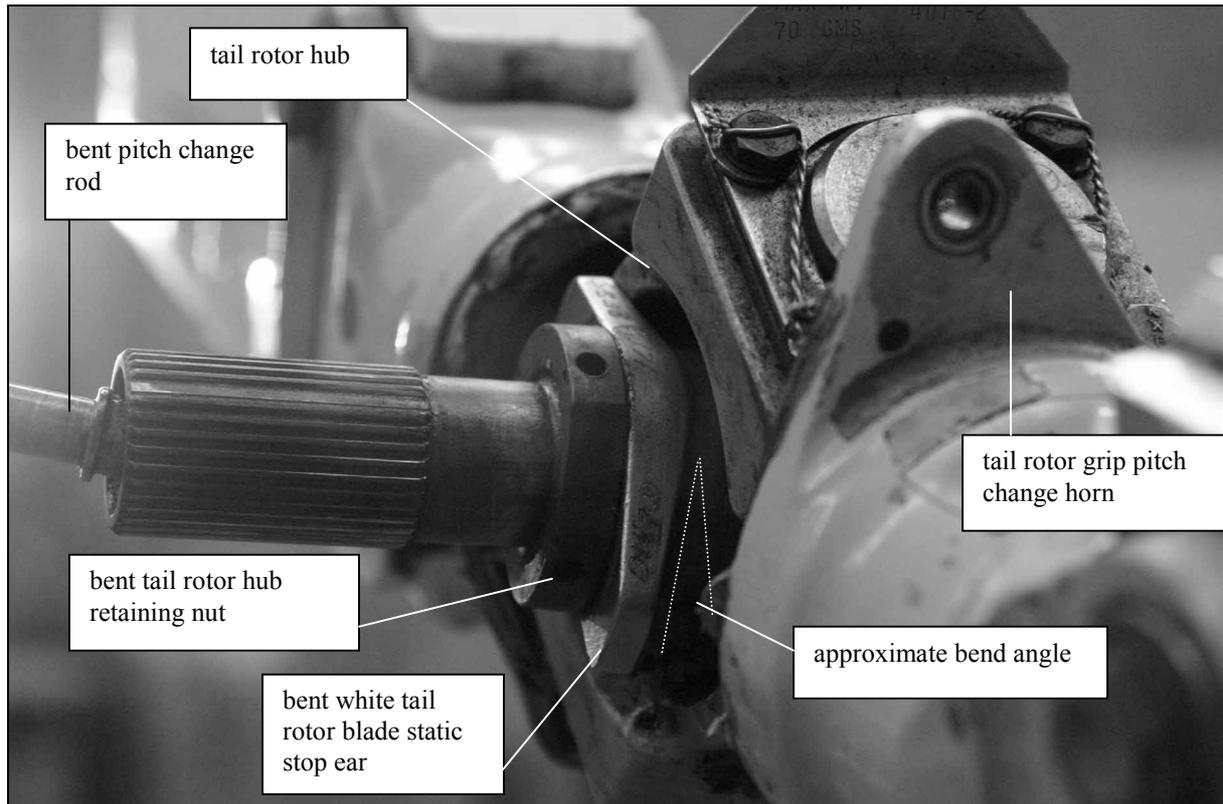
**Figure 10**  
**Bent static stop and tail rotor hub retaining nut from ZK-HJH**

1.13.48 Examination of the tail rotor hub static stop (see item 5 Figure 1, Figure 4, Figure 10 and Figure 11) showed that the ear on the white tail rotor blade static stop was deformed and bent noticeably outwards, away from the fin. The white side of the tail rotor hub showed corresponding evidence that it had struck the static stop. The tail rotor hub retaining nut, which tightened against the stop, was also deformed noticeably and bent outwards. Examination showed that because of the deformation to the ear of the white blade static stop, the red tail rotor blade could contact the fin. An undamaged static stop on a correctly rigged tail rotor assembly would mechanically limit the degree of tail rotor blade flapping and prevent the tail rotor blades contacting the fin, by limiting their travel to 2.5 inches (6.35 centimetres) from the fin. Also, normal rigidity of the blades would not allow them to flex enough to strike the fin. During normal in-flight operation, the tail rotor hub would not contact the static stop.

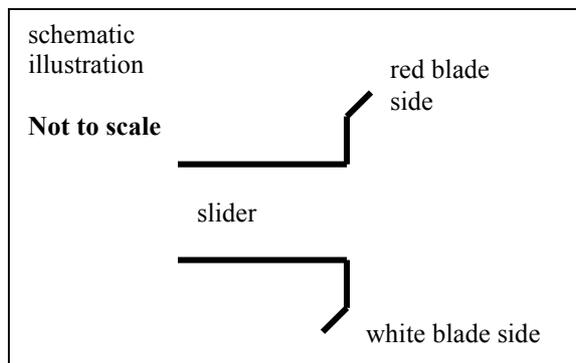
**Figure 12**  
**Schematic illustration exaggerating bent crosshead slider ears**

1.13.49 Examination of the tail rotor hub crosshead slider (see item 8 Figure 2, and Figure 4) showed that the slider ear on the red tail rotor blade side, where the crosshead bolt attached, was bent outwards away from the tail rotor hub. The corresponding slider ear, on the white tail rotor blade side, was bent inwards towards the tail rotor hub (Figure 12). The retainor plate that fitted between the slider and crosshead (see item 9 Figure 2) was bowed away from the slider and had some rotational scoring marks on its outer face. The end of the pitch change rod (see item 23 Figure 1, and Figure 10), which passed through the tail rotor drive shaft and connected to the crosshead, was bent away from the red blade slider ear.
