Report 01-010

**Embraer EMB-820C Chieftain ZK-RDT
door-open-in-flight incident near Auckland**

31 October 2001

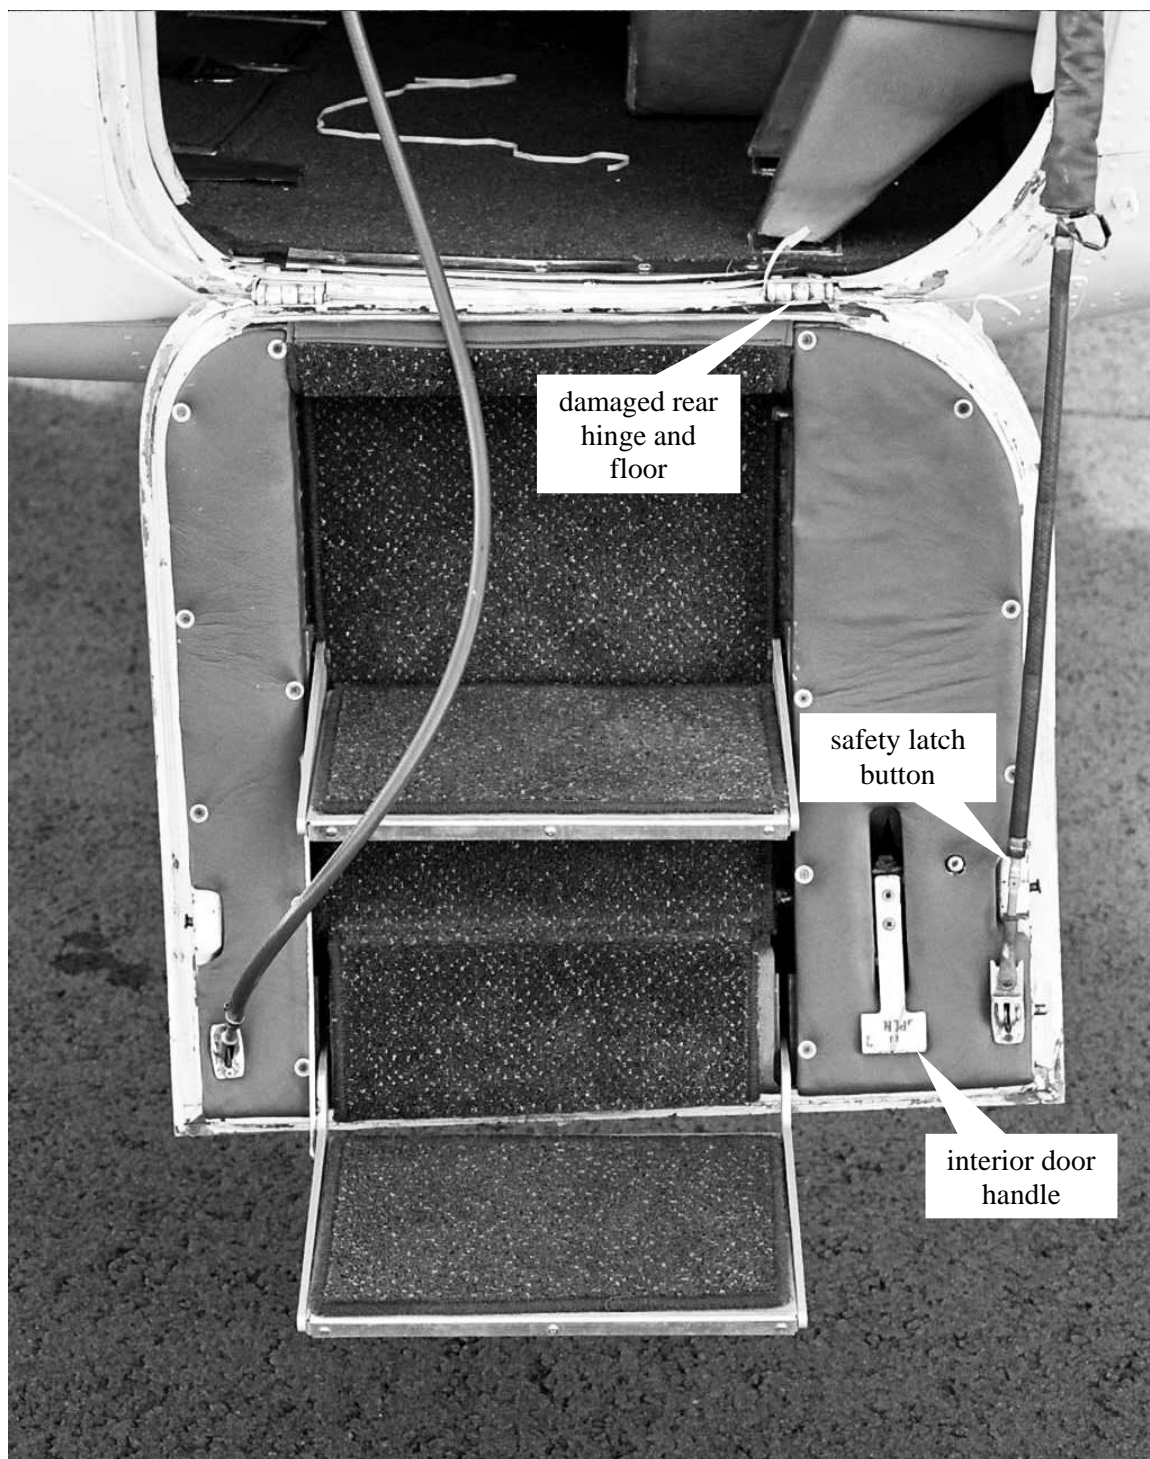
Figure 1
ZK-RDT lower cabin door after the incident

1.4.1 After the incident the appearance of the lower door was consistent with having opened forcibly; the forward support cable anchor was broken from the fuselage structure and the lower door rear hinge was distorted and partly separated from the cabin floor. The resulting misalignment prevented the lower door from being closed.

1.4.3 The rear hinge was removed to allow temporary alignment of the lower door, which then fitted the doorway without obvious distortion. The latch pawls engaged the striker plates, so that the door felt secure when latched closed.

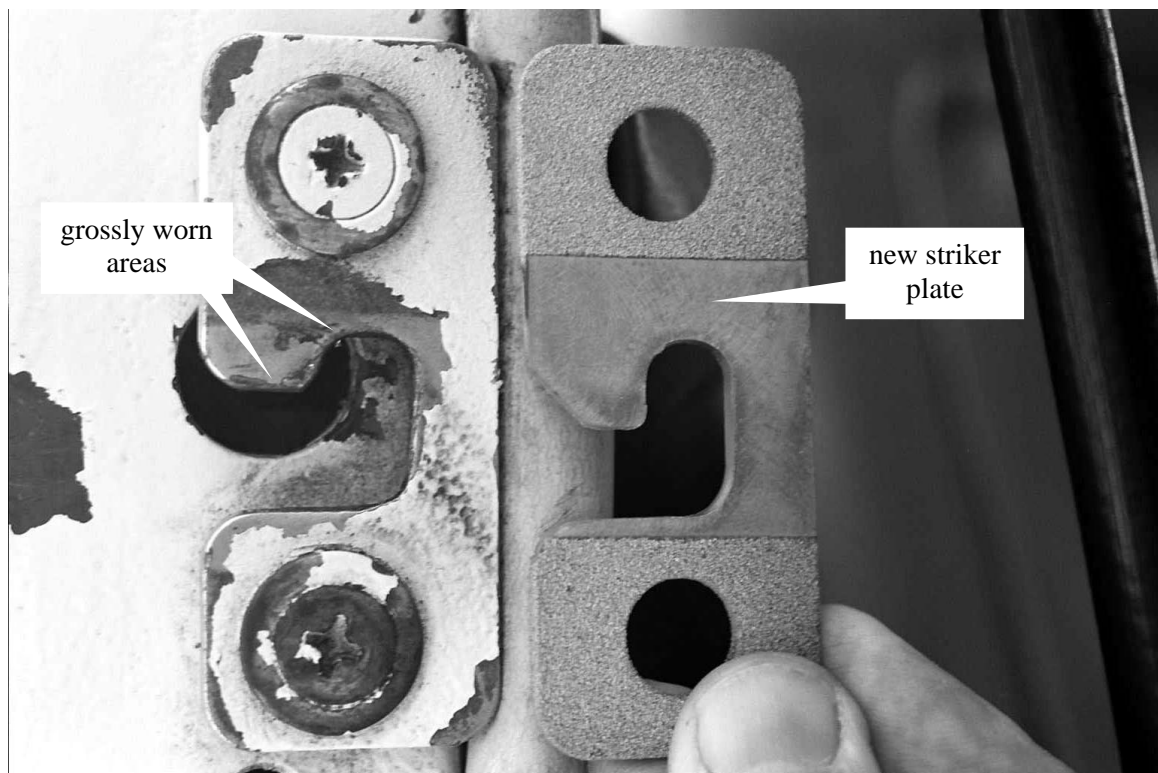
1.4.2 The latch pawls both operated with either door handle, but were bent by some 10°. The interior door handle could be operated without first pushing the safety latch button. The striker plates were secure on the doorway, but showed appreciable wear. The forward striker plate was grossly worn, with some 40% of the engaging tongue missing, compared with a new plate. The striker plate surface which engaged with the pawl was worn to present an inclination of about 60°, rather than a 90° face (see Figure 2).

Figure 2
ZK-RDT Cabin door latch forward striker plate

- 2.5 Although most components of the door latch mechanism exhibited wear and distortion, the grossly worn forward striker plate was probably the single component most likely to promote an unlatching of the door. The worn shape of the surface presented a 60° ramp to the latch pawl, which would produce a downward reaction force if pressure was applied to the door, tending to rotate the latch pawls towards the open position. The missing striker plate tongue area would have allowed the latch to disengage early, and some racking of the door could complete the disengagement of the rear latch.

- 2.7 The generally worn and damaged condition of the latch mechanism was not surprising after 20 years and nearly 4000 hours in service, because the door interior would trap dirt and promote wear, and was not readily accessible for inspection or servicing. The wear on the forward striker plate, however, should have been readily visible and its potential for causing an unlatch fairly obvious to a diligent engineer. Replacement of the plate with a new one would have involved a few minutes' work with a screwdriver. Similarly, a simple functional check of the safety latch should have logically led to an internal examination and rectification or adjustment.

Publish educational material such as a “Vector” article on the topic of the need for pilots and engineers to be aware of mechanical deterioration of items such as this door latch mechanism to ensure that timely remedial action is taken before failure occurs.
(021/02)
