Report 01-011

Cessna A185E Skywagon

ZK-JGI

forced landing following power loss after take-off

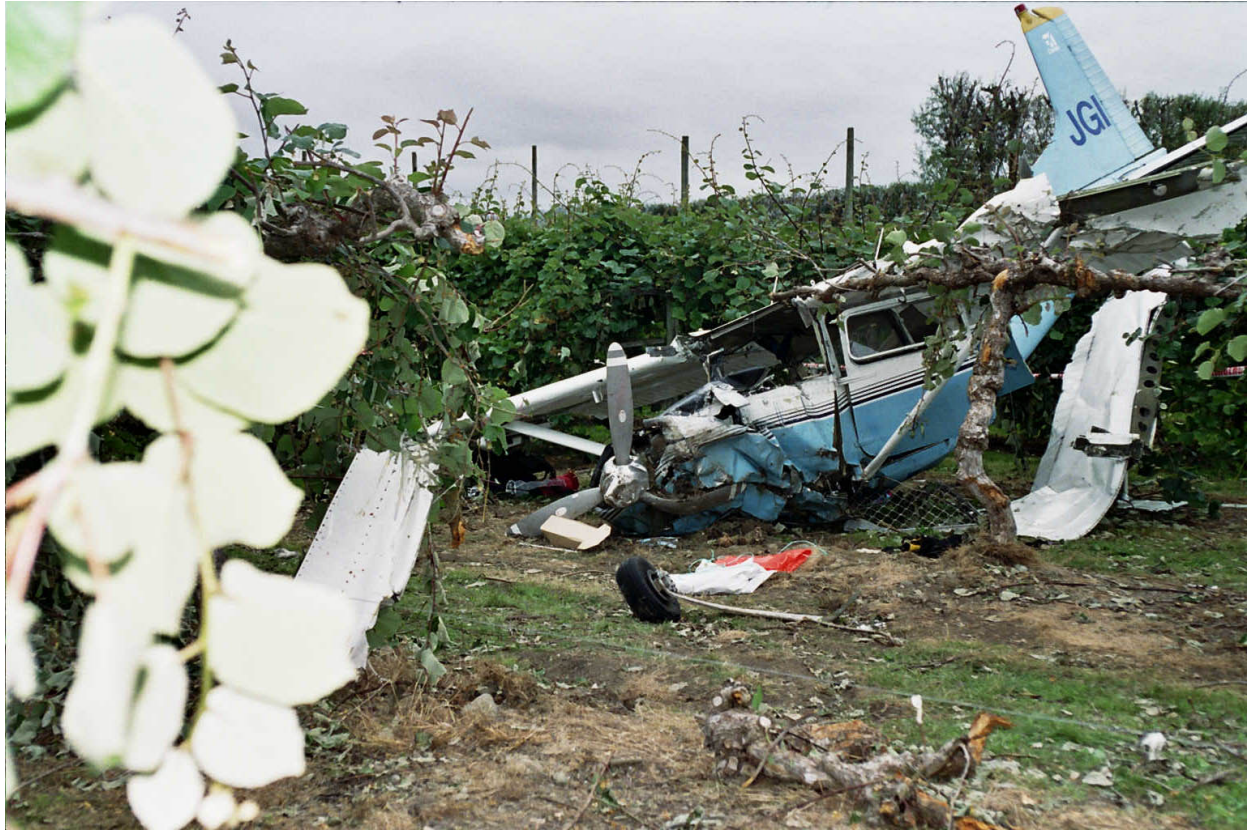
Figure 1
Cessna A185E ZK-JGI after the accident

- 1.6.2 The aircraft was destroyed. The left main wheel and outer wing section had separated after the aircraft had struck the ground. The aircraft was resting on its belly and right wing tip. Both fuel tanks were intact and contained fuel. Fuel was dripping from the vent for the right tank, which was also partially blocked by a light reddish substance.

- 1.6.3 The propeller was still attached to the engine. One propeller blade was bent backwards underneath the engine, while the other 2 blades had sustained little or no damage. The type of damage was indicative of slow or no rotation of the engine as the aircraft struck the ground. The cabin structure remained intact; however, the engine mounting and rear fuselage were both bent upwards.

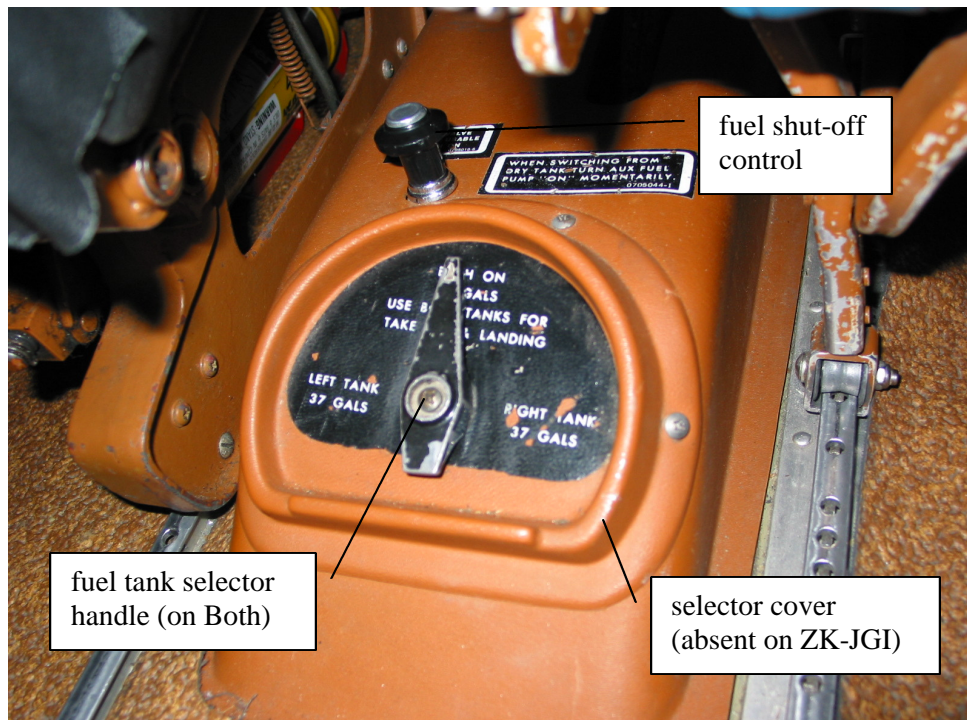
- 1.4.6 The Cessna 185 model of aircraft was fitted with 2 wing tanks that supplied fuel to a fuel control unit and manifold on the engine via an accumulator tank, a shut-off valve, a fuel strainer, an electric auxiliary pump and an engine-driven fuel pump. In addition to the fuel shut-off valve some Cessna 185 aircraft, including ZK-JGI, were fitted with a 3-position rotary fuel selector that enabled fuel to flow from the left, right or both tanks to the fuel accumulator tank. The fuel shut-off and tank selection controls were located immediately to the right of the pilot on a central pedestal beside the seat (see Figure 2).

- 1.4.7 Normally the fuel selector handle was able to be rotated only through a 180° forward arc, with the Left and Right tank selections pointing to their respective tank. The Both option was achieved with the handle pointing centrally forward. The selector cover normally prevented rearwards rotation of the handle. The absence of the selector cover on ZK-JGI meant that with the Perspex cover lifted the handle could be rotated through 360°. Though not labelled, by positioning the selector handle to the rear the fuel flow from the wing tanks to the accumulator tank could be shut off.

Figure 2
Cessna 185 fuel management controls similar to ZK-JGI pre-modification

- 2.5 By rotating the fuel selector handle to the rearwards position, the pilot inadvertently shut off the fuel flow to the accumulator tank, which had a capacity of 3.28 litres. The manufacturer estimated this would provide sufficient fuel for the aircraft to taxi and get airborne before the tank ran dry.

- 2.13 The absence of the selector cover changed the function of the selector handle, from a 3-position operation to a 4-position operation that included an Off capability. There was no reminder to alert a pilot to this additional capability or hazard.
