Report 01-101

**passenger express Train 901 *Southerner* and
stock truck and trailer unit**

collision

**Makikihi Beach Road level crossing
between Timaru and Oamaru**

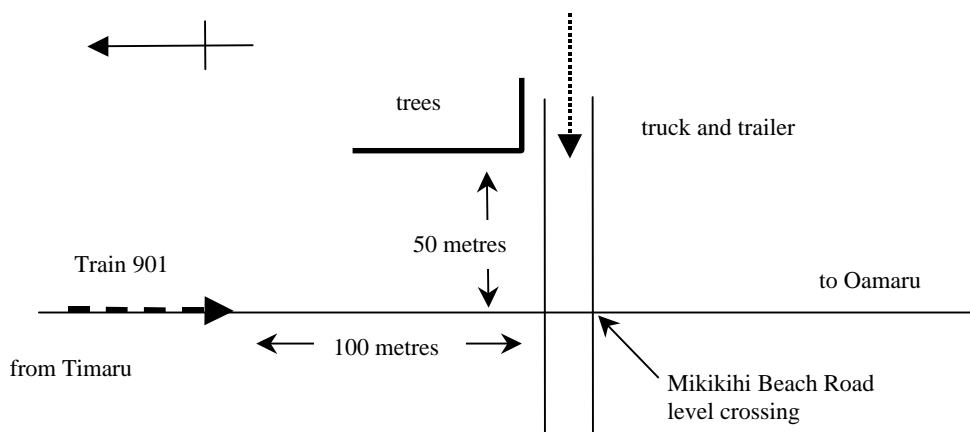
Figure 1
Site plan of Makikihi Beach Road level crossing
(not to scale)

- 1.2.1 Makikihi Beach Road level crossing was on the Canterbury Plains and offered good visibility for LEs, and for motorists within about 50 m of the level crossing. Both the rail and road approaches were straight and crossed at right angles. After crossing a bridge over the Makikihi River, about 200 m north of the level crossing, the track approached the crossing along an embankment, which lifted it above the paddocks on both sides.
- 1.2.2 The level crossing was not protected by warning lights, bells or barriers. It was protected by roadside signage, which included a St Andrews cross and a Give Way sign immediately before the crossing but did not include an Intermediate Advance Warning sign. There were markings on the road surface and a Level Crossing warning sign about 120 m back from the crossing on either side.

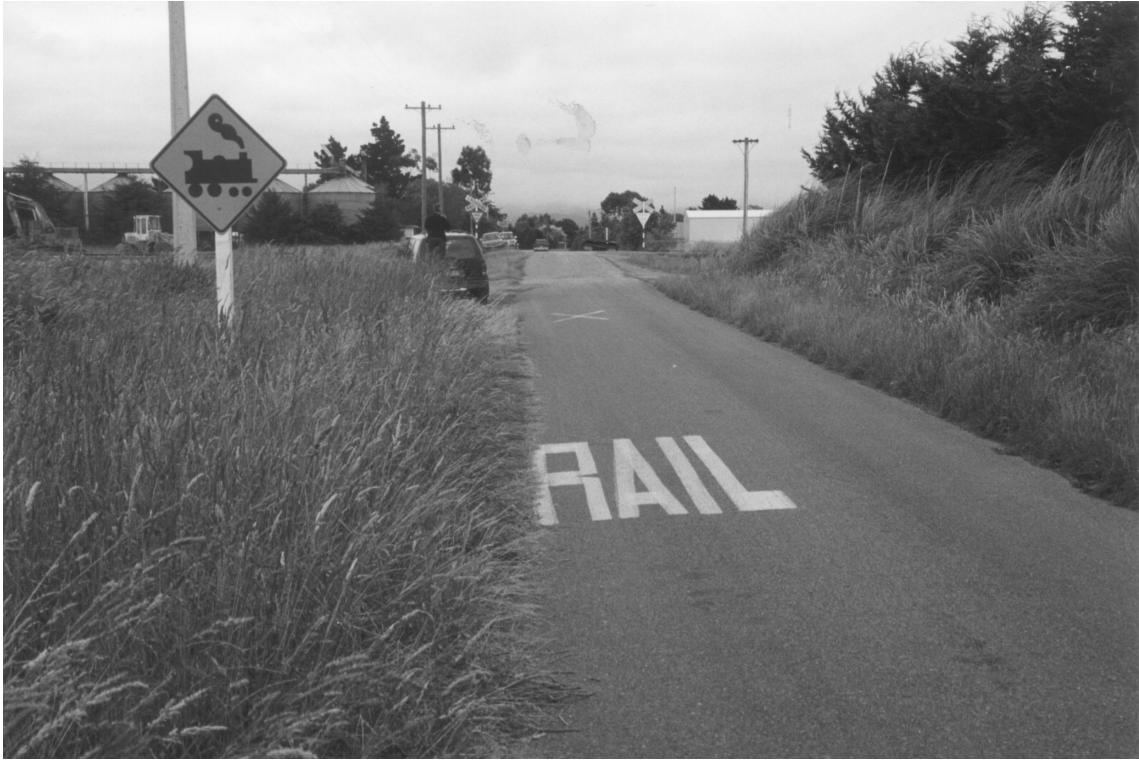
Figure 2
View about 100 m from Makikihi Beach Road level crossing approaching from the east, the direction from which the truck and trailer unit approached

2.3 If the level crossing was to fully meet the guidelines outlined in the manual, a PW-61 Railway Level Crossing Intermediate Advance Warning sign should have been placed 100 m from the level crossing, between the Railway Level Crossing Ahead sign (refer Figure 2) and the level crossing. To accommodate this, the Railway Level Crossing Ahead sign would have had to have been positioned 160 m from the level crossing in accordance with Clause PW-57 of the manual. The level crossing therefore did not meet the guidelines of the manual, however it is doubtful that the existence of a Railway Level Crossing Intermediate Advance Warning sign would have avoided this collision for the following reasons:

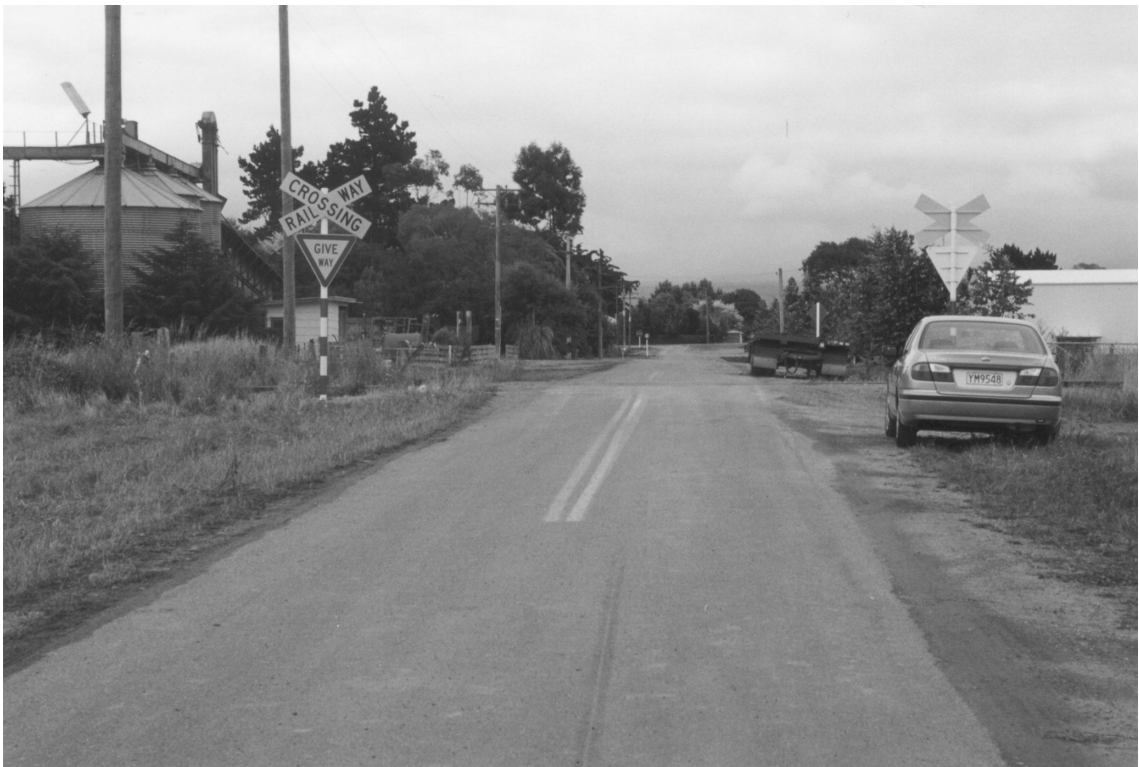
Figure 3
Signage and road markings at Makikihi Beach Road level crossing

2.1 The Commission has investigated this accident mainly from a rail perspective so the reasons why the truck driver did not give way as he approached the level crossing have not been established. The road signage and markings that were in place both approaching and at the level crossing were clearly visible and in good condition and met the guidelines included in the manual. There was adequate sighting distance for the truck driver to have seen the train and stopped had he approached the level crossing preparing to give way. It is clear from the road signage that Train 901 had the right of way through the level crossing.

- 3.5 The standard and condition of the existing level crossing signage and road markings were in accordance with guidelines published in the "Manual of Traffic Signs and Markings", Part 1, and they were clearly visible and in good condition.

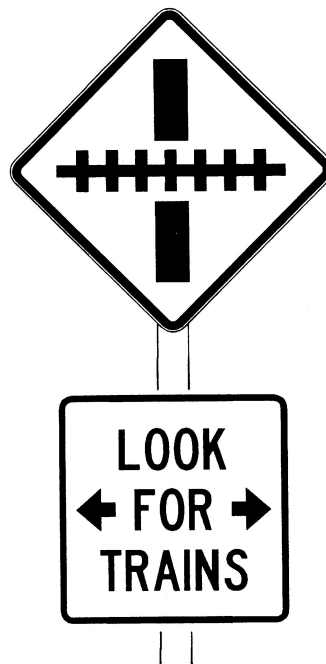
Figure 4
A PW-61 Railway Level Crossing Intermediate Advance Warning sign,
black characters on a yellow background

The level crossing did not qualify for a Stop sign but did meet the guidelines for a PW-61 combination sign.

- 3.6 Because a PW-61 Railway Level Crossing Intermediate Advance Warning sign was not erected the level crossing did not fully meet the guidelines specified in the "Manual of Traffic Signs and Markings", Part 1, but the presence of such a sign was unlikely to have avoided the collision.

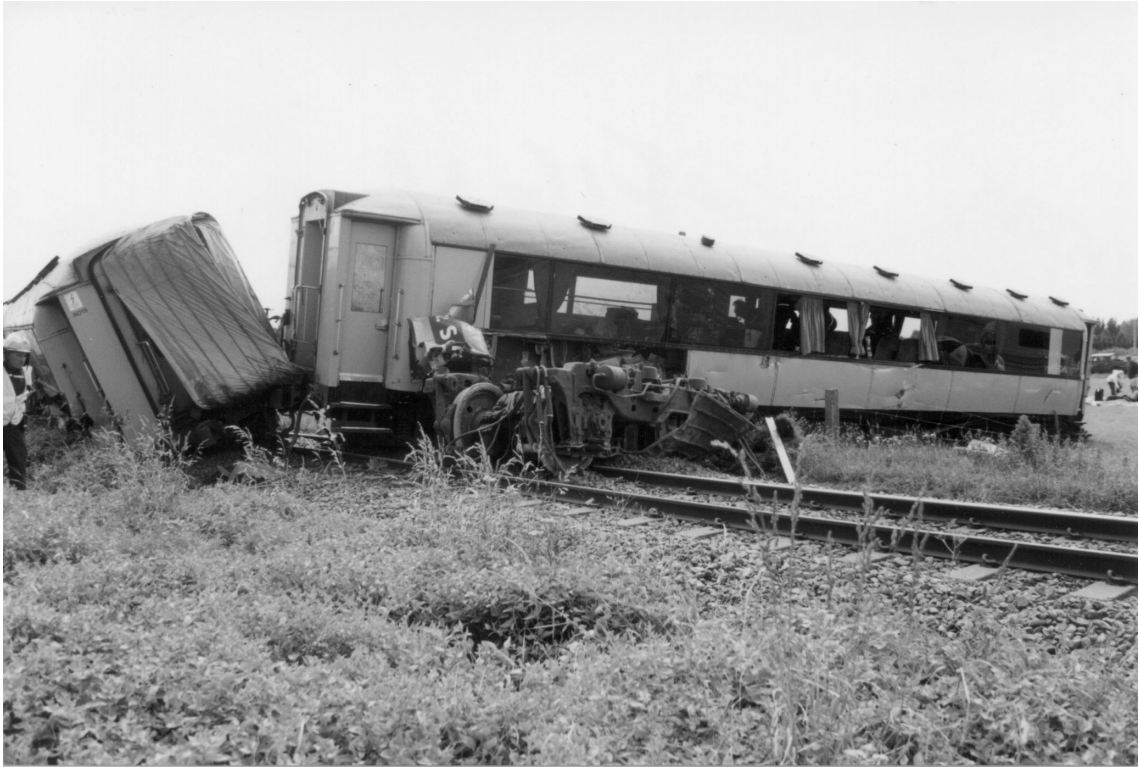
Figure 5
The leading passenger carriage as it came to rest (photograph courtesy NZ Police)

1.4.1 Marks at the site showed that after impact the leading passenger carriage derailed and travelled at right angles to the main line for about 70 m with the front of the carriage and leading bogie travelling about 24 m through a trackside paddock. The carriage remained upright and stopped when the trailing end collided with the trailing bogie of the locomotive, which had separated from the locomotive and lay at right angles to the track.

2.9 The locomotive bogies remained close to the track after they had detached from the locomotive body, with the leading bogie stopping in such a position that it gouged the side of the second carriage as it passed. The trailing bogie was probably responsible for the majority of damage sustained by the leading carriage.

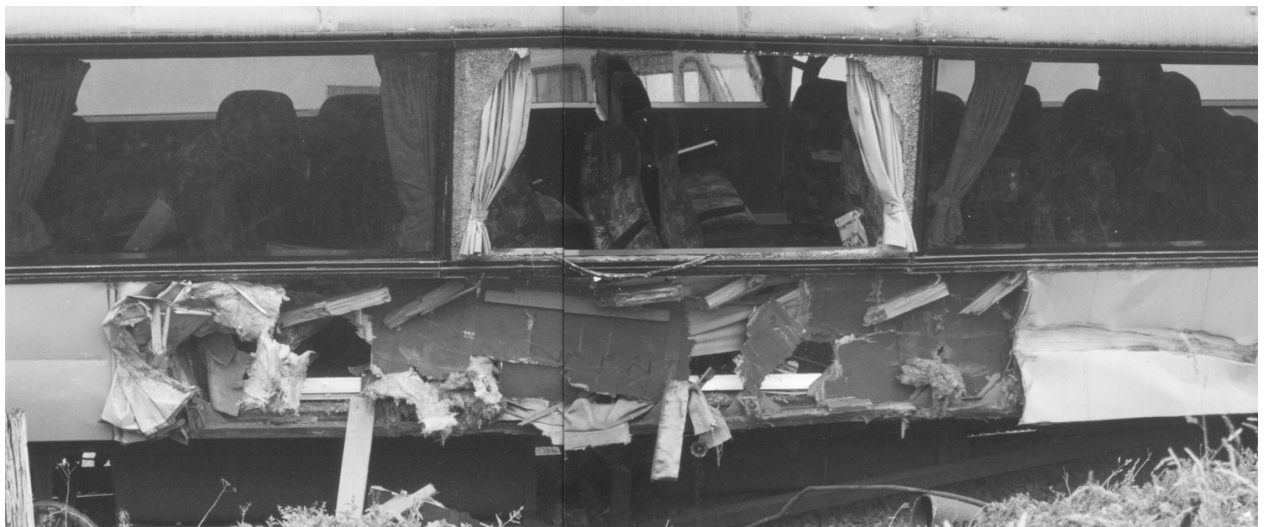
Figure 6
Damage sustained by the second passenger carriage

1.4.2 The second passenger carriage was also derailed but remained upright, although leaning at about 25 degrees towards the right-hand side of the track. It was extensively gouged below window level (refer Figure 6) as it passed the stationary leading bogie of the locomotive.
