Report 01-102

express freight Train 237 and express freight Train 144

derailment and collision on double-line track

23 February 2001

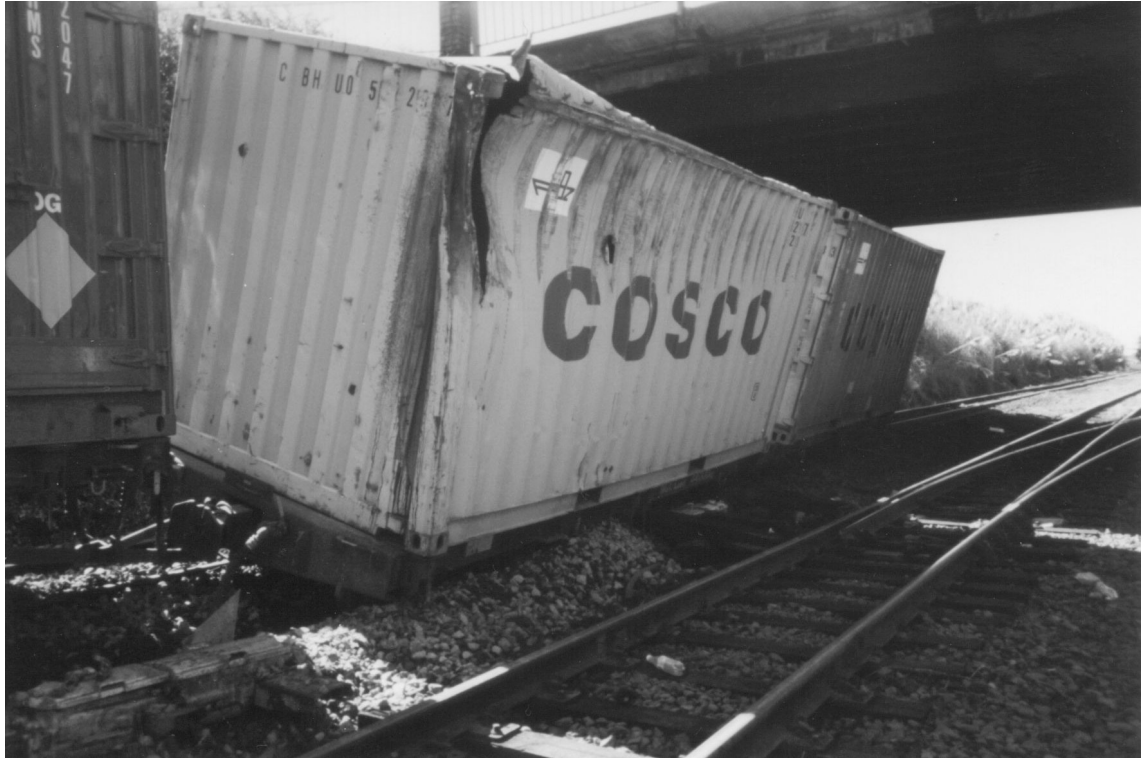
- 1.2.1 Train 237 came to a stop at 628.93 km with wagon PK 3138, the fifteenth wagon in the consist, at 629.19 km under Bridge 315, East Street overbridge. Figure 1 is a site plan of the derailment/collision area. PK3138 was derailed all wheels approximately 300 mm to the right of the Down Main (towards the Up Main) with the trailing end closer to the Up Main. The wagon, with its containers still attached, was leaning at an angle of 10⁰ towards the Up Main. The leading container showed no collision damage. The trailing container showed increasing collision damage on the right side from the leading end back towards the trailing end (refer Figure 2).

Figure 2
Wagon PK 3138 following the collision
(looking south)

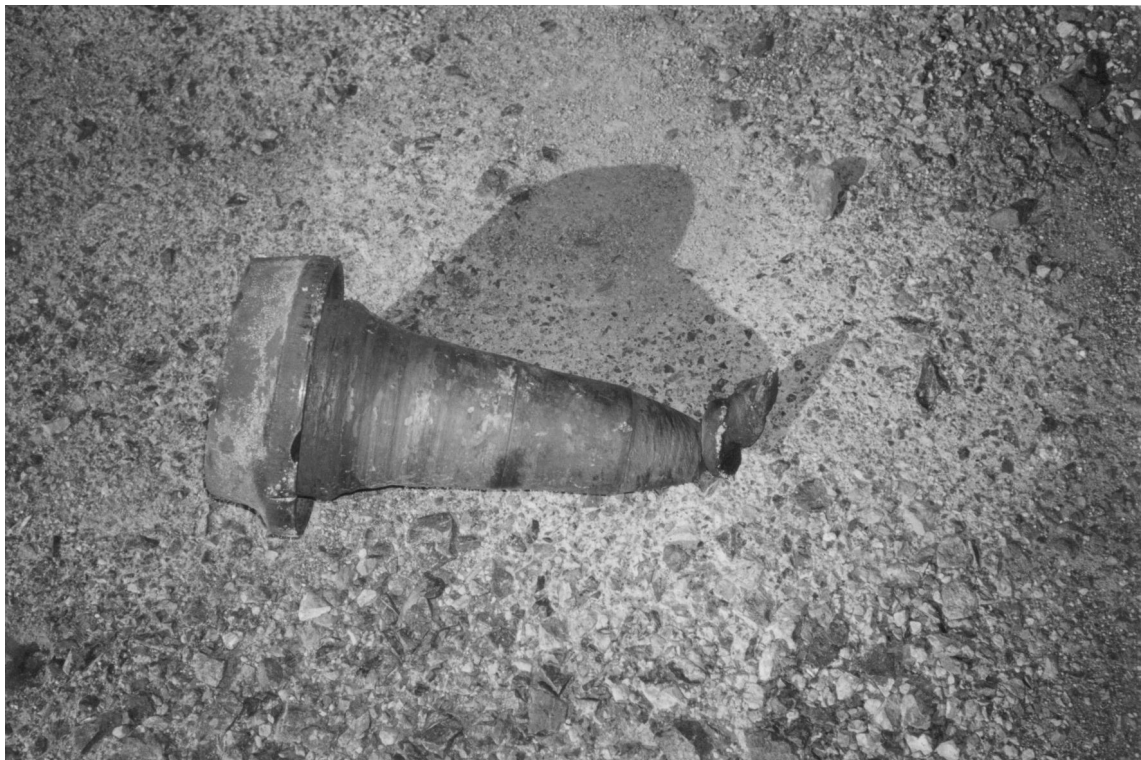
- 1.2.2 The leading axle of the trailing bogie on PK 3138 had sheared on the right side (refer Figure 3).
- 1.2.3 Various parts from PK 3183 were found trackside as follows:
- the sheared axle end (refer Figure 3) was found on the right side of the Down Main at about 633.6 km (just north of Crown Road level crossing)
 - a bearing inner race was found on the right side of the Down Main at about 633.56 km
 - a section of brake block was found at 632.7 km
 - brake rigging was found on the left side at 631.95 km.

Figure 3
The end of the sheared axle found near
Crown Road level crossing at 633.6 km NIMT

The failed bearing has suffered severe overheating due to spinning on its journal. The heat generated by the relative movement between the bearing cones (inner ring) and the journal has resulted in the lubricant failure followed by bearing seizure. This in turn has led to accelerated overheating of the journal, softening of the axle material, and eventual fracture of the axle.

The wear and damage to the cone face indicates that the cone was loose on the journal. In this case inadequate fits and tolerances were the primary cause of failure.

- 3.1 The bearing failure on PK 3138 was initiated by a loose bearing inner cone, probably caused by inadequate fits and tolerances during bearing overhaul in 1997.

- 3.2 Overheating generated by the loose cone ultimately resulted in axle failure, with related unrestrained wheel movement leading to the derailment of PK 3138.

- 4.1 Tranz Rail have checked and confirmed the suitability of current bearing overhaul practices and procedures (refer 1.6.3).
- 4.2 The following additional actions were taken following the incident:
- on 2 March 2001 the Rule of the Week distributed reminded all staff of the action to be taken when dragging equipment was suspected
 - a Safety Briefing was given to Train Controllers on 20 April 2001, highlighting actions required when advised of defects on trains.
- 4.3 Tranz Rail advised it is reviewing the process currently documented in Rule 6 to clarify actions required of locomotive staff.
- 4.4 Tranz Rail have compiled a CRM training module and completed a pilot presentation. Case studies are being added and training is programmed to commence in October 2001.
- 4.5 In view of the above actions, no safety recommendations have been made as a result of this incident.
