Report 01-107
passenger express Train 201
derailment
Otaihanga (near Paraparaumu)
6 June 2001

Abstract

On Wednesday, 6 June 2001, at about 1841, express passenger Train 201 *Overlander* derailed when a wheel on the leading axle of the trailing bogie of the power van fractured as the train approached Otaihanga Road level crossing near Paraparaumu on the North Island Main Trunk. There were no injuries to train crew or passengers and damage was limited to the trailing bogie of the power van.

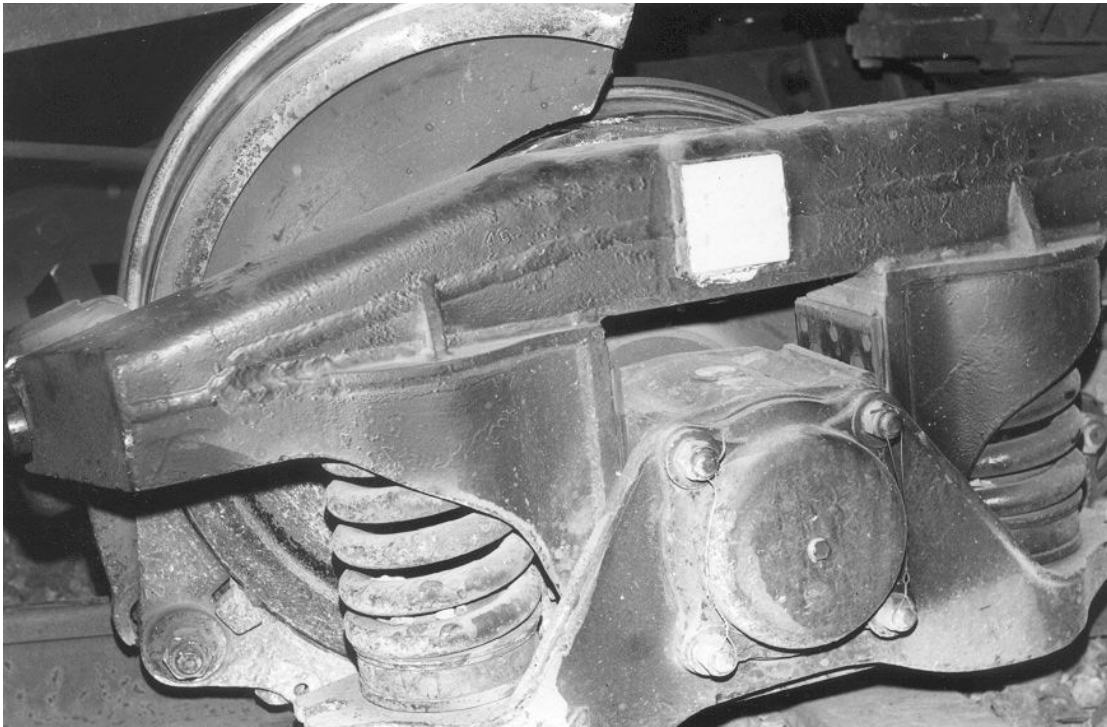
Figure 1
The fractured wheel lodged between the brake block and bogie side frame
(photograph courtesy of Tranz Rail).

- 1.5.7 When wheel 1 fractured, the broken-off section lodged between the brake block at the front of the bogie and the bogie side frame (refer Figure 1) and prevented the axle and wheel 2 from turning. After wheel 2 had derailed, it skidded along the sleepers and ballast for about 10 m before it hit the northern edge of the level crossing bitumen after which it continued to skid for another 300 m along sleepers and ballast south of the level crossing until the train stopped. The portion of the flange and wheel surface of wheel 2 making contact with the ground was worn almost flat. There was no evidence on the rail surface to suggest it had been skidding prior to the point of derailment.

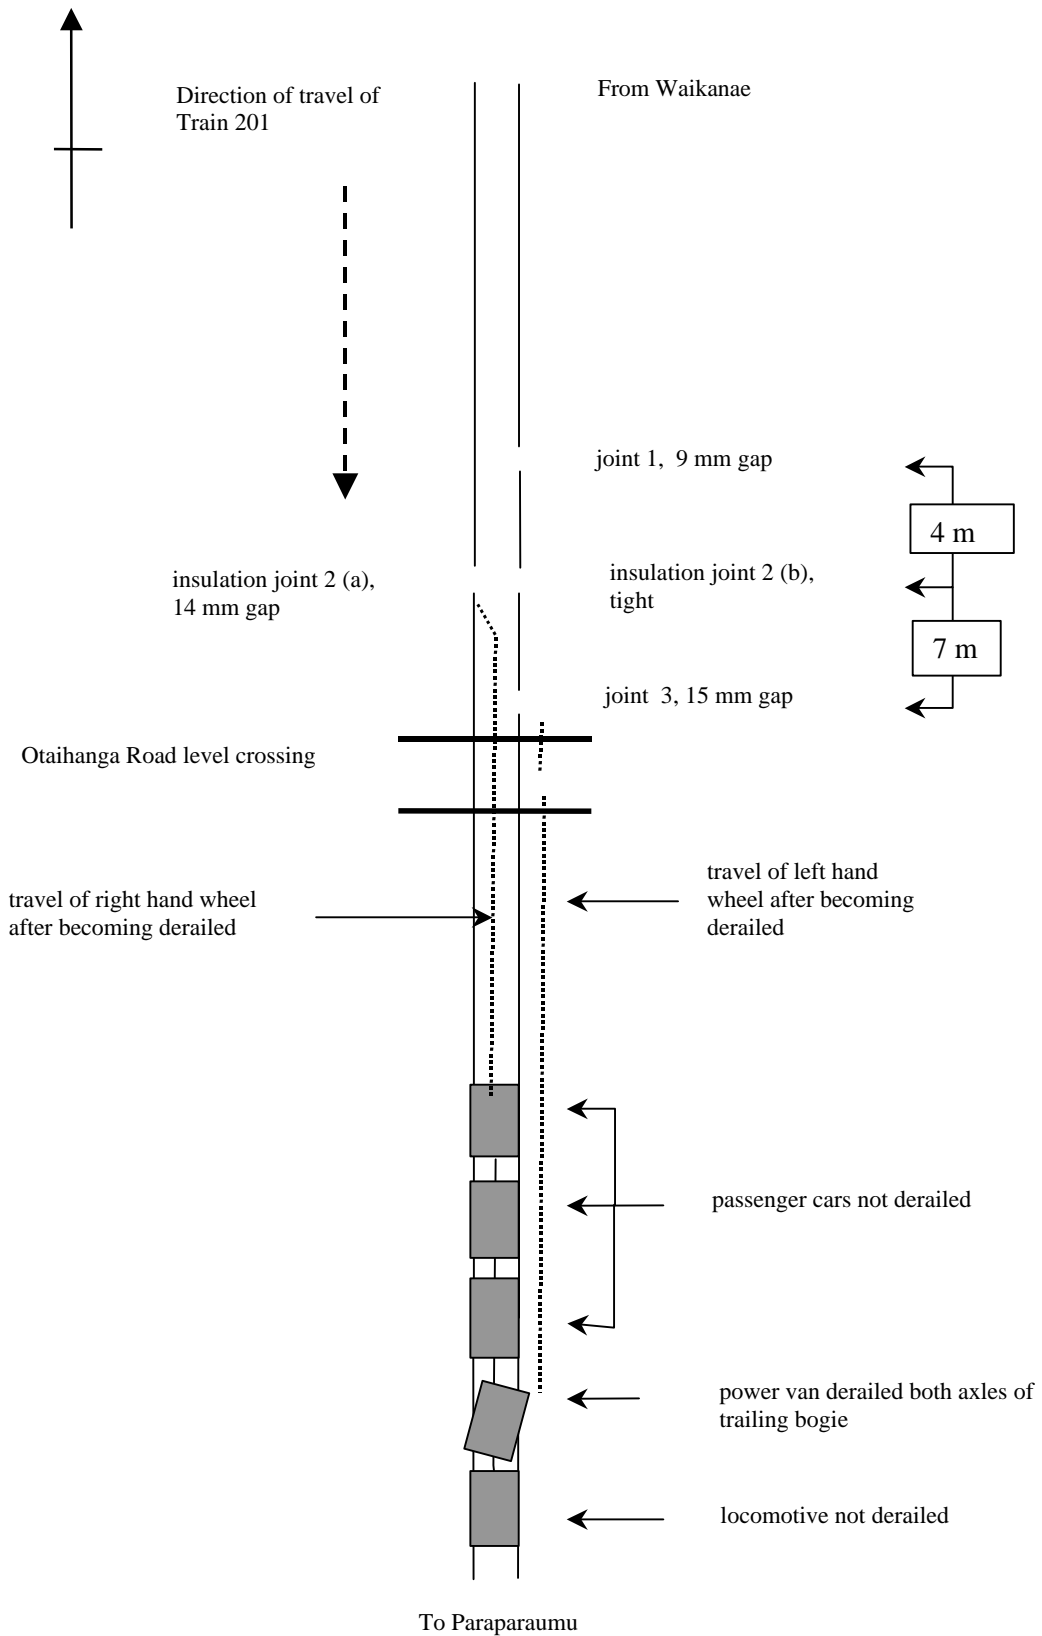
Figure 2
Derailed site plan (not to scale)

- 1.5.3 The condition of the 4 joints in the vicinity of the point of derailment were:
 - joint 1 Joint tight with 9 mm gap. Vertical movement of 10 mm under load

- joint 2(a) Joint bond broken with a 14 mm gap. No vertical movement under load
 - joint 2(b) Good condition, fully bonded. No vertical movement under load.

- joint 3 Joint tight with 15 mm gap. Vertical movement of 25 mm under load with signs of mud pumping.
- 1.5.4 The first evidence of the derailment were the marks of the derailed wheel inside the right-hand rail in the direction of travel on the first sleeper past insulated joint 2(a). This established the point of derailment at 51.62 km.

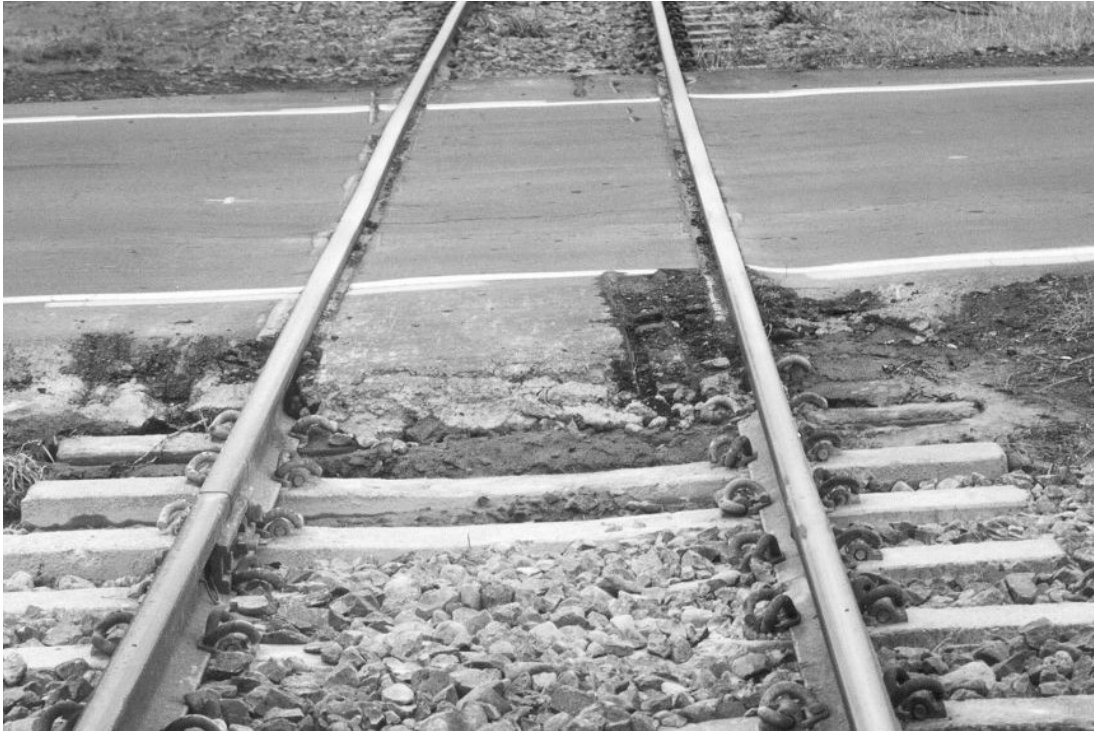
- 1.5.5 The northern edge of the bitumen seal on the Otaihanga Road level crossing (refer Figure 3) showed evidence of having been hit by both the fractured left-hand wheel (wheel 1) and the derailed right-hand wheel (wheel 2) but there were no further marks from these 2 wheels on the level crossing surface beyond the immediate point of impact.

- 1.5.6 About 5 m past the northern edge of the bitumen were two deep narrow gouge marks which ran to the south edge of the level crossing bitumen (refer Figure 3). These marks were made by the flanges of wheels 3 and 4 on the second axle, which had also subsequently derailed. These flange marks continued on damaged sleepers for about another 300 m south to where the train eventually stopped.

Figure 3
The northern edge of Otaihanga Road level crossing

1. Wheel 1 probably fractured a short distance before the point of derailment, allowing wheel 2 to derail almost immediately. With wheel 1 jammed and probably making little contact, if any, with the rail surface, wheel 2 on this axle supported most of the weight. The marks in the bitumen at the northern edge of the level crossing showed that wheel 2 hit the surface with a greater impact than wheel 1 (refer Figure 3), suggesting that wheel 1 may almost have been “floating” at that time.

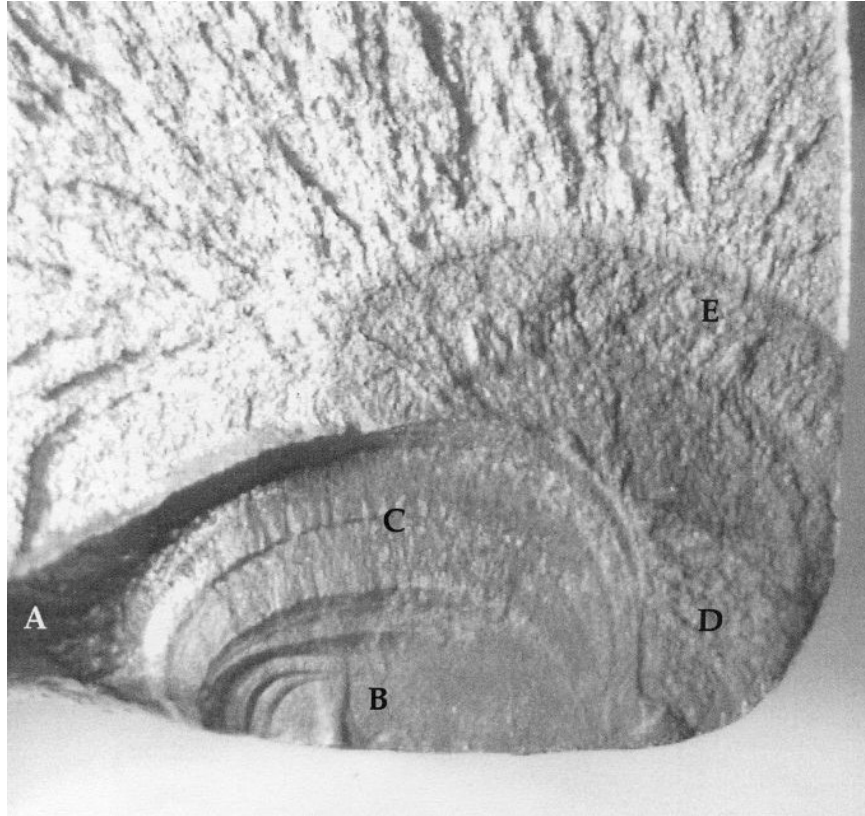
- 1.7.1 A section of the wheel rim and disk web had separated from the remainder of the wheel, which was still attached to the axle. Examination of the initiation region of the fracture surface revealed that 5 different pre-existing cracks were present (refer Figure 4).

Figure 4
The surface of the fractured wheel showing the 5 cracks

- Crack A consisting of a group of cracks which ran across the mid-section of the rim-bearing face
- Crack B consisting of 2 cracks that initiated on the surface of the rim-bearing face.
- Crack C was a single arced crack that grew from crack B
- Cracks D and E ran from the edge of crack C nearest to the front of the rim.

3. During the post-incident inspection, cracks were found in other Class C straight plate wheel discs on locomotive-hauled rolling stock which were consistent with Crack A and were probably the result of normal passenger speeds and braking patterns.

4. Cracks B and C were typical of fatigue cracks and were possibly caused by thermal fatigue as a result of power braking. None of the other Class C wheels were cut open to see if similar fatigue cracks were also present in them, but Tranz Rail issued a special bulletin following the derailment (refer Safety Action 4.1) which prohibited the use of power braking above a notch 2 throttle setting on passenger trains.

5. Crack D occurred as a result of overload, possibly due to the overheating at Palmerston North on 12 May 2001, one month earlier. Tranz Rail staff were adamant that the fractured wheel was not involved, but that incident would have provided an opportunity for overload through overheating. However, it was not possible to confirm this because of the time between that reporting and the subsequent derailment of AG147.

6. Crack E probably occurred as a result of the heating and cooling of the wheel when the brakes were applied for about 19 minutes as Train 201 travelled between Palmerston North and Shannon and later cooled between Shannon and Levin. Overload would have occurred when the wheel cooled down and the surface went into tension. The tensile loading due to the thermal stress would have been in addition to the normal operating stresses.

- 2.1 Power car AG147 derailed at Otaihangā as a result of a fractured Class C wheel.
- 2.2 The wheel fractured because of the presence of thermal stress cracks, which were probably caused by earlier major overheating incidents. It finally failed after it was again overheated and

cooled down enough to produce a high tensile stress in the rim. This stress combined with normal operating stresses and caused the overload from a pre-existing crack.

3.4 On 14 January 2002, Tranz Rail advised all Type 14 straight plate wheel discs to AAR Class C standard on locomotive-hauled passenger rolling stock were replaced with curved plate wheel discs to AAR Class B standard following this incident. Tranz Rail introduced a policy prohibiting the use of AAR Class C straight plate wheel discs on locomotive-hauled passenger rolling stock in the future.
