**Report 01-108**  
**express freight Train 842**  
**derailment**  
**Otira Tunnel**  
**7 July 2001**

On Saturday 7 July 2001, at about 1900, express freight Train 842 derailed in the Otira Tunnel. The leading locomotive derailed 2 axles at a failed rail joint which had been installed as a temporary repair for a fractured rail found on Thursday 5 July.

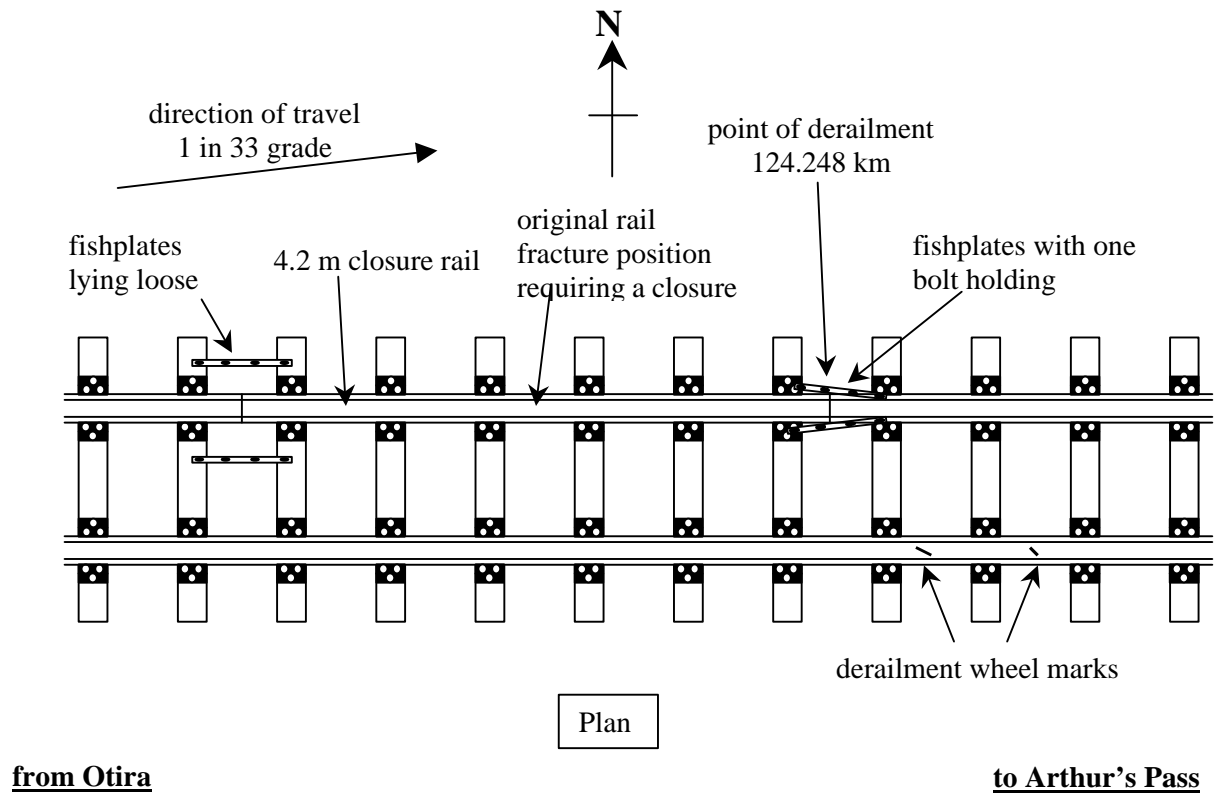
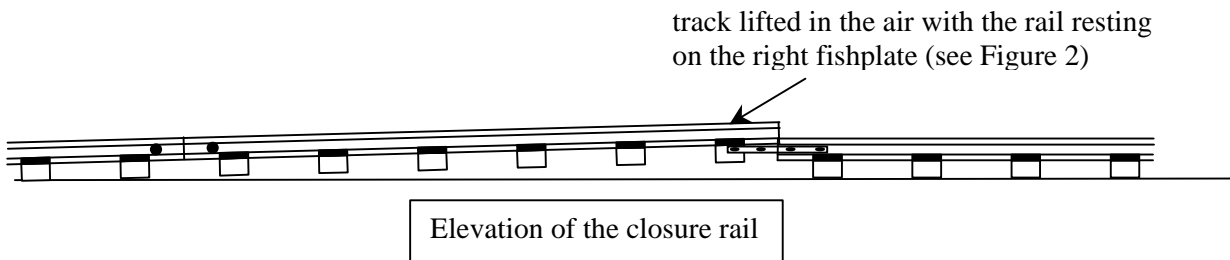
**Figure 1**  
The temporary closure rail as found following the derailment

- 1.2.2 Wheel damage to the sleepers and wheel flange marks on the right rail established the point of derailment at 124.248 km. This was at a joint in the left rail forming one end of a 4.2 m temporary closure rail which had been installed on Thursday 5 July 2001 to repair a rail fracture.

- 1.2.3 Figure 1 shows the relationship of the closure rail to the point of derailment. Figure 2 shows the east joint of the closure rail as found following the derailment, with Train 842 still straddling the joint.

- 1.2.4 The closure rail east joint had failed. One of the two bolts originally holding the fishplates had fallen out. The other bolt was in position but loose, allowing the fishplates<sup>1</sup> to splay. The foot of the closure rail was resting on the splayed end of the right fishplate causing the closure rail to sit proud of the tunnel rail by about 100 mm at the joint (refer Figure 1).

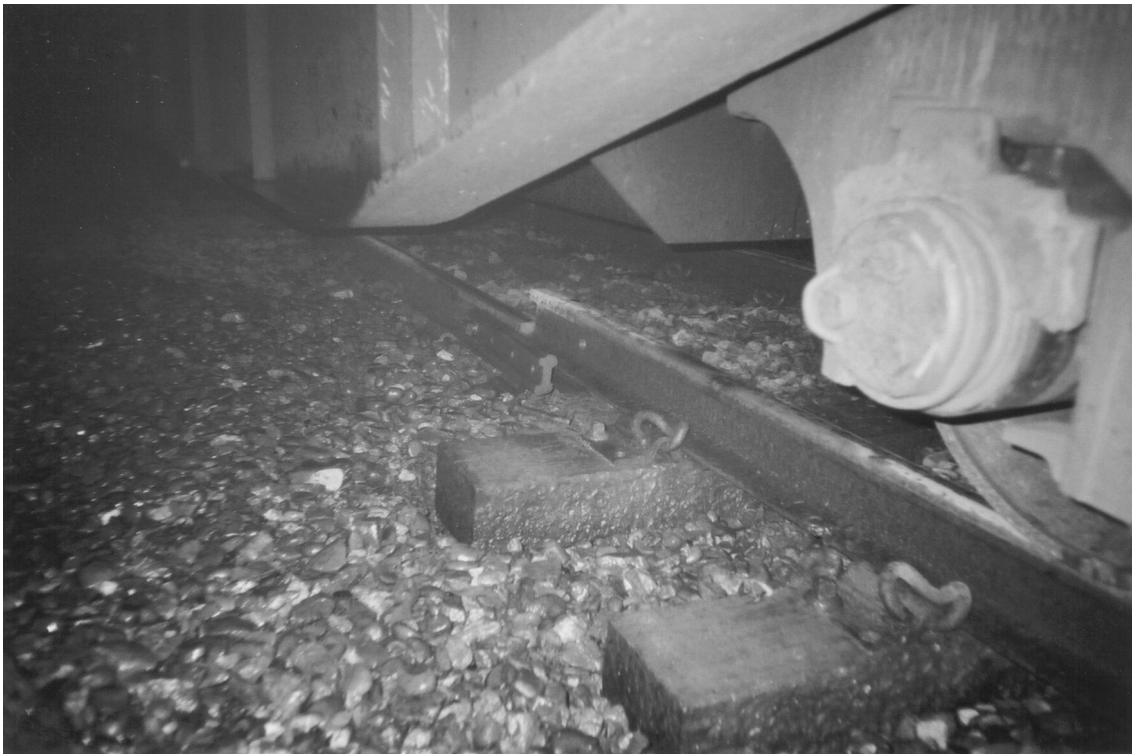
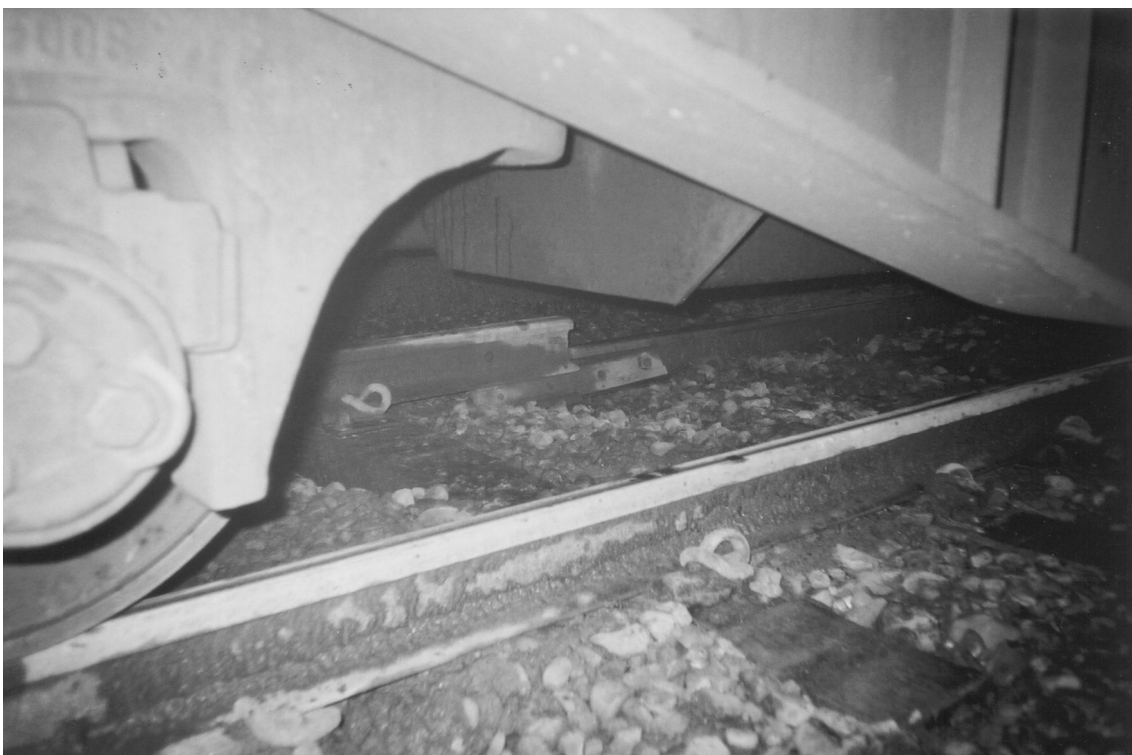
**Figure 2**  
**Two views of the closure rail east joint as found following the derailment**  
**(Train 842 still in position)**

- 2.3.2 Although the precise mechanics of the derailment could not be established it is likely that the vertical rail displacement occurred when the east end of the closure rail lifted as the leading axle of Train 842 passed over the failed west joint. This could have let the fishplate enter under the rail foot at the east joint. The resulting twist transmitted to the locomotive as the leading axle then negotiated the high east joint would have induced a derailment to the right. However, the condition of the closure rail joints was such that a number of dynamic rail/wheel interactions could have initiated a derailment.

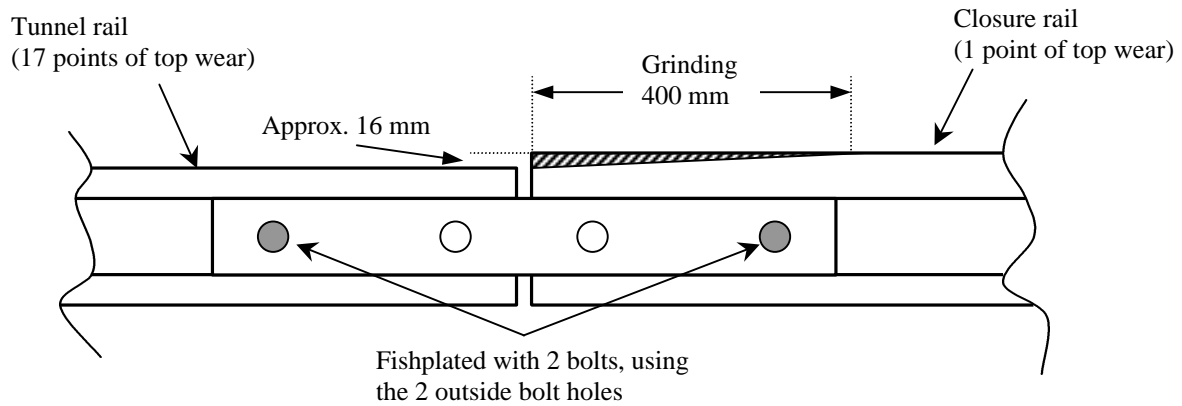
**Figure 3**  
**West closure joint detail**

- 1.2.5 The closure rail west joint had also failed. The fishplates and the 2 bolts were lying loose alongside the joint. Rail-to-sleeper fastenings still held the rail in vertical and horizontal alignment.
- 1.2.6 The point of derailment was at a wet spot in the tunnel, and overhead seepage had affected rail and fastening conditions. The wet ballast was contaminated by accumulated coal dust which had built up over the years. This contamination was present throughout the tunnel length.

- 2.3.1 The main reason for the failure of the west closure joint was dynamic loading from the particular tunnel rail traffic pattern, accentuated by the dip in the rail head profile caused by grinding to a depth of 16 mm maximum over a 400 mm length. The dynamic loading would have been exacerbated by the poor ballast support. Once the west joint had failed, the rail movement available caused the east joint failure, which then initiated the derailment. It is unlikely that the 100 mm vertical displacement of the rails at the east joint was present when the down bankers passed over the joint about 30 minutes before the derailment.

- 2.3.8 Additional impact loading was applied to the joint due to the dip in the rail top profile caused by the rail head grinding. This created a shock loading for the west closure joint as each axle passed over it, with vertical movement permitted by the general track condition adding to the effect of all loadings.

- Installation of closure rails:
      - Rail failures will be repaired with a 4.3 m closure. Closure joints shall be immediately welded in place if welding resources are available. Otherwise, the joints will be plated and four bolted. When welding can be undertaken the 4.3 m closure will be replaced with a 6.3 m closure and immediately welded. The 4.3 m closure can then be reused at another location. Emergency joggle plates and any bolted joints shall be inspected daily.
