**Report 01-112**

**shunt 84**

**runaway wagon**

**Stillwater**

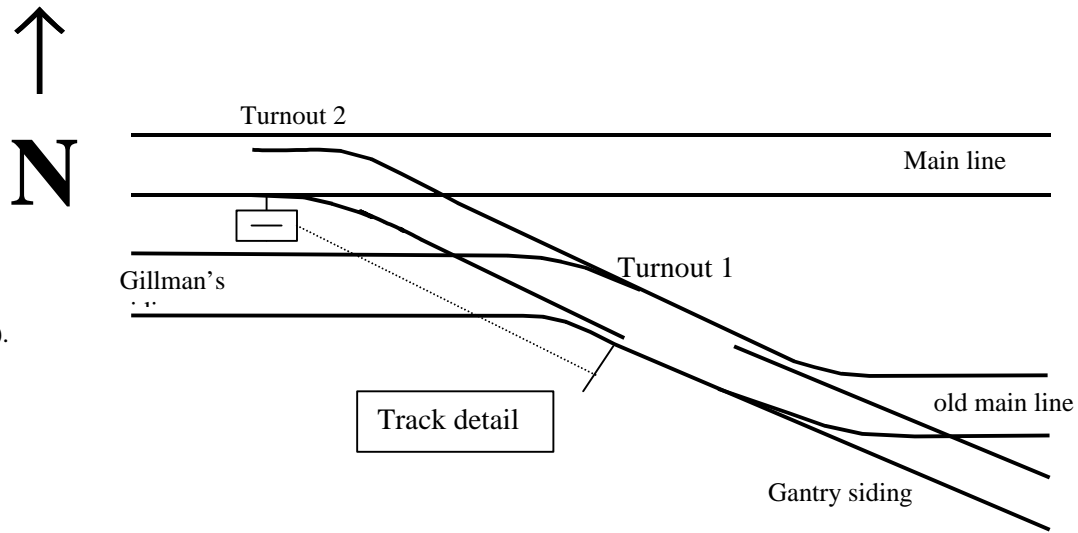
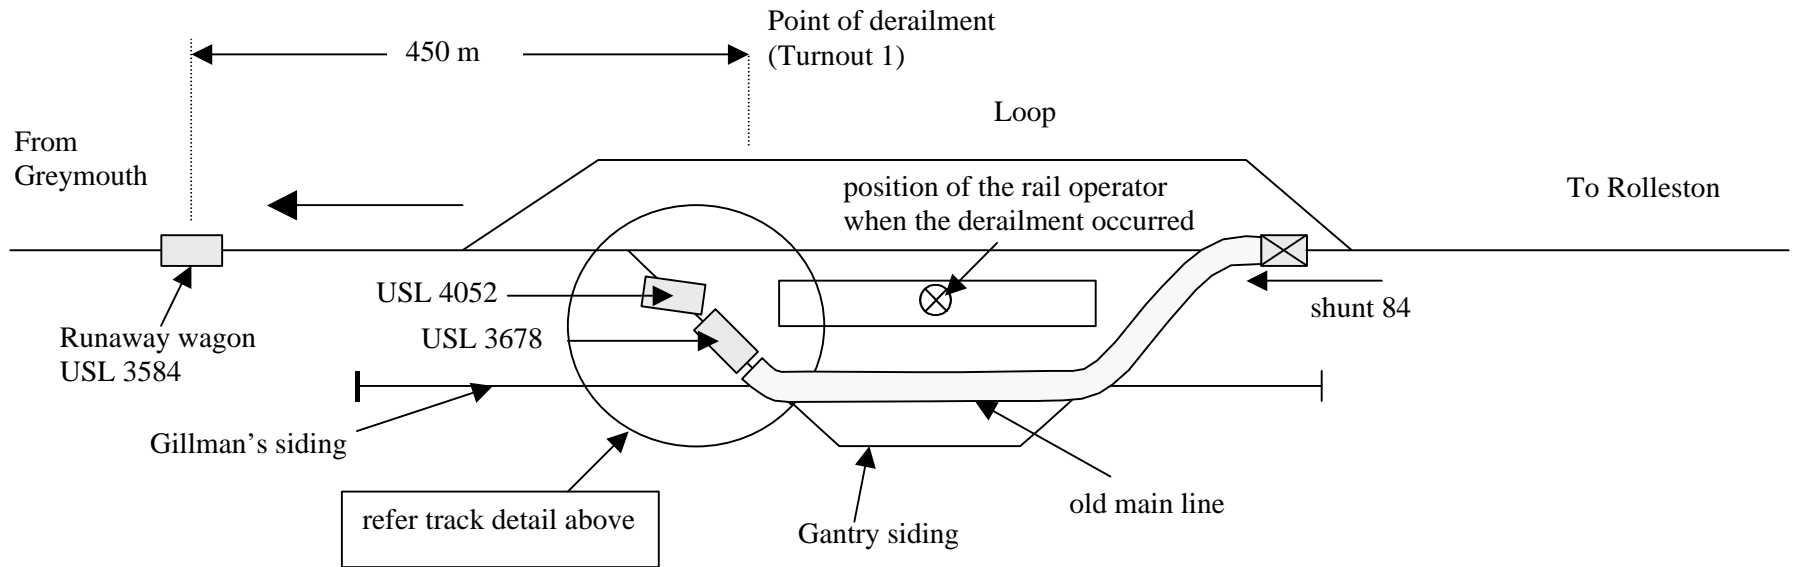
**Figure 1**  
**Site details**  
**(not to scale)**

- 1.2.1 Turnout 1 at which USL 4052 was found derailed was a frame-lever controlled turnout which was interlocked with a main line turnout (turnout 2) as shown in Figure 1. The interlocked turnouts were locked when not in use and could only be operated by authorised Tranz Rail staff.

Note:  
 Turnout 2 is operated manually by a frame lever, and security locked when not in use.  
 Turnout 1 is interlocked with turnout 2 and operated by the same lever.  
 When turnout 2 is set for the main line route, turnout 1 is set for Gillman's siding (as shown).

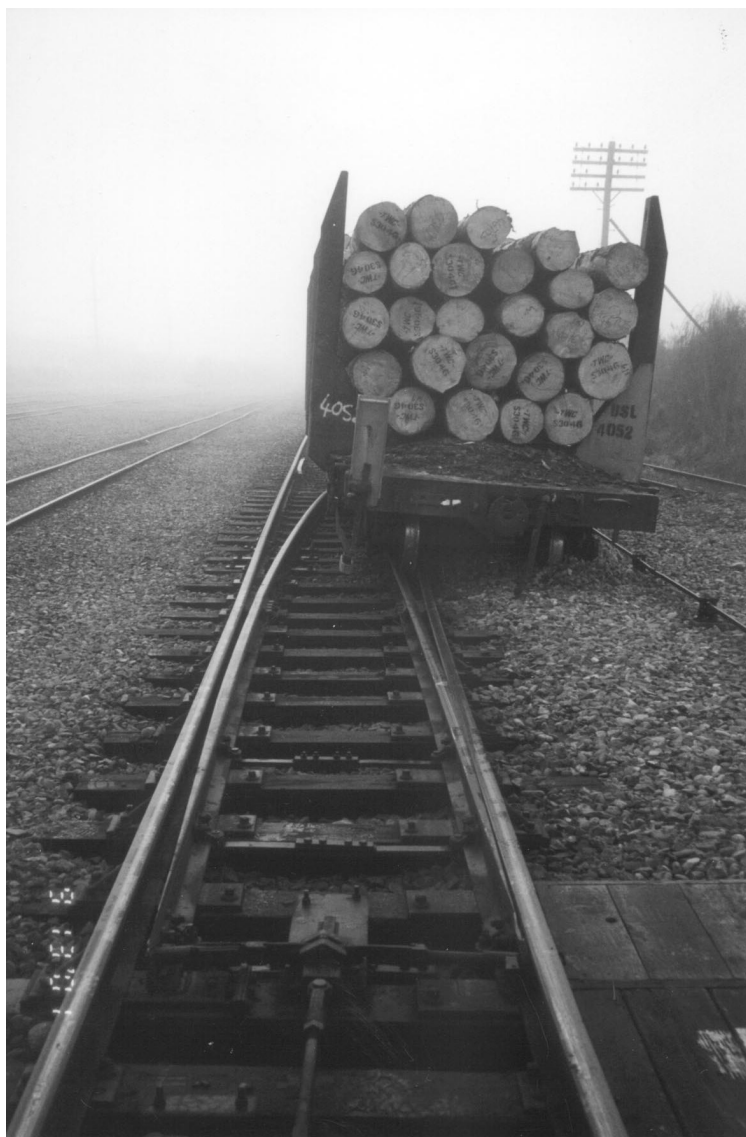
- 1.1.9 From his position on the platform the RO could not see turnout 1 in the fog as he guided the shunt in by radio. His first indication of a problem was when the LE advised him he could not push in any further. The RO walked about 100 m to turnout 1 and found wagon USL 4502 at the end of the rake with its leading bogie derailed (refer Figure 2) and fouling the main line at turnout 2.

**Figure 2**  
**Looking east at the derailed wagon**  
**(taken shortly after the derailment with fog still evident )**

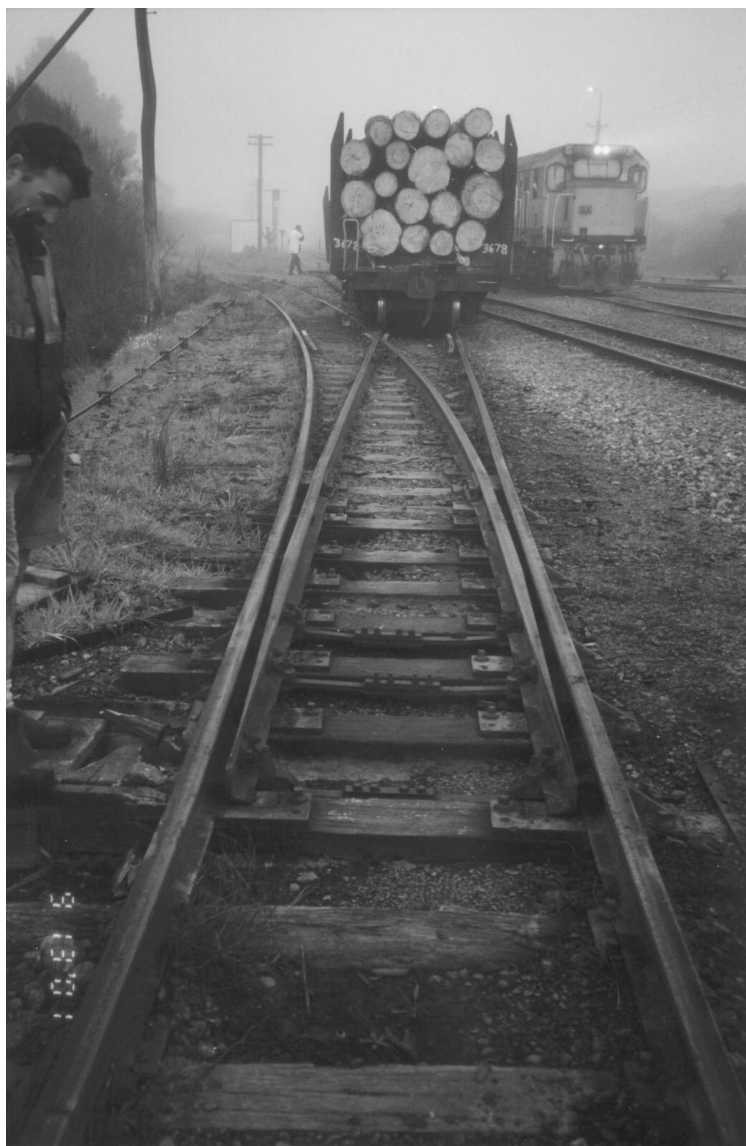
- 1.2.2 Both switch rails of turnout 1 were found open following the incident (refer Figure 3). The inside of the left-hand switch had recent heavy score marks at the point of the switch (refer Figure 4) and about 1 m from the point of the switch (refer Figure 5).

**Figure 3**  
**Looking west from the turnout which initiated the**  
**derailment, showing both switches open**

- 2.2.2 USL 3584 followed a route incorrectly set to the main line due to damage to the points equipment leaving the right-hand switch open. The damage to the switch of turnout 2 occurred when USL 3584 trailed through the turnout and the wheels forced the switch open. Although the shunt was only moving slowly the steepening downgrade was sufficient to allow the unconnected USL 3584 to roll approximately 500 m. The passage of USL 3584 through the turnout caused the leading bogie of USL 4052, the second wagon, to take 2 roads at the split points and derail. The rest of the shunt followed the route to the main line before being stopped by the derailed wagon.

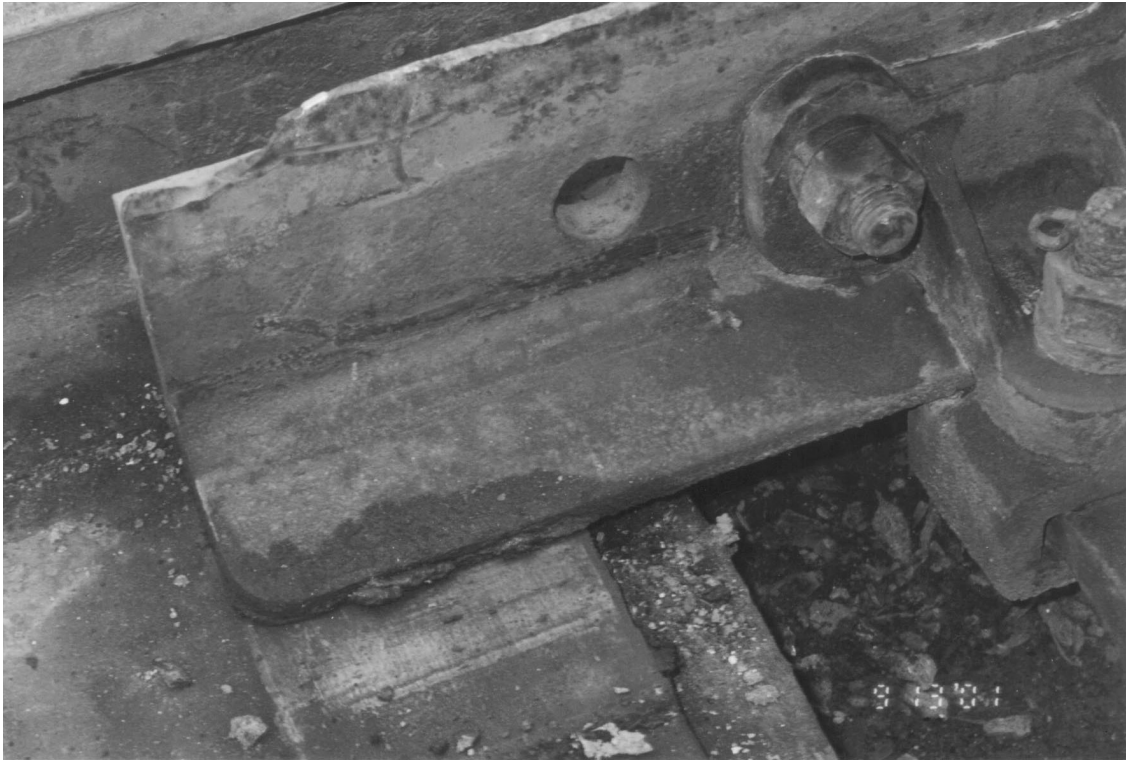
**Figure 4**  
**Score marks at the point of the switch**

- 2.1.1 As a result of the removal of the levers controlling entry to the gantry siding, and the lack of communication regarding this and any alternative arrangements for operations, T Croft staff had for some days been setting a route to the gantry road when required by using the tines of the log loader to push the switch rails to the desired position. The spikes holding the switches closed had either been taken out or dislodged by the log loader operation. Marks on the switch of turnout 1, some 10 m from the west gantry siding turnout, showed that tines had also probably been used to attempt to move these points by mistake. As they were interlocked mechanically with the main line turnout they could not move freely. However, the pressure applied was probably sufficient to have damaged the control rods and opened up the right-hand switch without the log-loader driver realising this had happened.

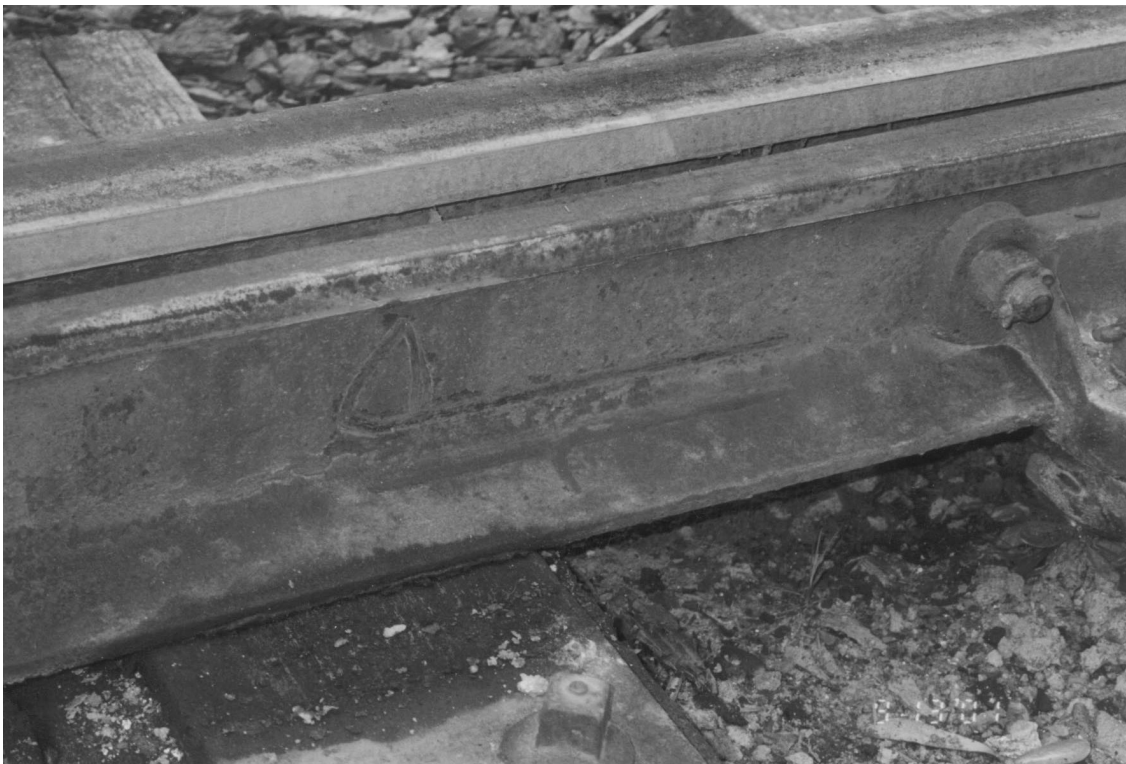
**Figure 5**  
**Score marks 1 m from the point of the switch**
