## **Report 01-202**

### **commercial jet boat *Shotover 6***

#### **engine failure and collision with river bank**

#### **Shotover River, Queenstown**

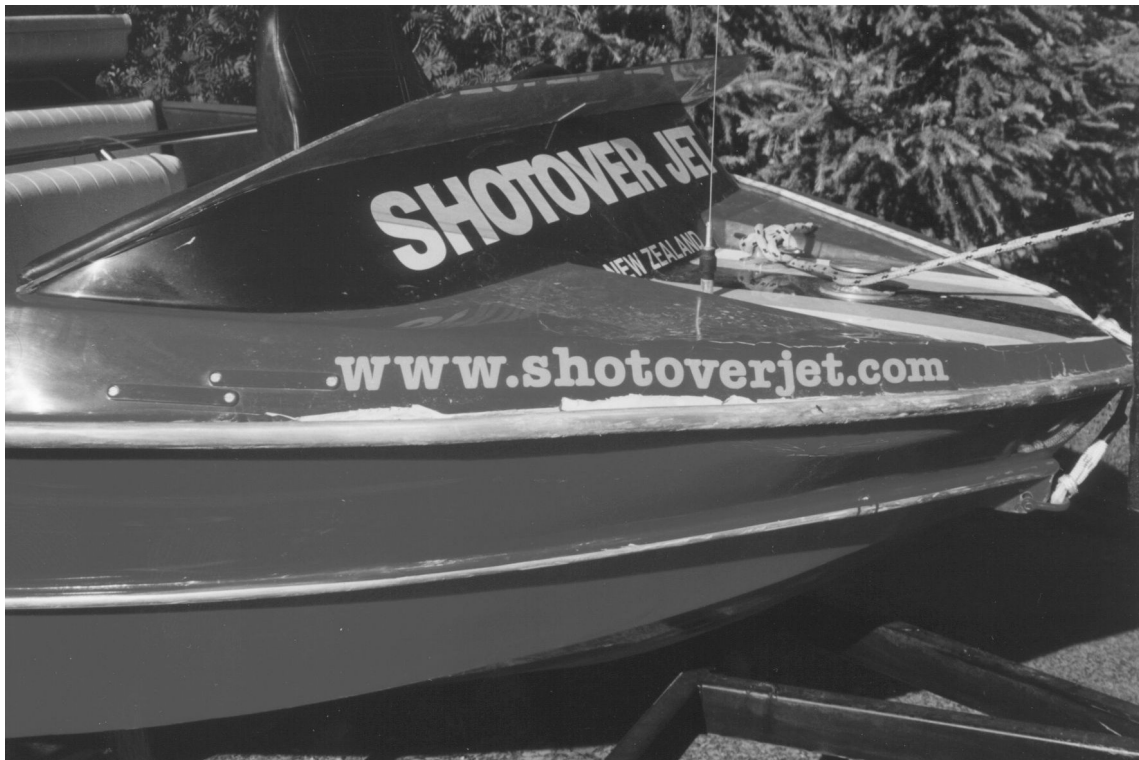
**Figure 2**  
**Damage to the starboard bow of *Shotover 6***

- 1.2.1 Damage to the hull of *Shotover 6* was minor. The belting around the starboard bow was bent and the hull underneath dented. There were also scratches and minor dents on the port bow and down the starboard side (see Figure 2).
- 1.2.2 Both engine exhausts had become dislodged from the hull penetrations at the flexible rubber joining sections.
