Report 01-203

container vessel *Nicolai Maersk*

fatality during lifeboat drill

13 February 2001

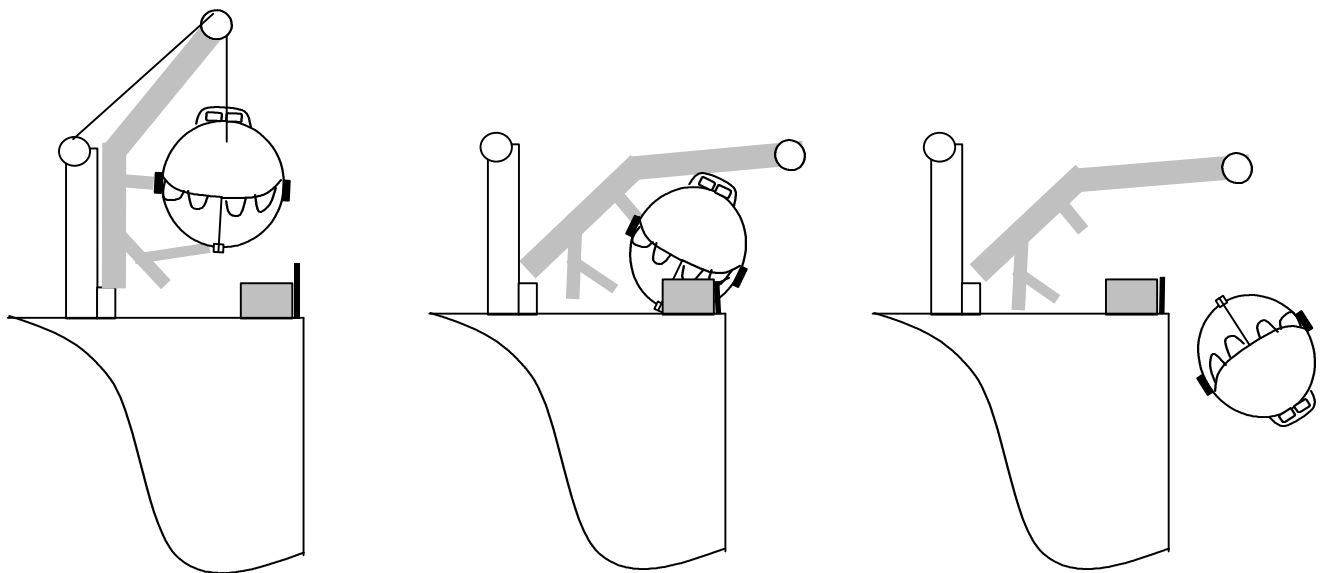
Figure 1
Simplified drawings showing accident sequence from left to right
(not to scale)

- 1.1.12 In the compressor room, the electrician heard the chief officer say “stop” and took his finger off the contactor button, but not before the davit arms had come hard up on their stops and both wire falls parted.

- 1.1.13 When the wire falls parted, the davit arms and lifeboat fell outboard. The lifeboat did not pass free of the boat deck as it normally would, but landed on the edge of the boat deck with the davit arms on top of it. The boat teetered there momentarily and then rolled over the edge, falling some 16 m to the sea and landing upside down (see Figure 1 below).

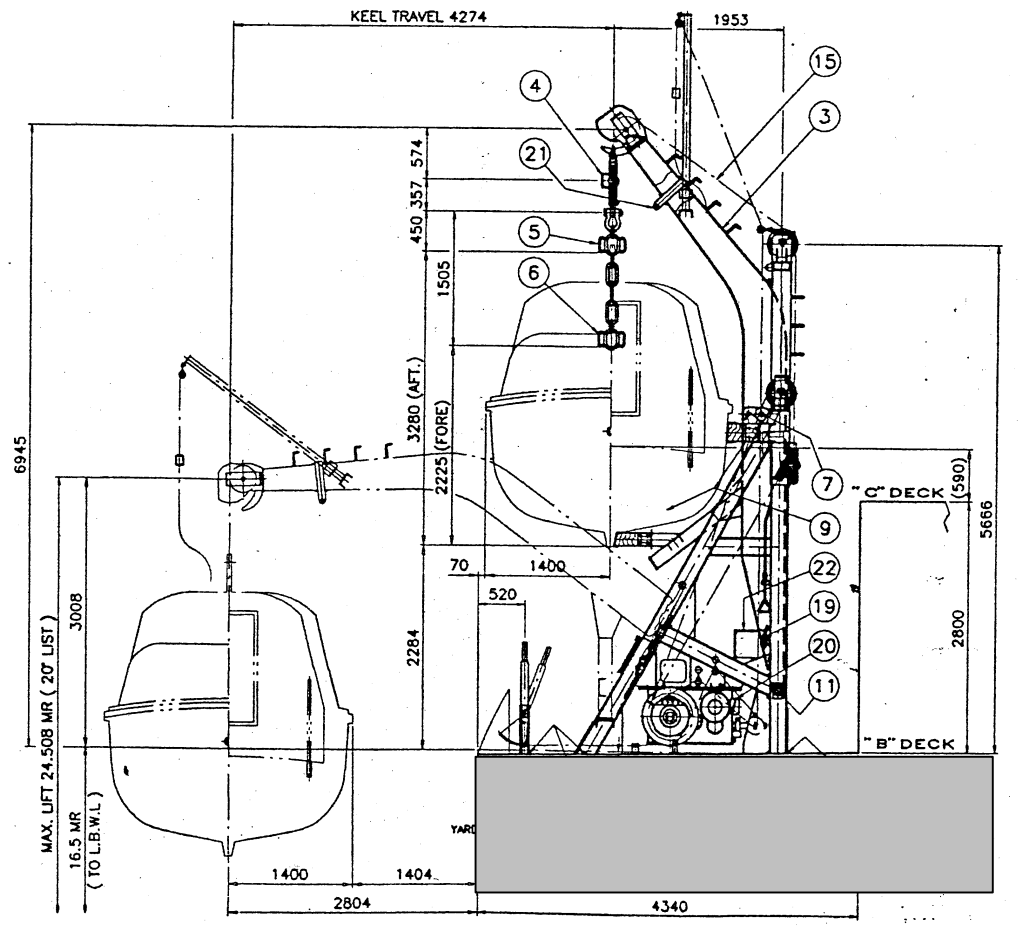
Figure 2
General arrangement of lifeboat davit

1. The fall blocks that were attached to the lifeboat lifting points each fitted over a suspension horn welded directly to the davit head. If the wire fall parted, or the winch brake failed, the lifeboat would hang from the davit heads on these horns instead of falling directly to the deck. These alone would not prevent the davit arms from falling outboard.

2. There were 2 cradle stopper hooks between the fixed structure of the launching apparatus and the davit arms. When engaged, these 2 cradle stoppers would prevent the davit arms from swinging outboard. Between the suspension horns and the cradle stoppers, the wire fall could part or slack back and the lifeboat would remain in its stowed position.

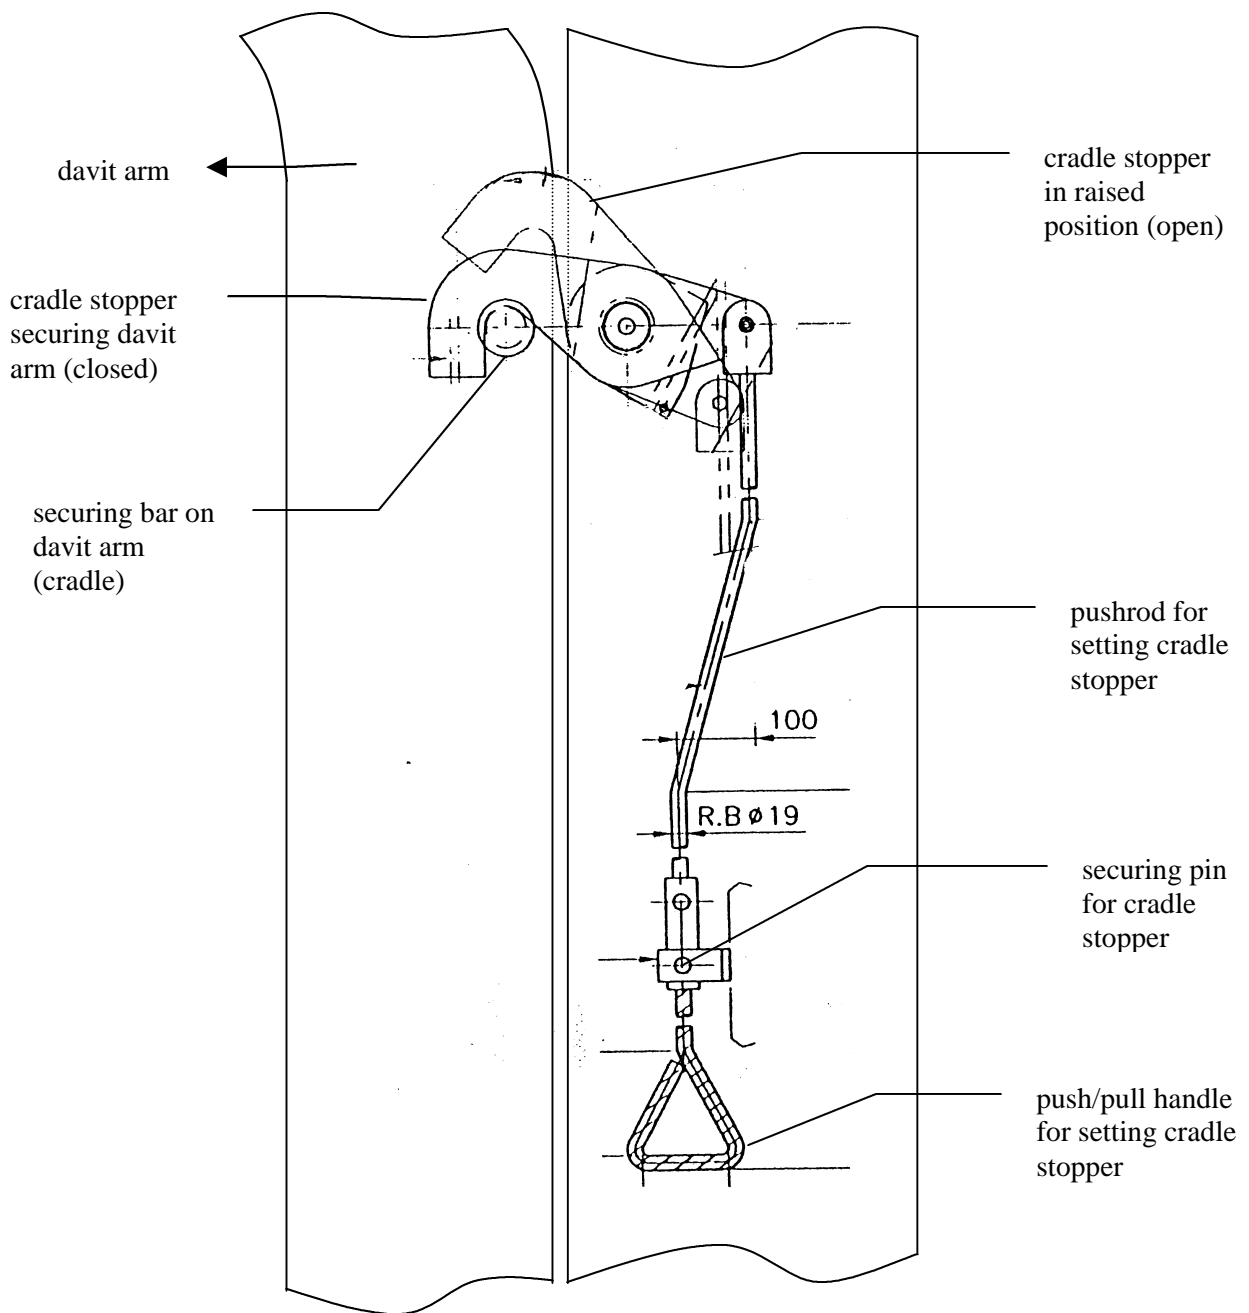
Figure 3
Drawing of cradle stopper

2.2.8 The cradle stoppers were designed to fall naturally in the open position. To close them and secure the davit arms the crew had to physically push the operating rod up and secure it with a pin.

1. When the davit arms were pulled hard up against the stops by the winch motor during the accident sequence, they were not automatically secured by the cradle stoppers.
2. It would have been a relatively simple engineering feat to design the cradle stoppers so that they were self-latching. Had this been the case, both wire falls could have parted and the davit arms and lifeboat would have remained in the stowed position. The accident would not have happened. This is an example of a basic safety feature that should be mandatory on all lifeboat installations of this type.

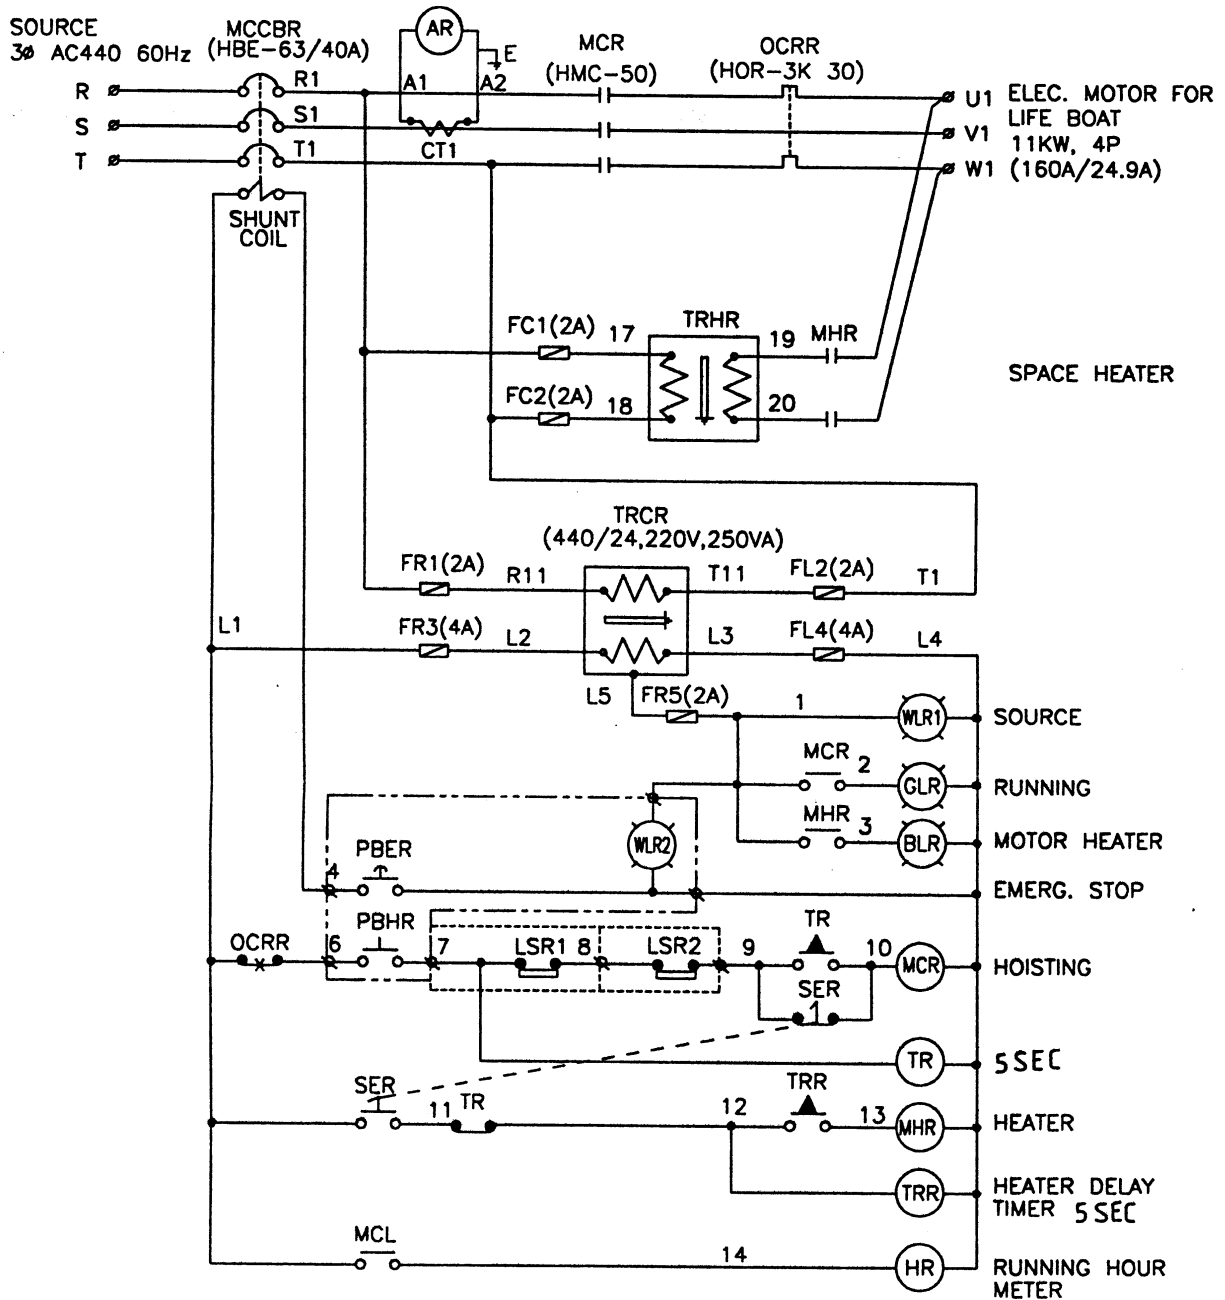
Wiring diagram for lifeboat winch starter

1. The way the protection circuitry was set up meant that in the event of a high electrical load on the hoist motor, the motor overload would trip before the circuit breaker; however, pushing the manual button on the contactor would force the motor to run regardless of its overload protection having tripped. This had the potential to damage the hoist motor, but in this case the current being drawn was sufficient to trip the circuit breaker as well. By repeatedly resetting and operating the winch motor the crew risked causing permanent damage to electrical components.

2. With the motor heater selected “On” a low-voltage current was supplied to one phase winding of the winch motor. Normally when the hoist button was depressed on the remote control, the heater was disconnected and there was a delay of 5 seconds before the hoist motor would operate. This feature was built in to avoid potential damage to the motor.

3. By manually closing the contactor in the lifeboat winch starter box, the circuitry logic was bypassed. This resulted in both main current and current from the heater supplying the motor at the same time, which together with the normal operating load caused the circuit breaker to trip on over-current.

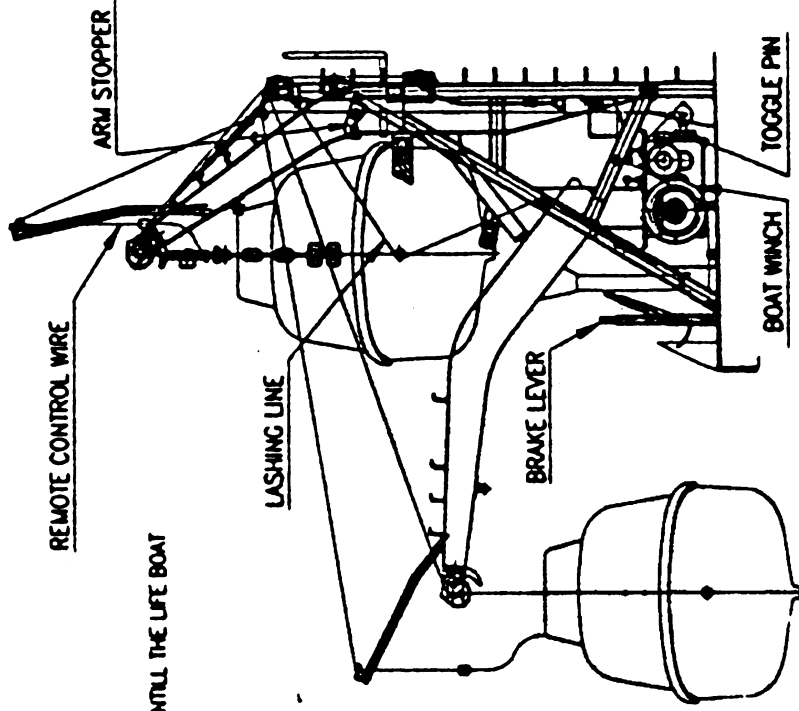
3. An example was, instruction number 4 for hoisting included the caution "*when turn in the life boat davit, to shift clutch lever to lower direction*". When lowering the lifeboat using the clutch lever, it would normally be raised. The instruction was intended to tell the operator to ensure the clutch lever was not raised while hoisting. During testing after the accident, one crew member was observed to misunderstand this instruction and do the opposite.
