## **Report 01-207**

***Osprey***

**swamping and manoverboard**

**Uawa River bar, Tolaga Bay**

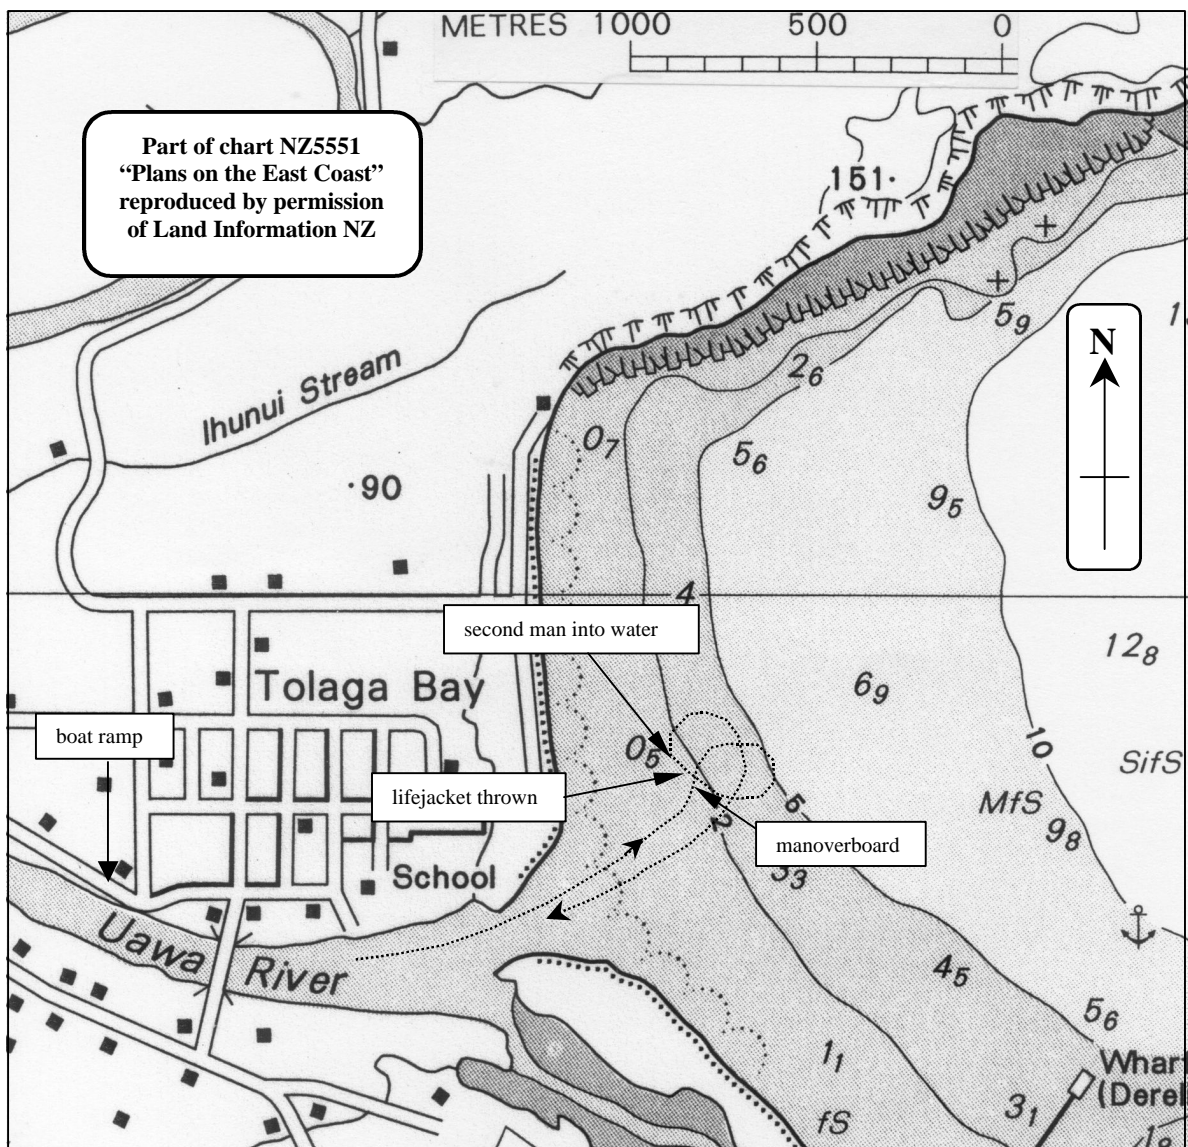
**Figure 2**  
Part of chart NZ 5551 showing approximate track of the *Osprey*

- 1.1.20 The passengers in the boat decided that one of them should get into the water to help the man who had been washed overboard. One of them climbed over the side and started to wade towards him. The skipper had been manoeuvring the *Osprey* to keep the propellers away from the first man and was also keeping a watch on the breakers. By the time that the second man went into the water there was about 50 m between them (see Figure 2).
