Report 01-210

Spirit of Enterprise

grounding

28 July 2001

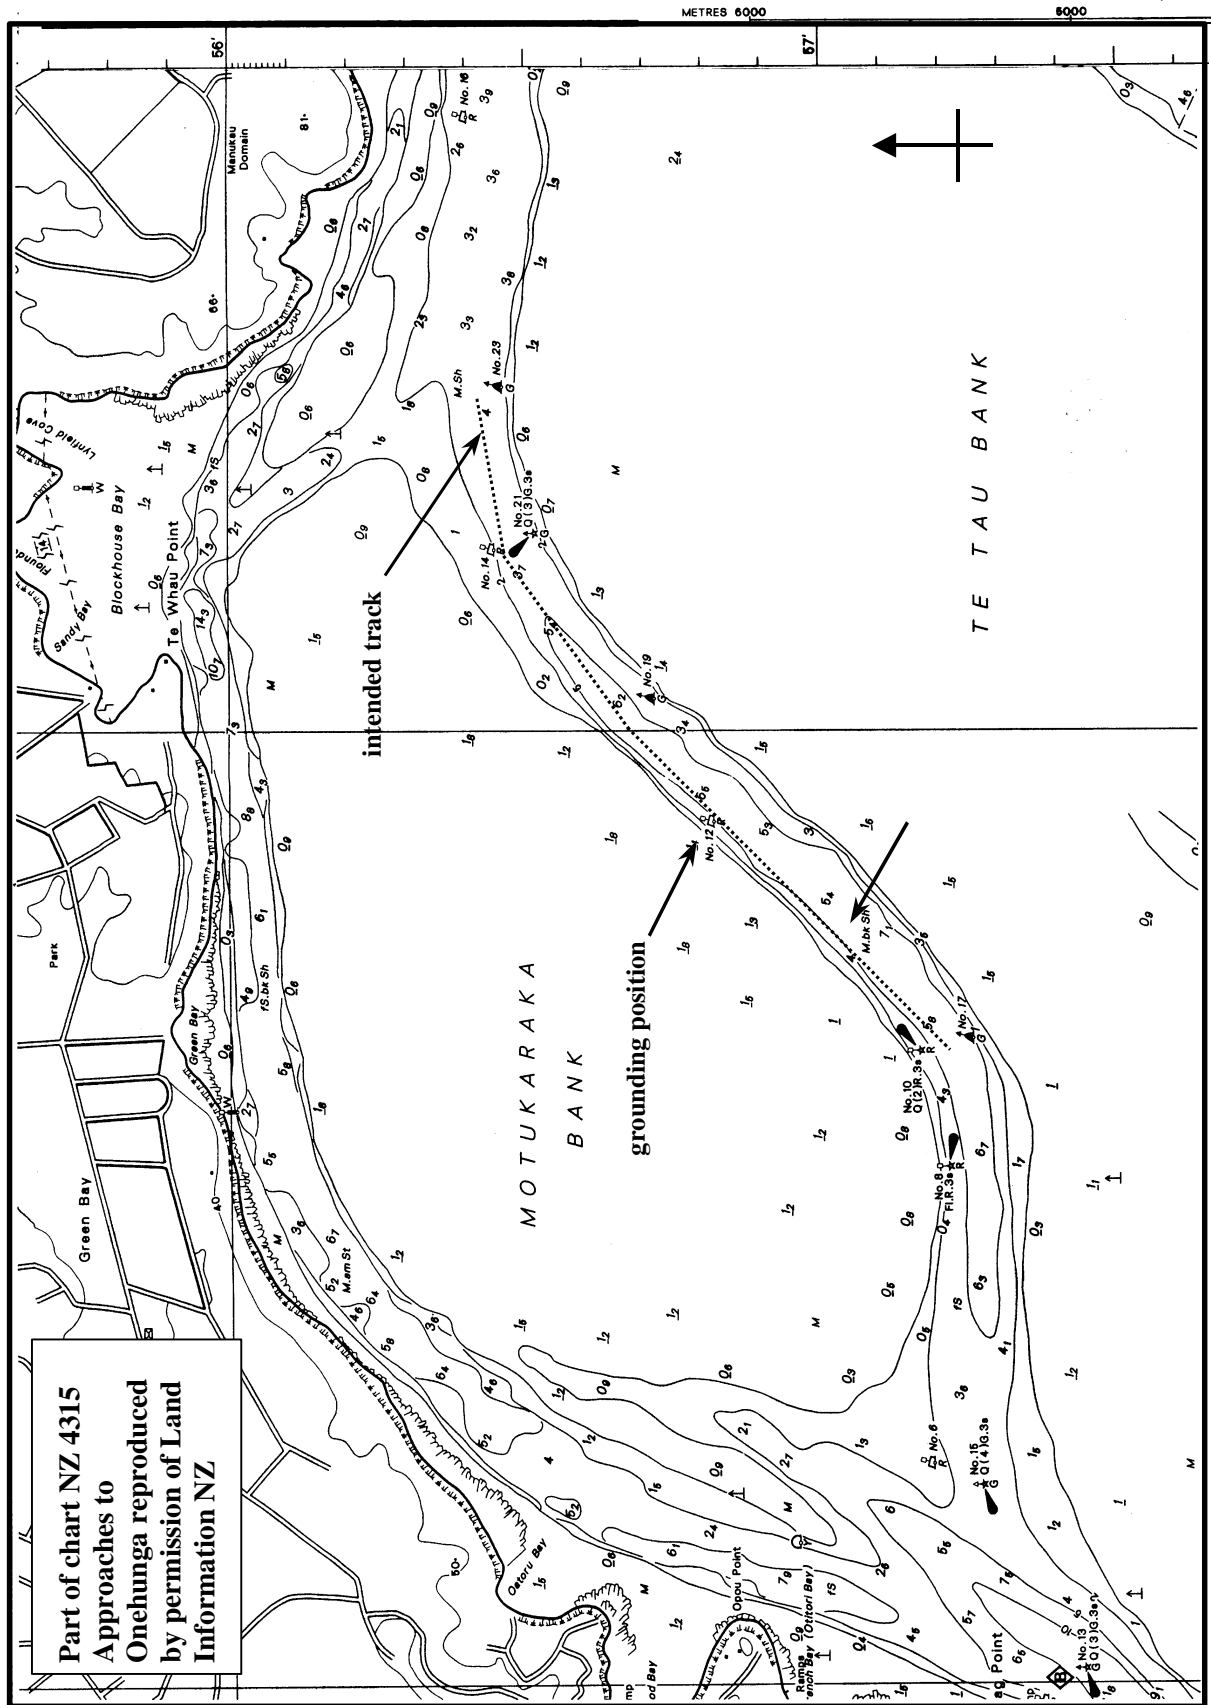
Figure 2
Part of chart NZ 4315 showing area of grounding

- 1.1.11 At 0501 unlit buoy number 23 was passed, "giving it good clearance due to concerns about shoaling", the master stated later in his report to Pacifica. The pilot was aware that masters of other ships had reported shoaling in the area and he discussed it with the master during the inward passage. The course was altered to 260 degrees true and the ship proceeded at about 7 knots towards the "gateway" between unlit buoy number 14 and lit beacon number 21 still to the north side of the channel (see Figure 2).

- 1.1.13 As the ship approached navigation marks 14 and 21 the pilot ordered a course change to 234 degrees true. In the vicinity of number 19 buoy the master observed the underkeel clearance on the echo sounder decrease from about 4 m to about 2 m, so he went to the chart table to check the chart. The pilot recalled sighting unlit buoy number 19 and had noted the time of passing it as 0510. He also recalled sighting lit beacon number 10 ahead in the distance but did not recall sighting unlit buoy number 12.

- 1.1.16 Shortly afterwards the chief officer reported that the speed was dropping. He then went to the wheelhouse window and could see number 12 buoy on the port side of the ship, abeam of number one hatch. The bridge team then realised that the ship had grounded and the pilot ordered the engine to be stopped. The time of the grounding was recorded in the log book as 0512. The helmsman recalled the ship's head was 231 degrees true at that time.

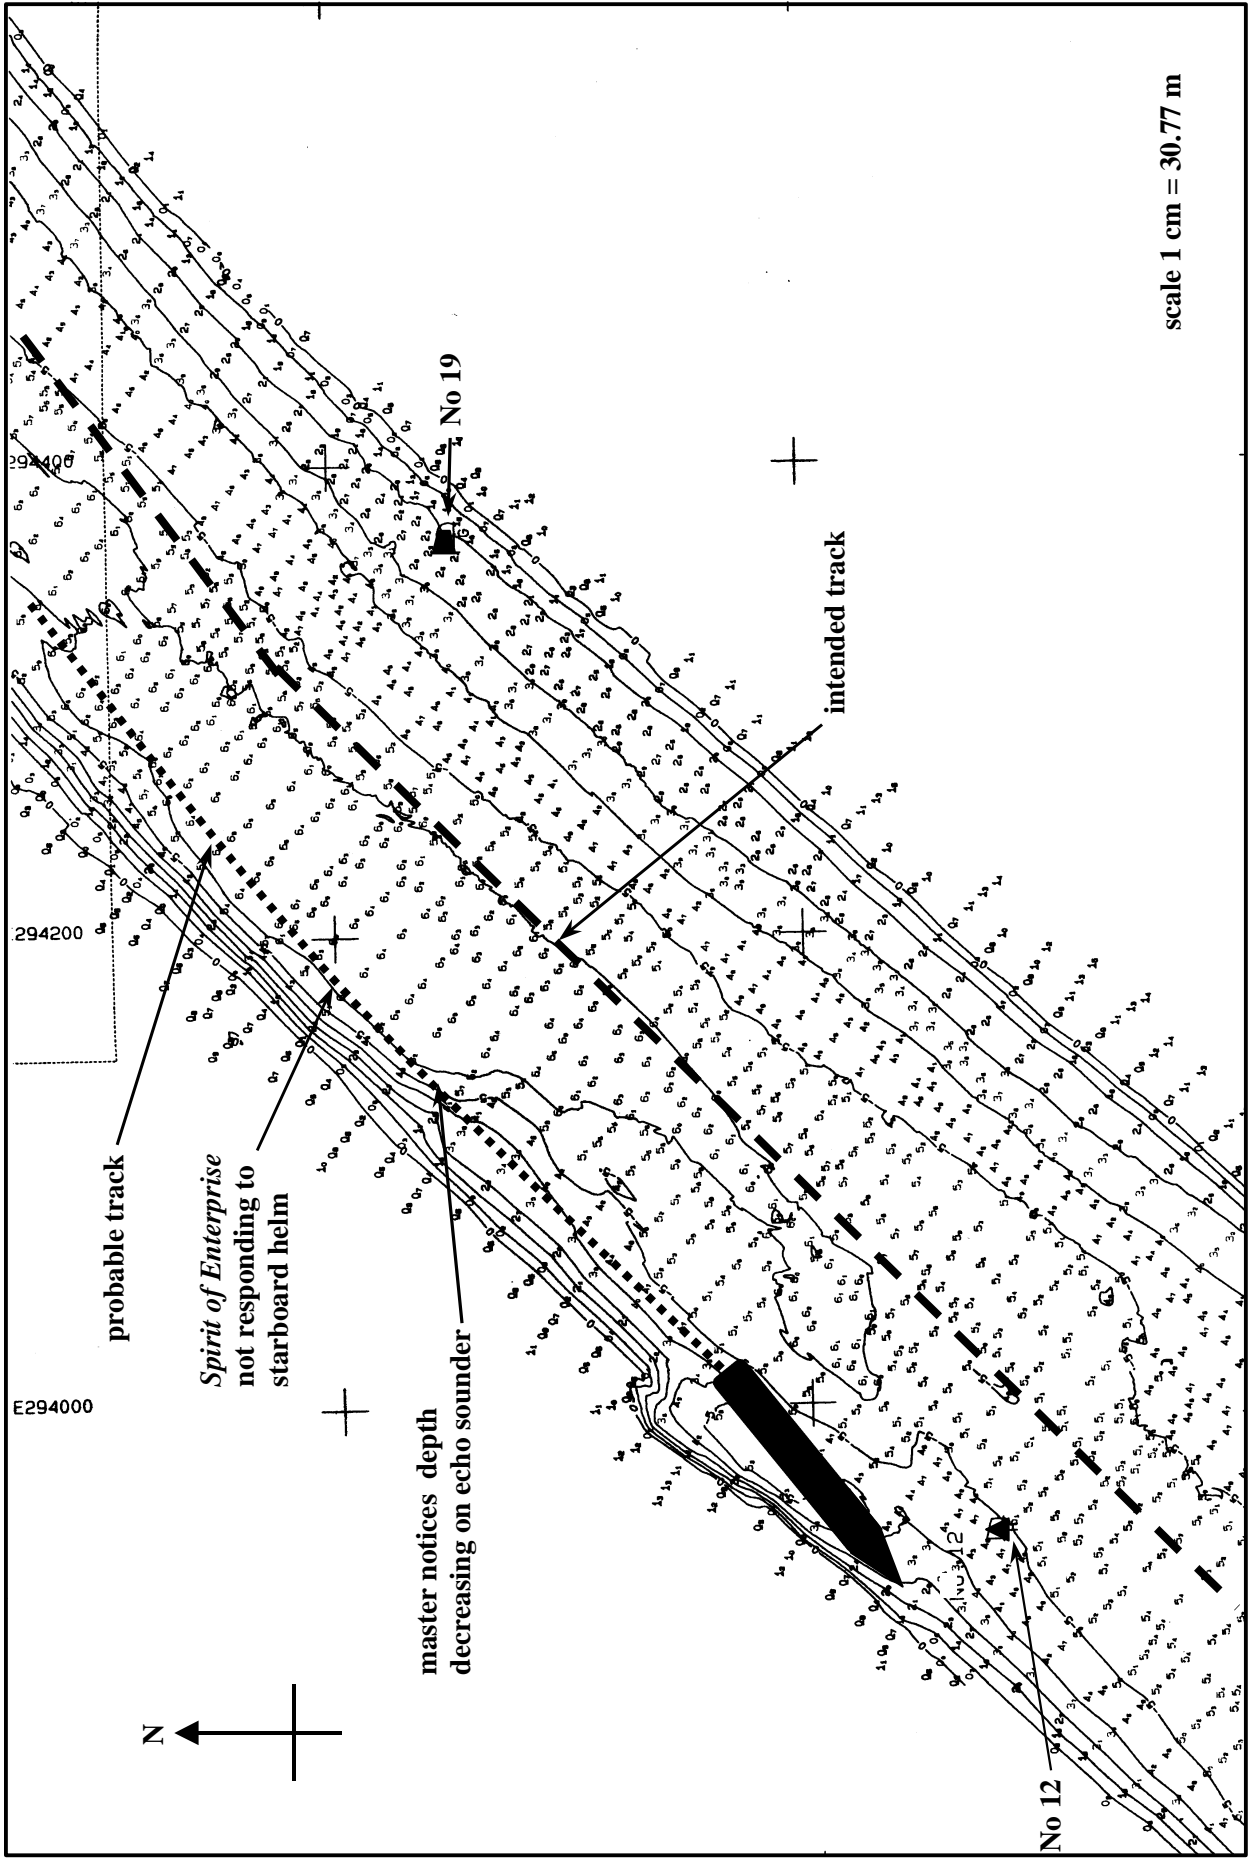
Figure 3
Sounding chart in area of grounding

- 1.4.5 The New Zealand Pilot 15th edition 2001 stated the maximum permissible draught for the port of Onehunga was 6 m. About 3 weeks after the grounding occurred POAL conducted a hydrographic survey of the area and compiled sounding charts. In the immediate area where the *Spirit of Enterprise* grounded the water depth had increased to over 5 m. This was thought to have been caused by the *Spirit of Enterprise* sitting on the bottom at low tide and the tidal flow scouring the mud from around the hull (see Figure 3).

- 1.4.6 The sounding charts showed the depth of water on the port side of the channel in the vicinity of buoy 23 to be more or less constant at about 3.5 m, with no shoaling evident in the area.
