Report 01-213

commercial jet boat

Shotover 21

engine failure and collision with rock face

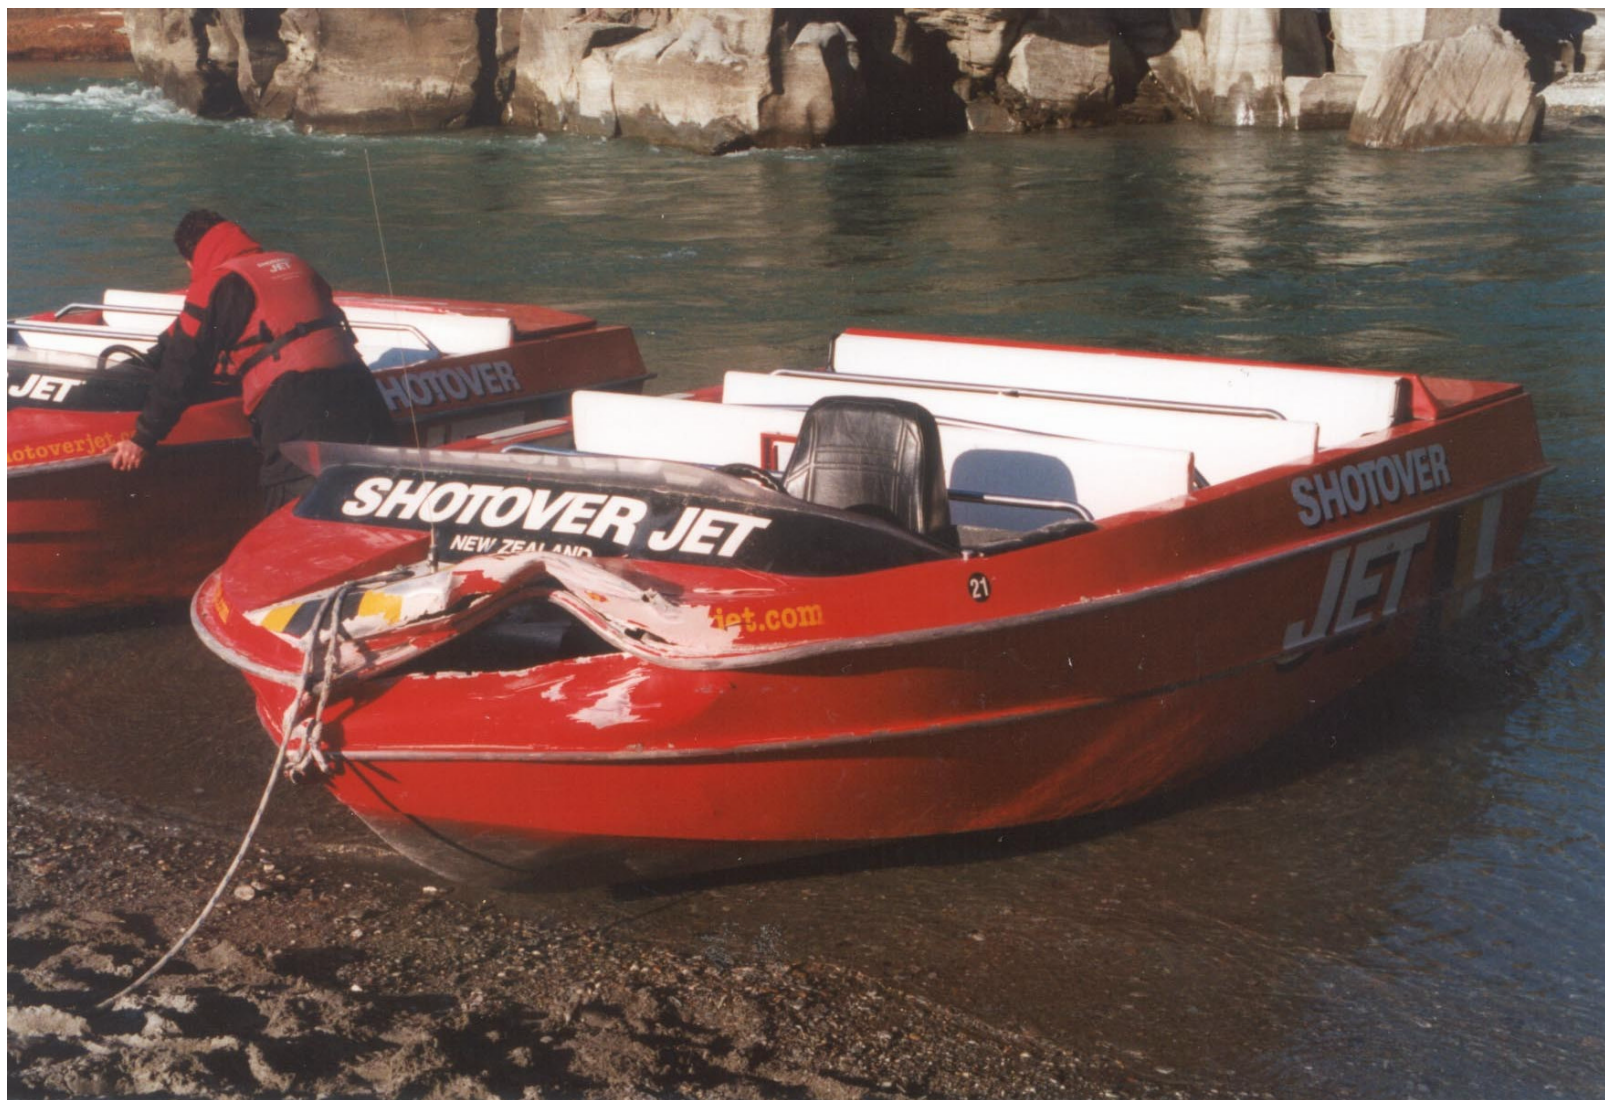
Shotover 21 at the accident site

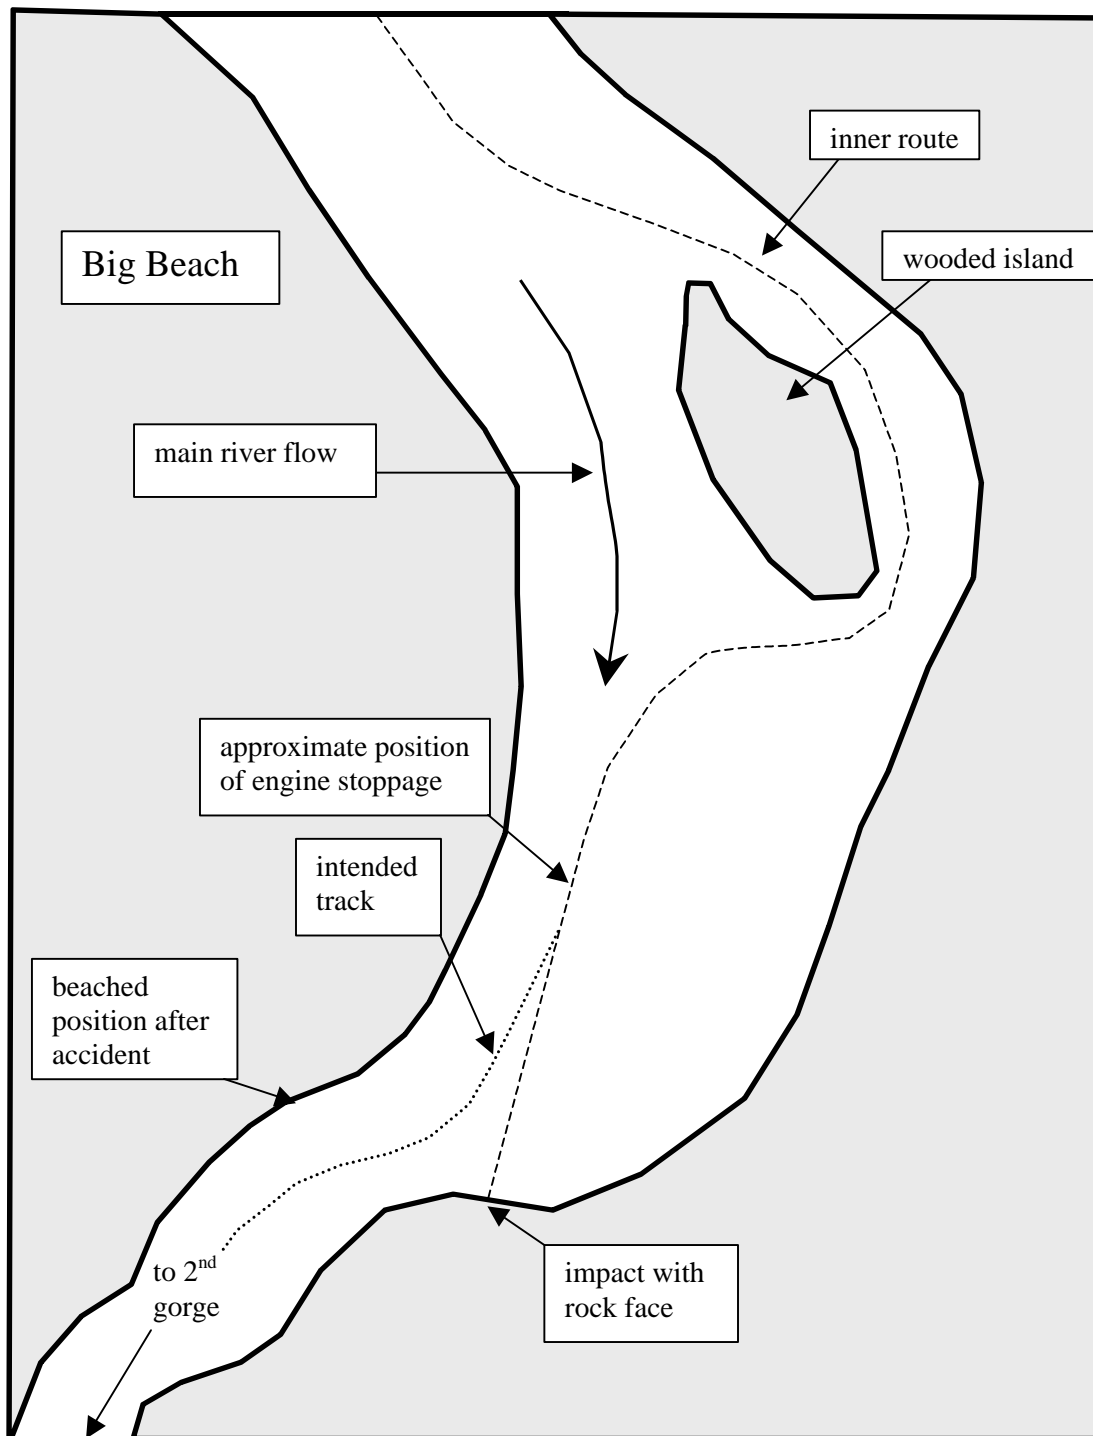
Figure 1
Diagram of accident site

- 1.1.11 At the time of the engine stoppage, *Shotover 21* was travelling downstream in a straight line with a sheer rock face about 60 m ahead. Without the engine running, the driver was unable to steer and just before the boat hit the rock face he warned the passengers to hold on.

- 1.1.12 *Shotover 21* hit the rock face almost head on, at an estimated speed of about 30 km/h, throwing the driver and passengers forward.

- 1.1.13 *Shotover 21* settled in the water with its bow wedged against the rock face and its stern against a submerged rock. The boat remained pinned at the point of impact by the river flow.
- 1.1.14 The driver immediately used the boat radio to contact the second jet boat travelling downstream behind him. He told the other driver of the accident and requested that he return to the jetty, disembark the passengers and come back to assist.

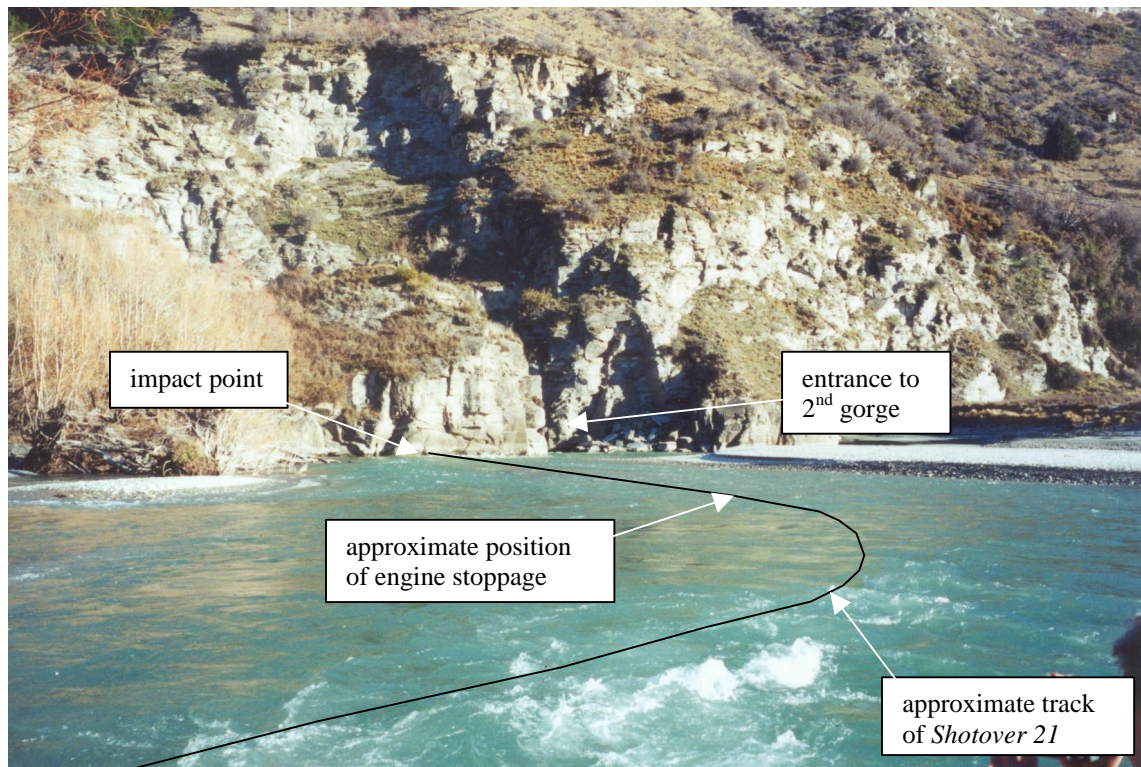
Figure 2
The accident site showing approximate track

- 1.1.9 Shortly after the driver had established his driving line, and while still travelling at about 60 km/h, the engine stopped suddenly (see Figure 2). There was no prior indication that the engine was about to stop and no alarms from the engine warning system sounded.

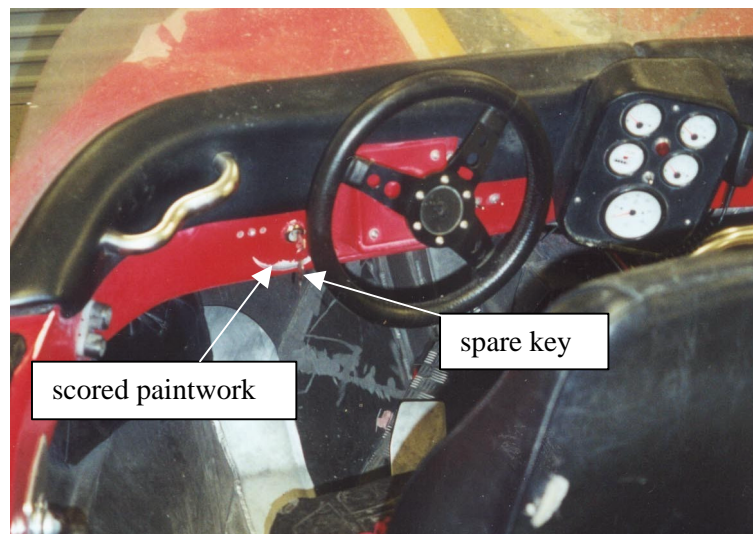
Figure 3
Dashboard of *Shotover 21*

- 1.8.17 The operation of the ignition key was checked and all appeared as expected. The key unit was cut open and all parts were found clean and free of corrosion and wear. The ignition key was on a ring together with a second key. The paint on the dashboard below the ignition switch had been rubbed off in an arc where the second key hung down from the ring and made contact with the dashboard (see Figure 3).

18. The only time that the engine was made to stop during simulation was when the battery connection to the ignition was inadvertently disconnected. This had the same effect as turning the ignition key off. This may have occurred during the simulation conducted by the operator, which might be an explanation for how the operator induced an engine stoppage. The wiring and joints in the ignition system were inspected and could not be faulted. This leaves one scenario of the ignition key arrangement itself being a possible cause.

20. Had the ignition been inadvertently turned off at a time when the battery was open circuit and power was being supplied by the alternator, the driver would have no battery power to restart the engine. This scenario has been considered in the absence of any other cause being found.
