MARINE OCCURRENCE REPORT

01-216

Yacht *Toolka-T* and tug and barge *Wainui* and *Sea-tow 11*,
collision, Takatu Point, north of Auckland

16 November 2001

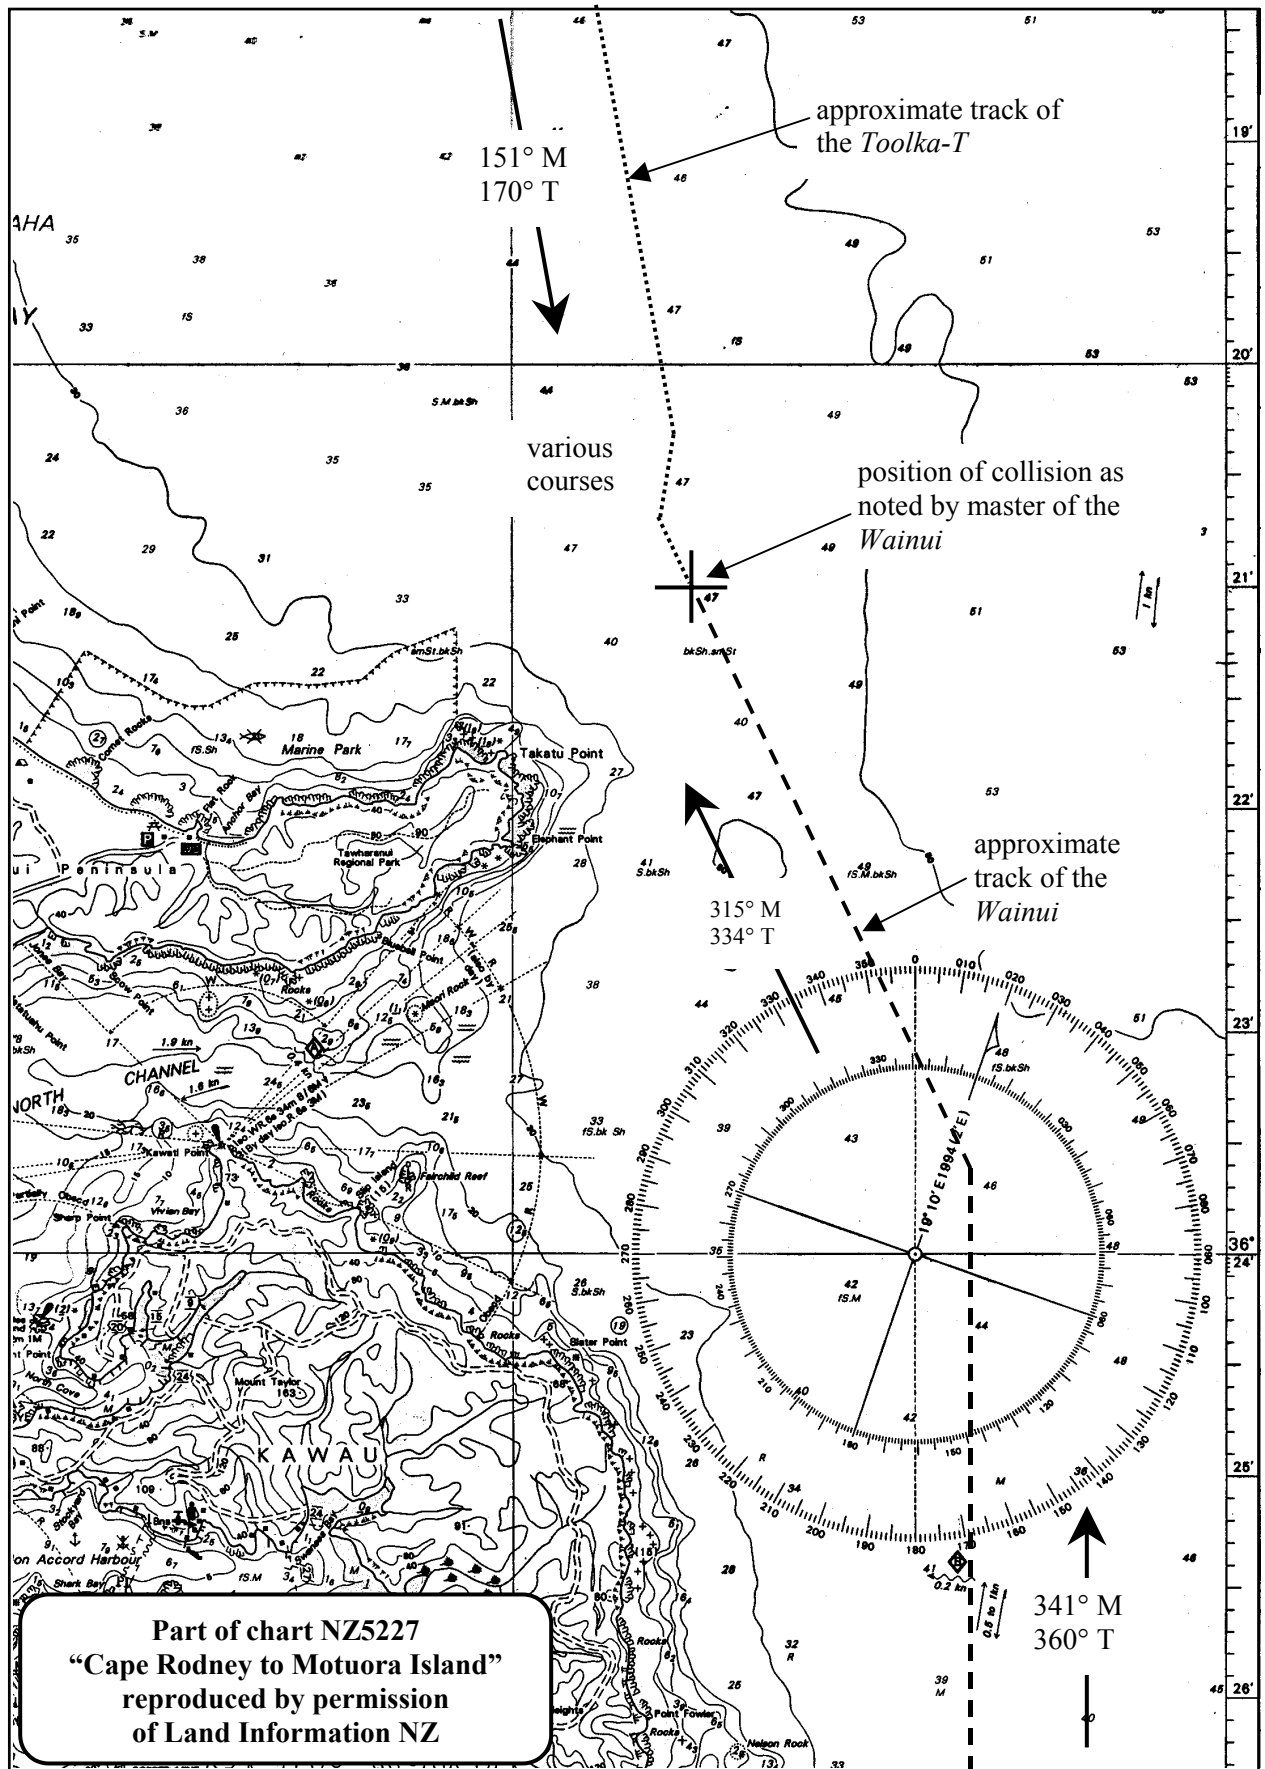
Figure 1
 part of chart NZ5227 showing approximate tracks of the Wainui and the Toolka-T

- 1.1.4 The first deckhand stood the second sea watch to a position off Takatu Point. The charted course past Takatu Point was 334° true, relating to 315° magnetic (see Figure 1). Shortly before reaching Takatu Point, the deckhand saw a green light on the starboard bow and a corresponding echo on the radar. He estimated that it was about 20 degrees on the bow but could not remember at what distance. When Takatu Point was abeam, he recorded the time of 0435 in the logbook and briefly went below to call his relief.

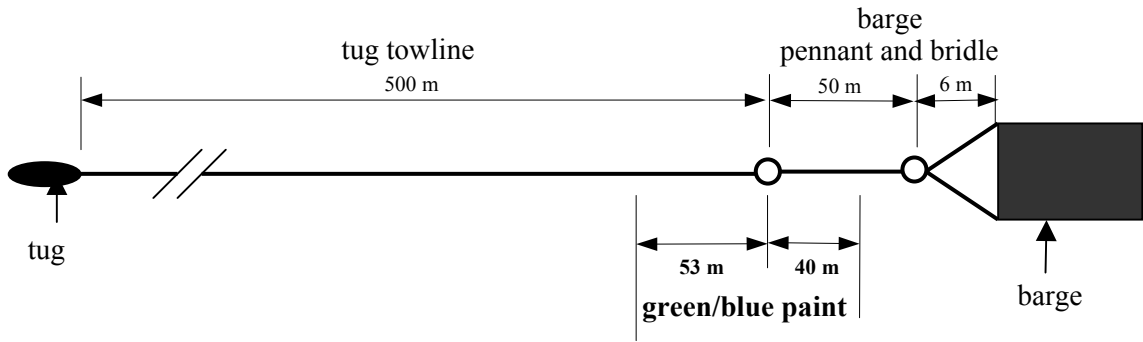
Figure 2
diagram showing extent of paint marking on tow (not to scale)

- 1.5.1 The barge *Sea-Tow II* suffered only minimal damage during the collision. There were witness marks on the bow of the barge showing where the *Toolka-T* had hit and been dragged under the barge. The wire bridle contained traces of metal indicating where the rigging of the yacht had struck. The towing pennant was marked with blue/green paint for about 40 m of its length (see Figure 2).
- 1.5.2 The tug *Wainui* suffered no damage during the collision. The towline, which was wound onto a towing winch, was marked with green/blue paint (see Figure 3). The paint on the towline and the barge pennant was said to match the antifouling paint of the *Toolka-T*.
- 1.5.3 The towline was attached to the bridle of another of the company's barges and stretched out. The towline was marked with the paint over a length of 53 m from where it attached to the towing pennant of the barge.

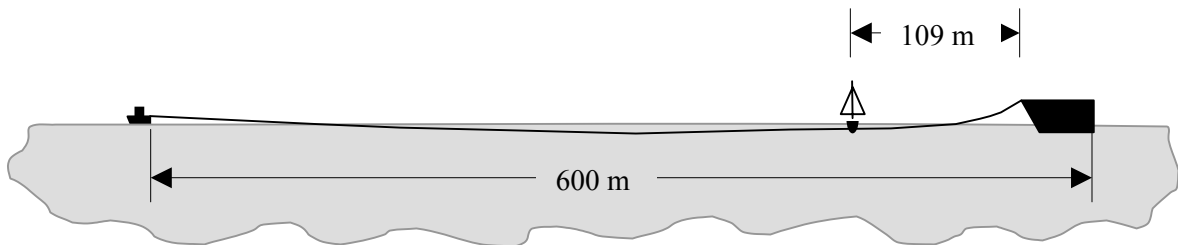
Figure 4
approximate position where the *Toolka-T* fouled the towline

1.5.4 The antifouling paint left on the towline indicated that the *Toolka-T* fouled the line about 109 m ahead of the barge, and that the line came free of the hull only about 16 m ahead of the barge (see Figure 4).

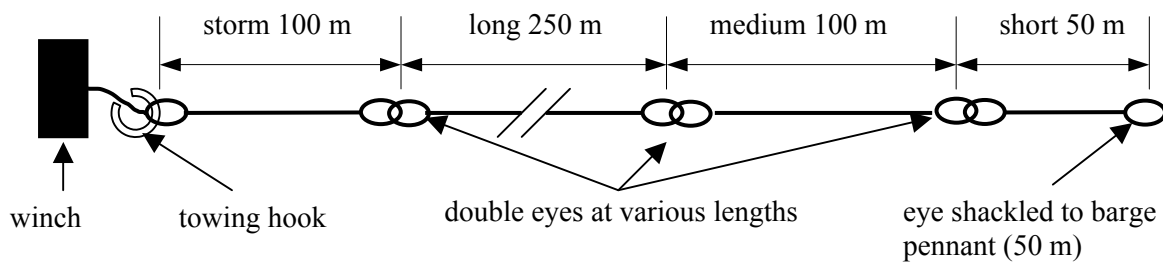
Figure 5
diagram showing make-up of towline on the *Wainui* (not to scale)

1.7.4 The towline on the *Wainui* was 500 m long and made up of various length sections to be used in certain conditions. Each length had soft eyes spliced at the end and through the spliced eye of the next length. The tug's towline was shackled to the towing pennant permanently rigged on the barge, and the other end put on the towing hook at whatever length was required. The towline was made of 56 mm multiplait rope (see Figure 5).

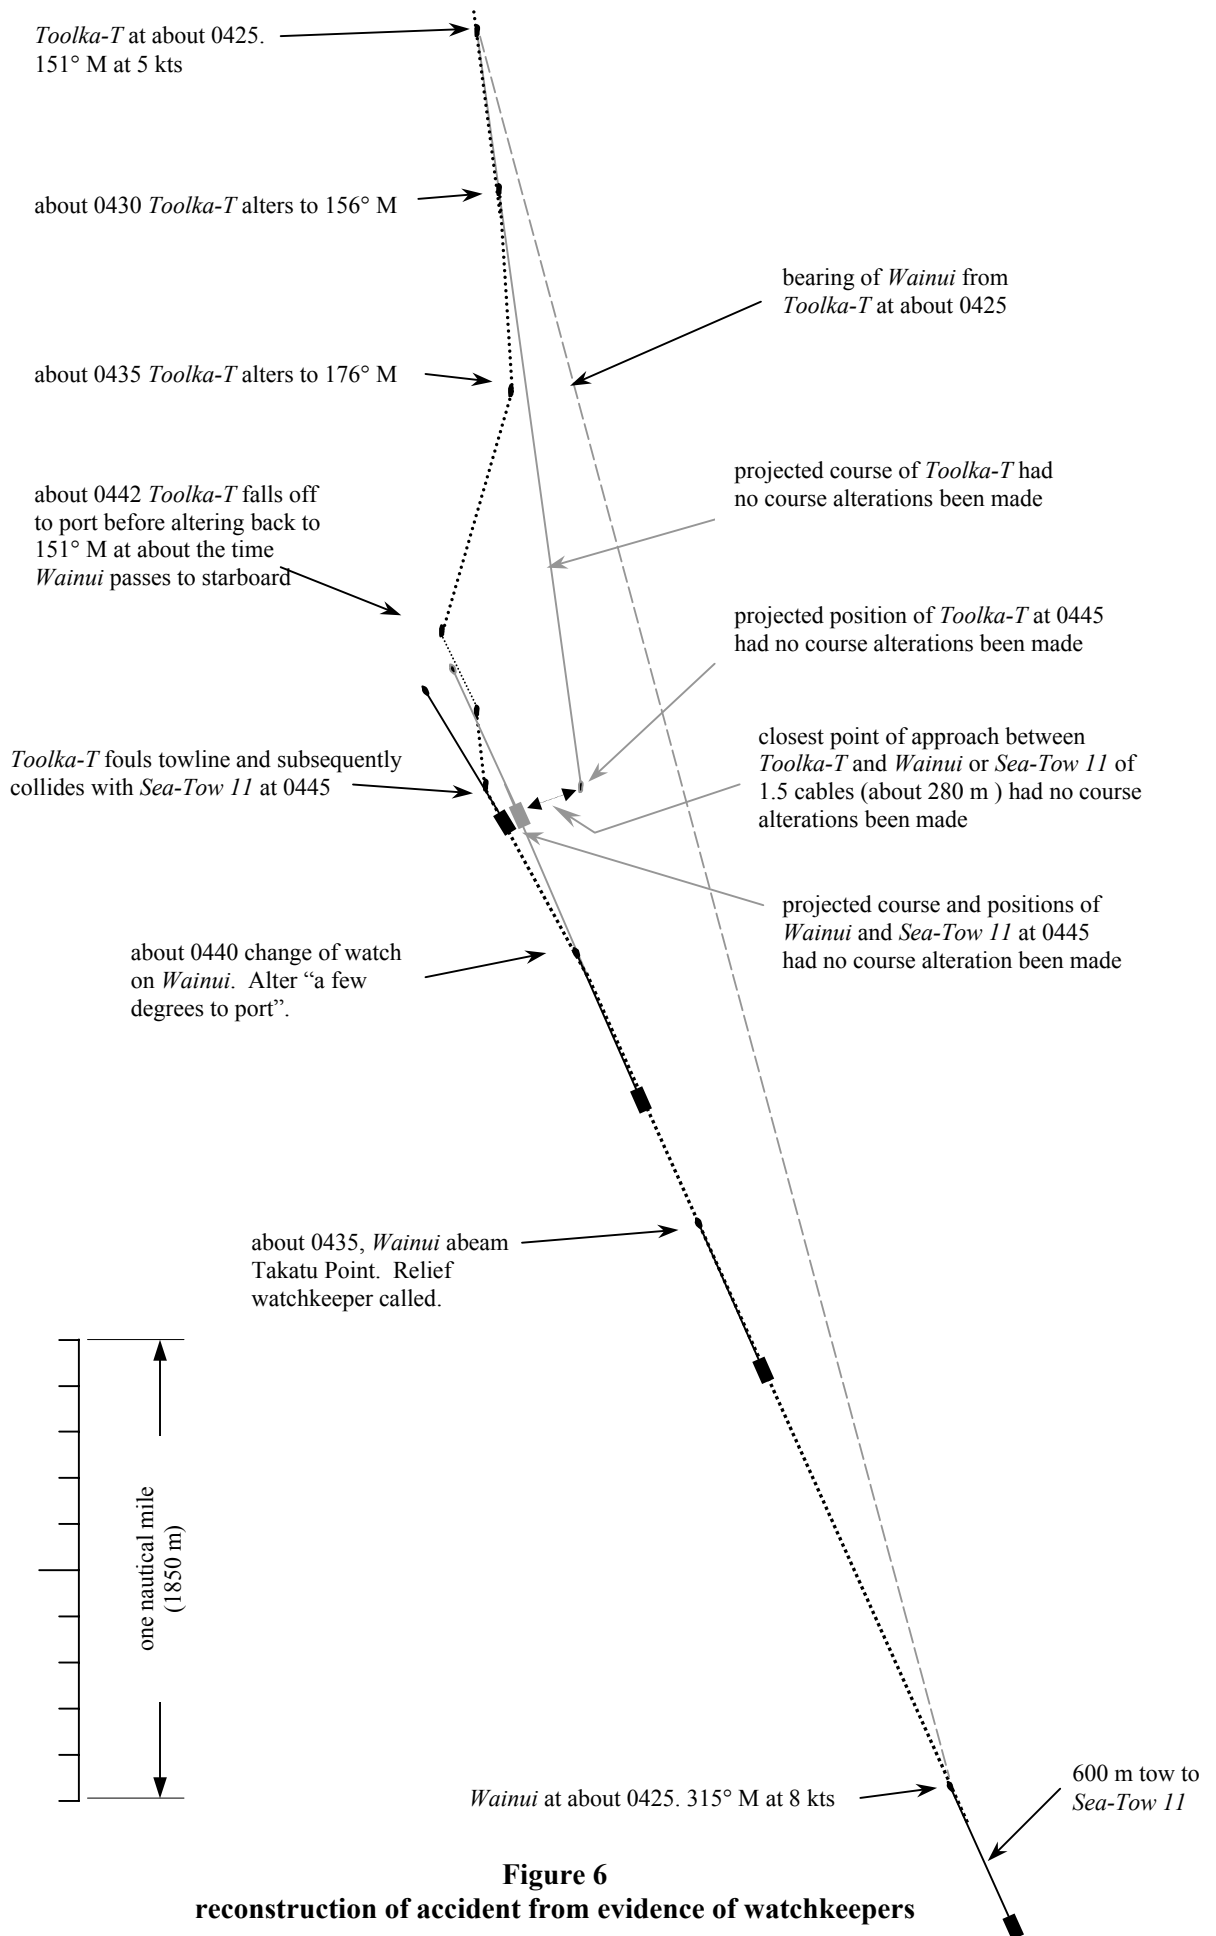
Figure 6
reconstruction of accident from evidence of watchkeepers

- 2.25 A reconstruction of the accident worked back from the accident position and using the evidence from both vessels indicated that had the watchkeeper not made any alteration of course, the *Toolka-T* would have passed the starboard side of both the *Wainui* and the *Sea-Tow 11* (see Figure 6).
