AVIATION OCCURRENCE REPORT

02-001 Cessna 207, ZK-SEV, collision with terrain, Gertrude Saddle area
11 km southeast of Milford Sound

19 January 2002

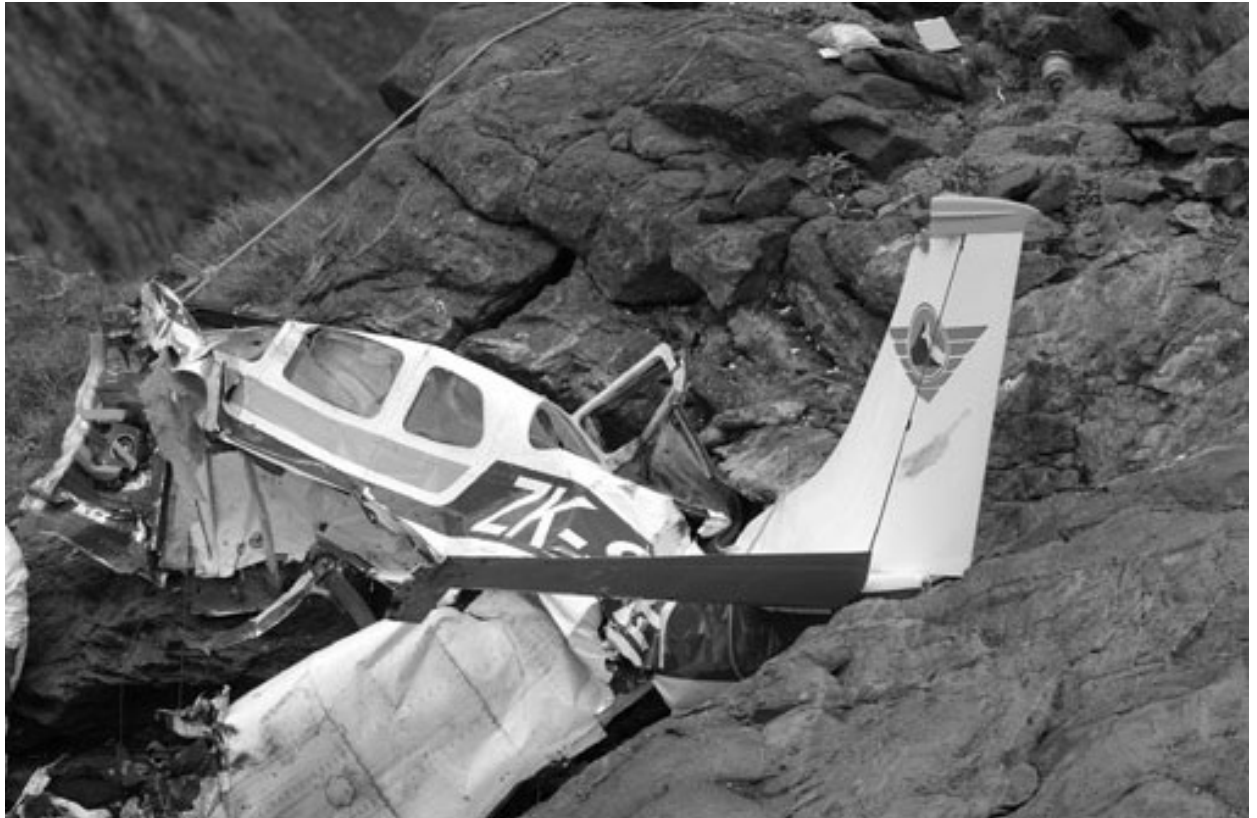
ZK-SEV wreckage at the accident site
