## AVIATION OCCURRENCE REPORT

02-002

Piper PA34-200T Seneca ZK-SFC, undercarriage failure and subsequent wheels-up landing, Gisborne and Hastings Aerodromes

25 January 2002

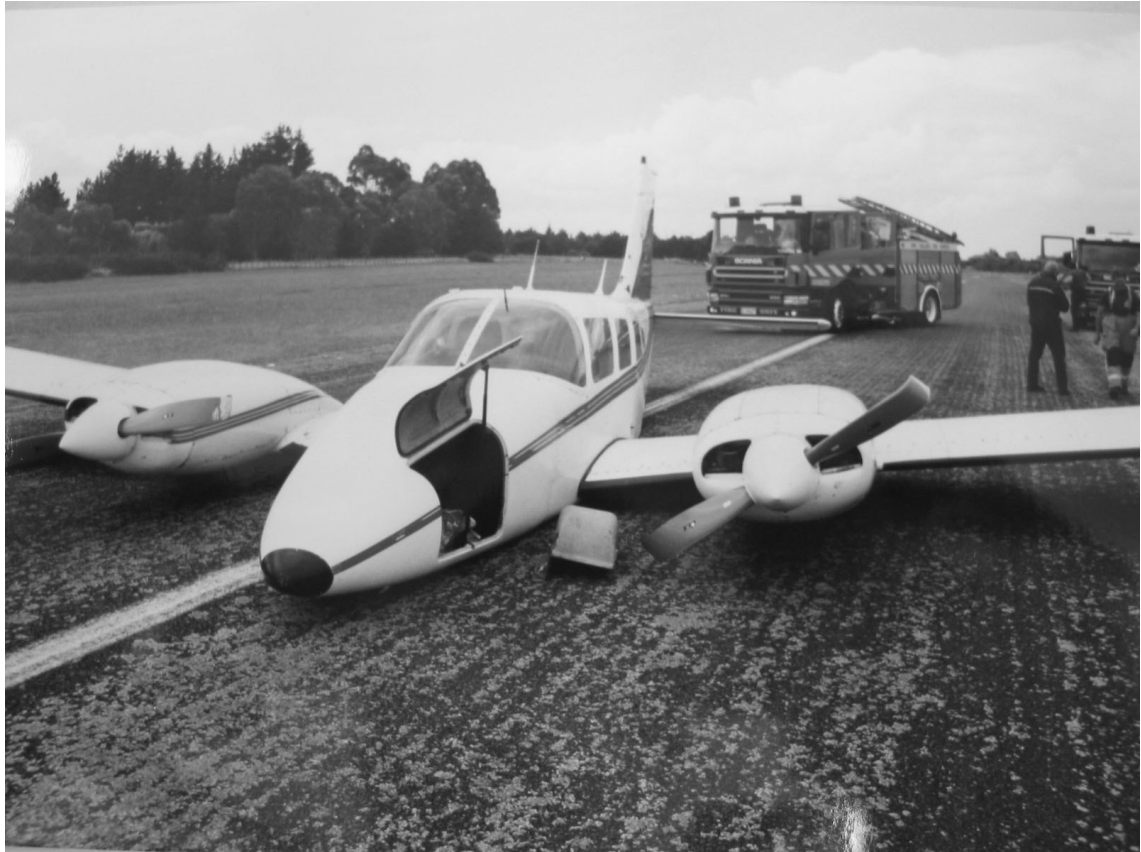
**Piper PA34-200T Seneca ZK-SFC  
after landing at Hastings**

- 1.2.1 The aircraft slid along the runway on its belly, causing lower panel and antenna damage. The propellers on both engines struck the runway and were damaged beyond repair. Inspections on both engines were required before they could be returned to service.

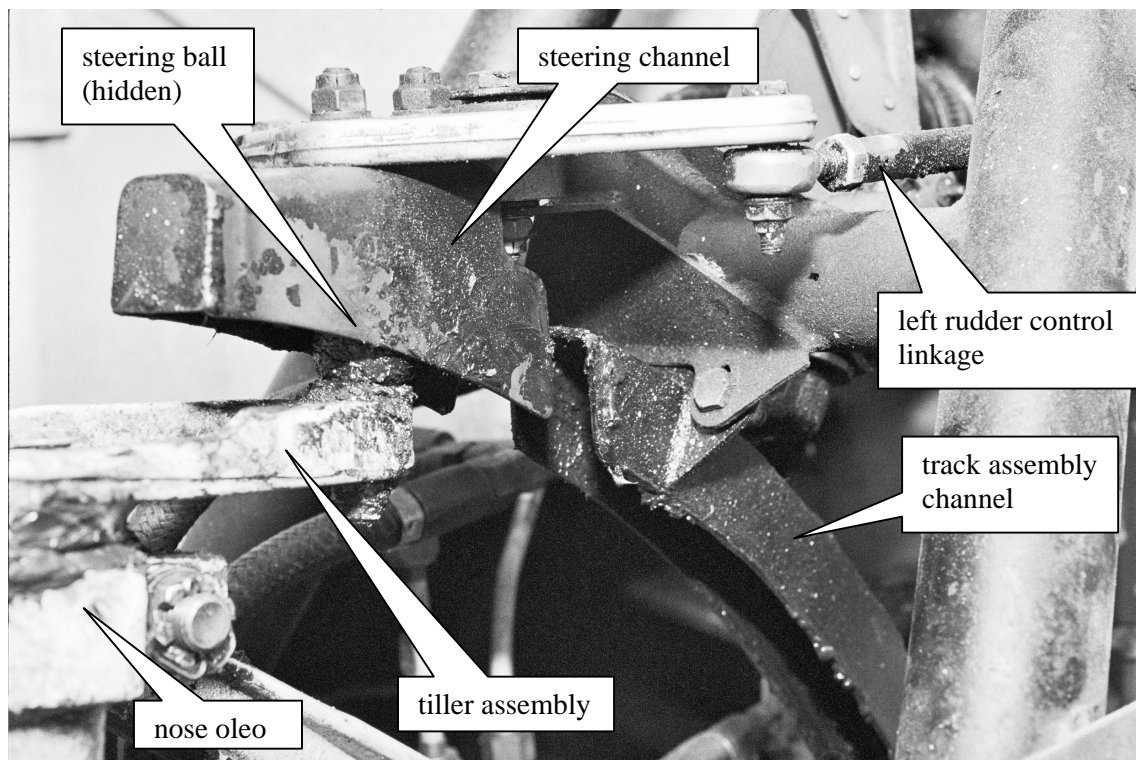
**Figure 1**  
**Nose undercarriage on ZK-SFC**  
**(looking rearwards with the undercarriage down)**

- 1.4.5 The nose undercarriage was steerable and hinged to retract forward into the nose well. Moving the rudder pedals not only moved the rudder at the tail, but also moved a “steering channel”, which was connected to the nose wheel via a tiller and steering ball arrangement as shown in Figure 1. The steering tiller was rigidly connected to the nose oleo strut. When the nose wheel was retracted the steering ball slid out of the steering channel and down a track assembly channel, leaving the rudder pedals free to move independently of the retracted nose undercarriage.

- 1.4.6 In the absence of any rudder pedal input, a gear-centring spring helped align the nose wheel fore and aft, to ensure the steering ball fed cleanly into the track assembly channel when the undercarriage was retracting. The track assembly channel guided the steering ball and the nose oleo strut into the nose undercarriage well.
- 1.4.7 If the pilot was applying rudder inputs at the time the undercarriage was retracting, the steering channel would not be aligned fore and aft with the track assembly channel, but there was enough tolerance built into the arrangement to allow for such occasions.

- 1.5.2 Inspection of ZK-SFC confirmed that the ball on the nose undercarriage oleo tiller had travelled down the right-hand outside of the channel track for most of its length before jamming. Other than the damage caused by the aircraft sliding along the runway, the nose undercarriage and retraction system appeared normal. There was no other observable damage or disturbance to the nose undercarriage assembly.

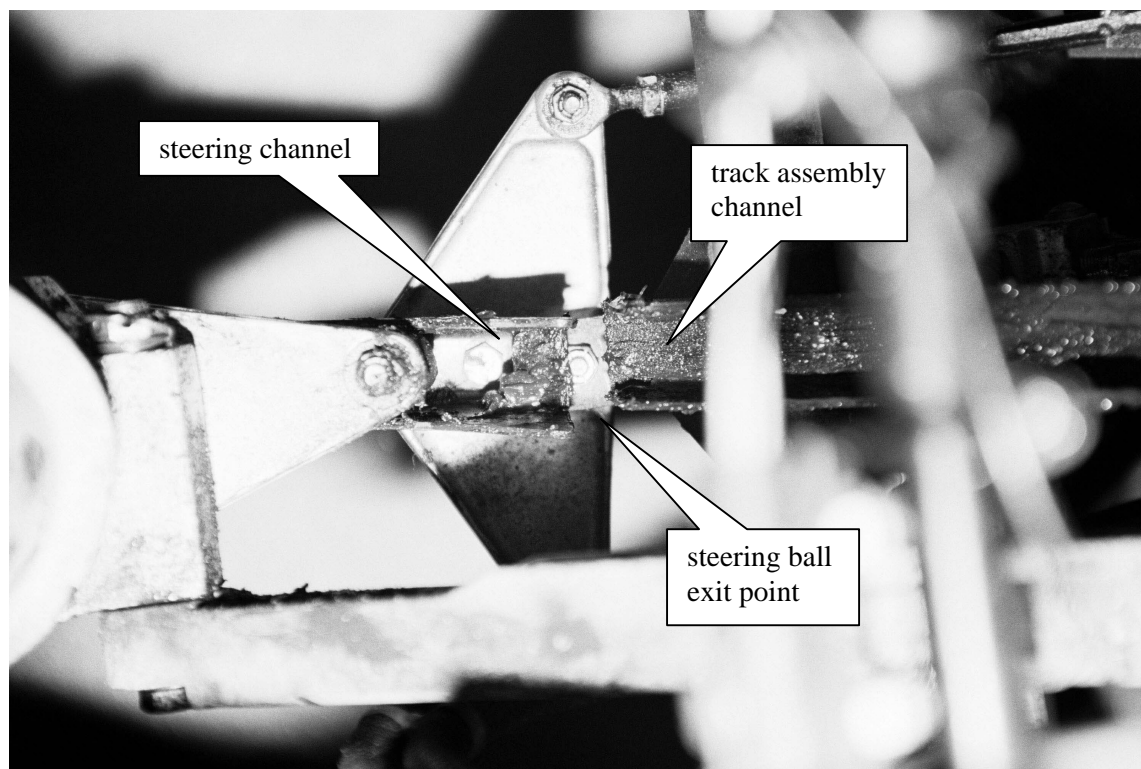
**Figure 2**  
**Alignment of nose undercarriage channels on ZK-SFC**  
**(looking upwards)**

- 1.6.1 The aircraft was suspended on jacks and the nose leg rotated left and right by use of rudder application. The nose leg was able to rotate freely throughout its designed range of travel. With the rudder pedals central and the nose wheel facing directly fore and aft, the steering channel was noted to be misaligned from the track assembly channel, with some flaring out of the steering channel on the right side (see Figure 2). In addition to some general deterioration, the steering ball was damaged during the landing and, therefore, an accurate assessment of ball diameter was not possible. However, the ball was estimated to be between 20 and 21.4 mm in diameter. The replacement steering ball was measured to be 22.1 mm in diameter.

- 1.6.2 With the nose wheel straight, the gap between the 2 channels was 11.5 mm on both sides. With the nose wheel deflected fully to the left, the gap on the left side increased to 16 mm. Full right deflection opened the gap on that side to 15.7 mm. The manufacturer advised that there was no information concerning the limits for the gap between the fixed and upper steering channels and the ball.

- 2.5 The misalignment of the 2 channels meant that, as the nose wheel retracted, the steering ball would have been displaced to the right side, which was the side the ball exited the steering channel. The ball may then have jammed against the gap and been eventually forced through by hydraulic pressure. Subsequent tests were unable to repeat the failure, however, they were carried out manually without hydraulic assistance.

- 2.6 The reason why the channels were misaligned was not determined. The misalignment may have been progressive, or the result of a single incident. Performing tight turns while taxiing, especially over rough ground, would place additional sideways pressure on the steering channel. Likewise, exceeding the turning limits while towing the aircraft could damage the nose undercarriage assembly. The Commission was not made aware of any past incident that could have caused such a misalignment.

- 2.7 The nose undercarriage assembly was required to be inspected every 100 flying hours. The inspection would normally have been performed by first removing the cover inside the nose locker to gain access. This would have provided a side profile view of the upper assembly similar to the view in Figure 1. Alignment of the 2 channels would, therefore, have been difficult to identify. A vertical view of the channels, as in Figure 2, would have required the removal of the aircraft's lower panel, which only occurred when specifically required. The misalignment could, therefore, have been present for some considerable time.

- 4.1.1 Remind operators and maintainers of Piper PA34-200T Seneca aircraft of the requirement to adhere to aircraft towing limitations, and to regularly and thoroughly inspect the nose undercarriage assembly for correct alignment. (029/02)
