# AVIATION OCCURRENCE REPORT

**02-003** Schweizer 269C helicopter, ZK-HIC, loss of tail rotor authority and emergency landing, Karaka Downs South Auckland

15 March 2002

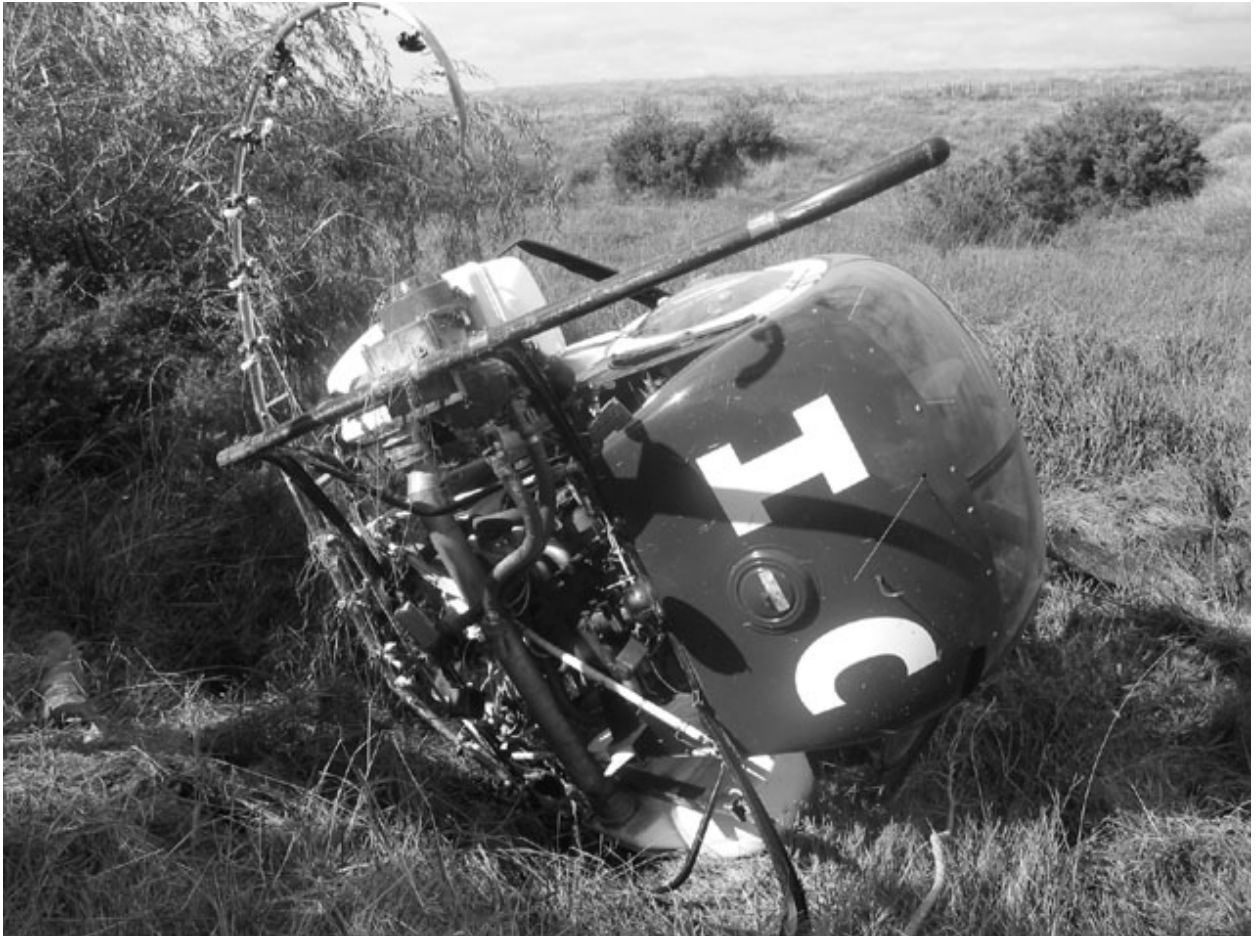
**ZK-HIC after the accident**

- 1.4.1 The helicopter came to rest on its left side. The main rotor blades were destroyed because of ground contact, and exhibited signs of low power rotation. The free-wheeling clutch operated normally. The engine to transmission drive belts were intact, and the drive between the engine and transmission was engaged.

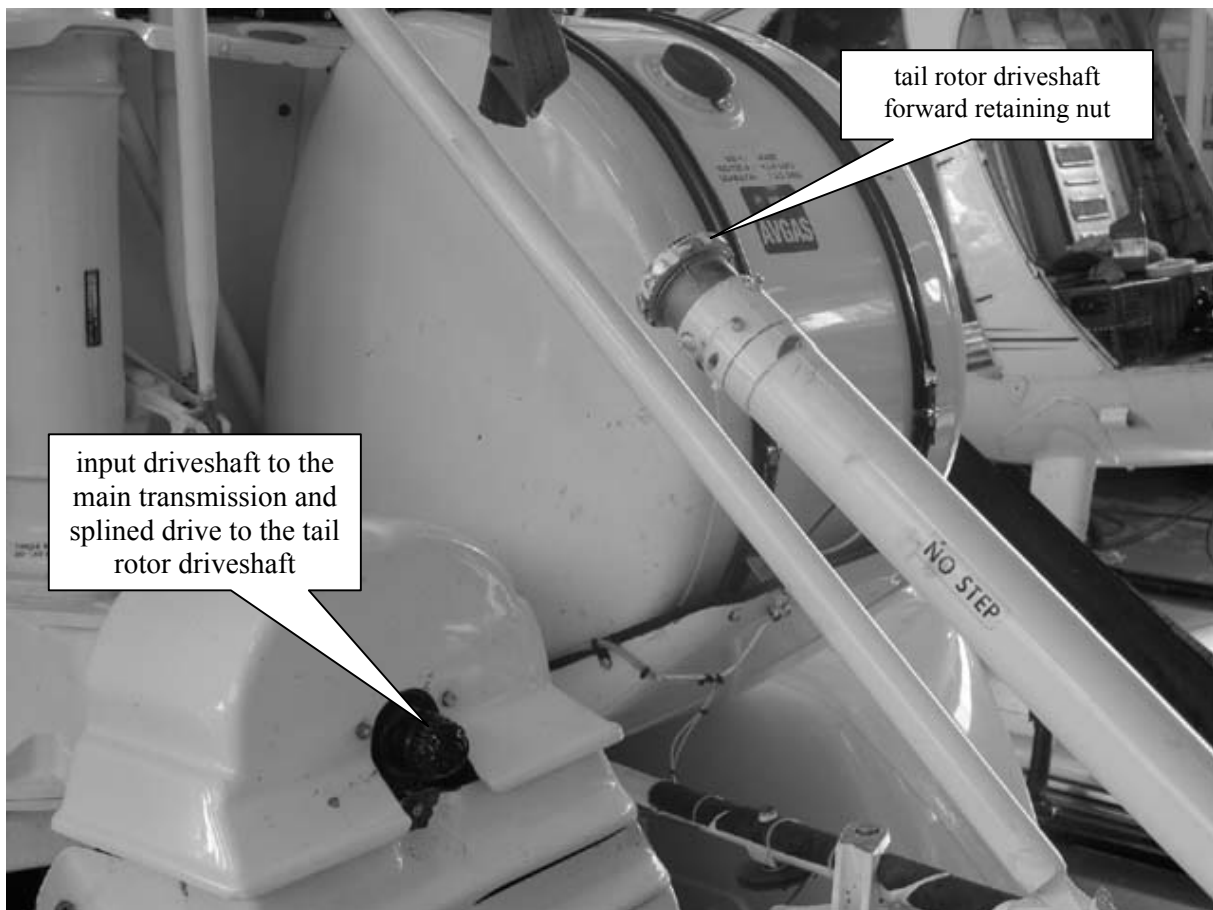
**Figure 1**  
**Forward portion of tail rotor driveshaft and spline drive**

- 1.3.13 The next day, on 27 November 2001, after about 0.5 hours of flying the pilot reported hearing a noise from the tail rotor driveshaft area. He reported that the forward retaining nut was again loose and in contact with the bearing housing on the input driveshaft to the main transmission, and that the nut lock wire had again broken.

- 1.3.14 The forward retaining nut should not be able contact the bearing housing on the input driveshaft to the main transmission, if the correct tail rotor drive train components are properly installed. There should be a minimum clearance of 0.100 inches (2.54 mm) between the nut and bearing housing. This clearance should be checked during any installation of the tail rotor driveshaft.

- 1.3.15 The engineer who had replaced the O-ring travelled to the helicopter and examined the tail rotor drive and anti-torque system, where he found the tail rotor gearbox spline-retaining nut completely loose. He removed the tail rotor driveshaft and gearbox and returned the gearbox to the maintenance hangar for repair. At the hangar he replaced the spline-retaining nut, put loctite<sup>2</sup> on the threads as an additional locking means, and torqued the nut to the correct value. The replaced spline-retaining nut was discarded. The tail rotor driveshaft was not returned to the hangar for inspection, but was inspected at the site.

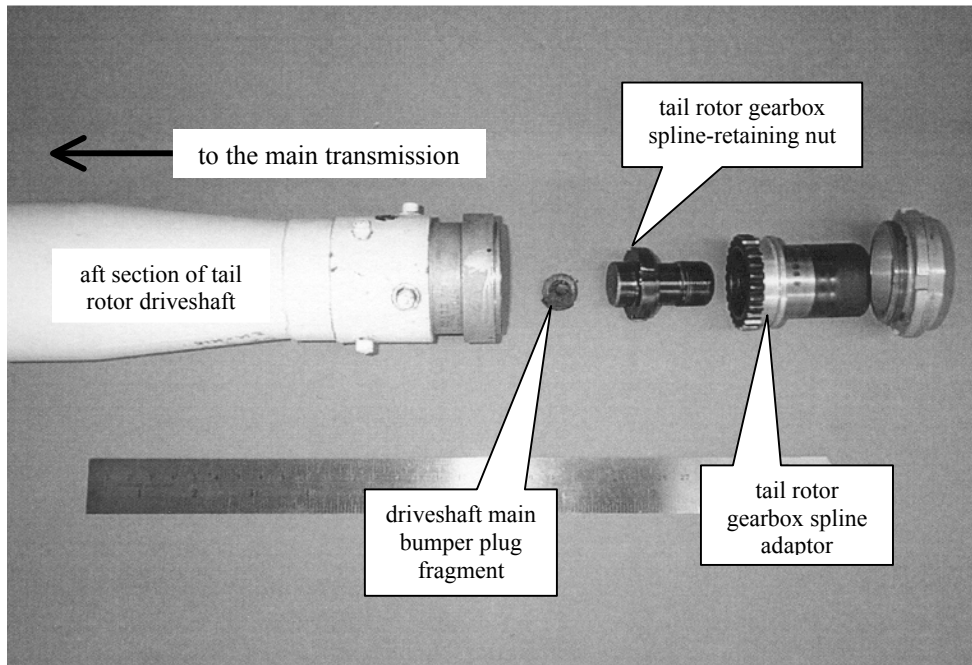
**Figure 2**  
**Components from the aft end of the tail rotor driveshaft and gearbox**

- 1.4.3 The helicopter was removed to a maintenance facility for further examination. When pushed aft the tail rotor driveshaft disengaged the spline drive to the tail rotor gearbox and did not rotate the tail rotor. The gearbox was removed for further examination and was found serviceable. The spline-retaining nut was tight but had some rotational scoring on its forward face.

Inspection of the tail rotor driveshaft aft bumper plug showed a neat round hole in the bumper plug, which matched the diameter of the forward face of the spline-retaining nut. This hole allowed the forward portion of the spline-retaining nut to pass through the aft bumper plug, which allowed the tail rotor driveshaft to move aft excessively and disengage the spline drive coupling to the tail rotor gearbox. Fragments of the bumper plug were located in the grease cavity, including a circular central main fragment. There was grease in the grease cavity, but no grease had transferred through the hole in the bumper plug. (See Figures 2 and 3)

- 1.5.2 The main aft bumper plug fragment was heavily cracked and had been subject to high temperatures from frictional heating. A significant feature was that the fragment was convex on the forward side when it should have been concave, thus showing the fragment had been pushed inwards at some point resulting in a large dent. The edges of the fragment were very thin, showing significant material wear. Around the central region was a shiny wear pattern with a large crack around the circumference. Although initial examination suggested the fragment could be ferritic dual phase stainless steel, a full material analysis showed it was aluminium alloy, which was the correct material.

- 1.5.3 The tail rotor gearbox spline-retaining nut showed significant circular wear markings on its end face. The wear patterns on the spline-retaining nut end face matched the wear on the bumper plug fragment. The wear patterns were off-centre showing there was some misalignment between the bumper plug and spline-retaining nut as they rotated relative to each other. The diameter of the forward segment of the spline-retaining nut neatly matched the diameter of the circular hole cut in the bumper plug, which allowed the nut to pass through the plug.

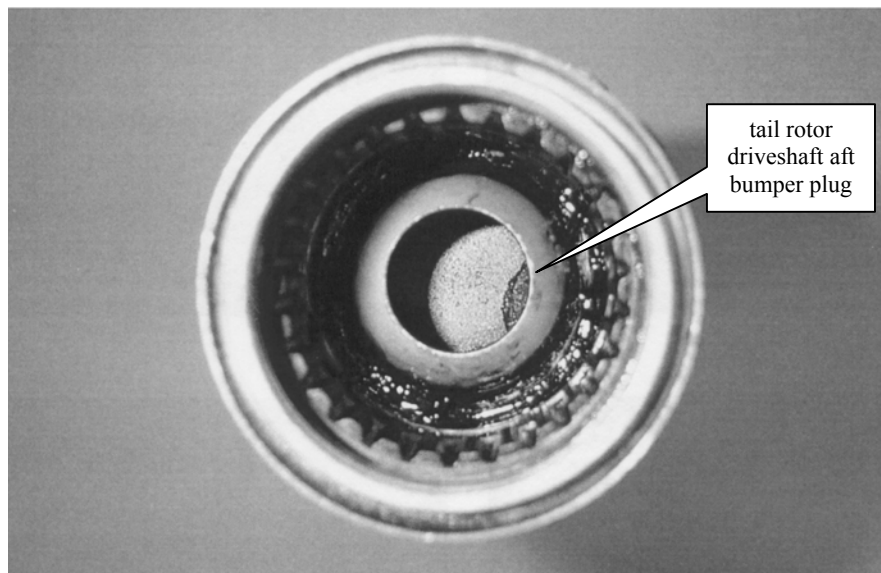
**Figure 3**  
**End view of tail rotor driveshaft showing the hole in the bumper plug**

- 2.9 After the aft bumper plug was deformed or possibly worn, it could no longer correctly limit the aft movement of the tail rotor driveshaft against a properly installed spline-retaining nut. With sufficient aft movement, the tail rotor driveshaft rear splined coupling was then able to disengage from the tail rotor gearbox.
