AVIATION OCCURRENCE REPORT

02-004

Cessna 210N Centurion ZK-TWA, collision with terrain, Conical Peak area 34 km southwest of Oamaru,

10 April 2002

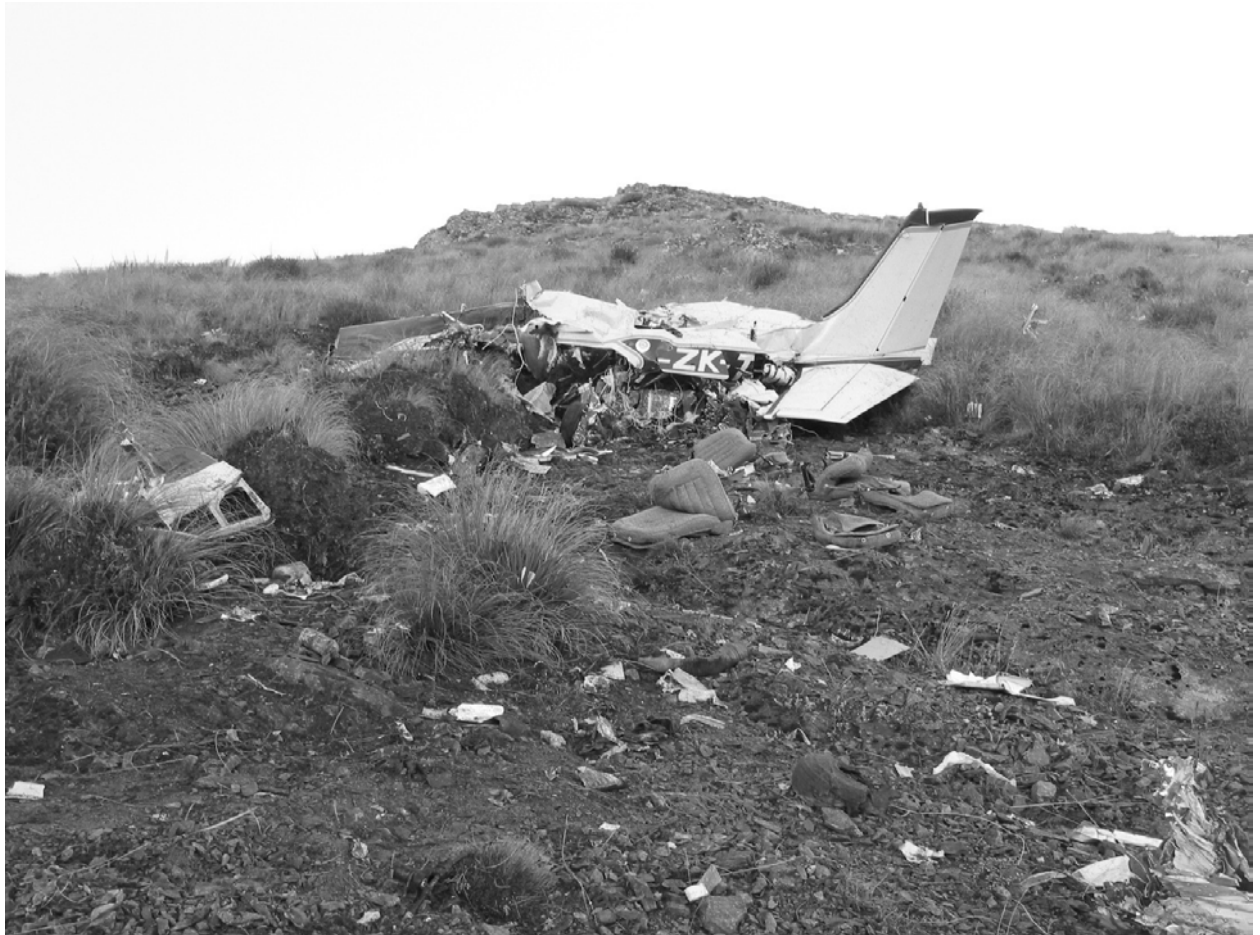
**Cessna 210N Centurion ZK-TWA after the accident
(looking in direction of travel)**

- 1.9.2 ZK-TWA had struck the hillside some 100 feet below the ridgeline, on a heading between about 350° and 360° magnetic, upright and in about a wings-level attitude. The hillside sloped at an angle of between 30° and 35°. Ground marks and damage to the leading edges of both wings were consistent with the aircraft striking the ground in a slight to moderate nose-low attitude. Fragmentation of the aircraft indicated that it had struck the hillside at high speed: cruise speed or higher.

- 1.9.3 After striking the hillside the aircraft had slid up the slope for some 25 m, rotating to the left through about 90°, before coming to rest. The aircraft broke apart as it did so.

- 2.9 Impact damage, ground marks and distribution of wreckage indicated that the aircraft struck the side of the hill in a wings-level and upright attitude, at cruise speed or higher. The engine control settings are consistent with this analysis, however, the controls could have moved as the aircraft struck the hillside and broke apart, and so their positions could not be relied on as evidence of pre-impact settings. The location of the wreckage and available radar information confirm that the aircraft had not altered heading after departing north from Swampy VOR/DME. Aircraft damage, ground marks and the stuck VSI indicator needle would indicate that the aircraft was in a slight to moderate descent when it struck the slope.
