AVIATION OCCURRENCE REPORT

02-005 Hughes 369D helicopter ZK-HRV, engine failure and forced landing,
near Tarawera

30 April 2002

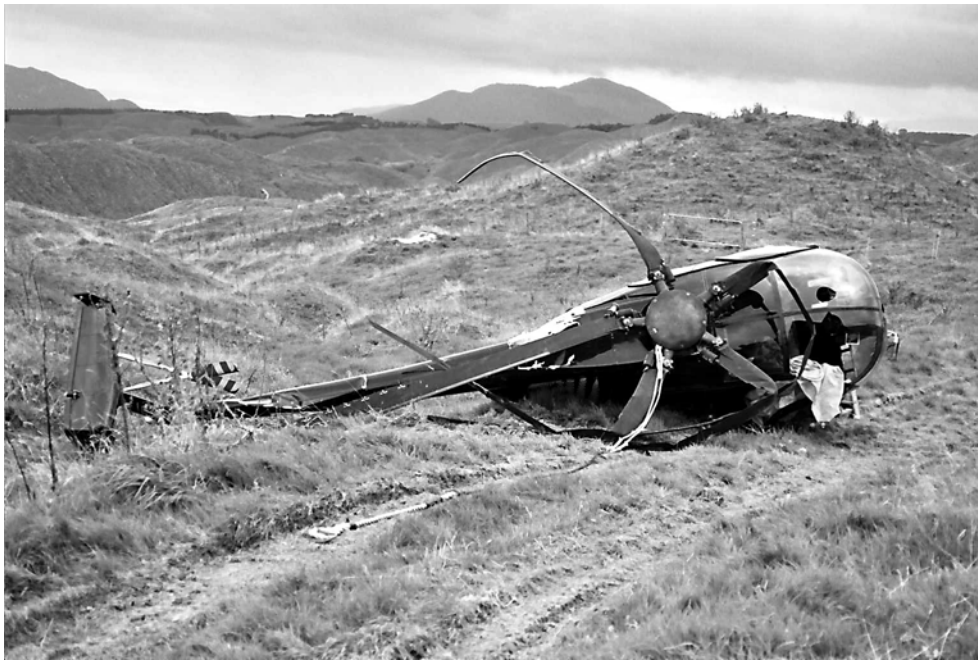
- 1.4.1 The accident site was on undulating and uneven pasture land, on a farm vehicle track, and at an elevation of about 1900 feet. The helicopter was lying on its right side, on a westerly heading, across the farm track. A group of ground marks some 8 metres away indicated that the initial touchdown had been along the track to the north, and on both main skids and the tail stinger. The position of the marks was consistent with a landing at low forward and vertical speed, but with the helicopter yawed to the left, and with the tail touching first (see figure 1).

- 1.4.2 The helicopter had rolled onto its right side, yawing left some 90° as it came to rest. The main cabin structure was intact, with some broken acrylic windows. Both skids had separated, and lay alongside. The tail boom was in place, but had received a significant main rotor strike, probably after the tail contact with the ground on landing. The main rotor blades showed damage typical of ground contact while rotating without power.

Figure 1
ZK-HRV accident site

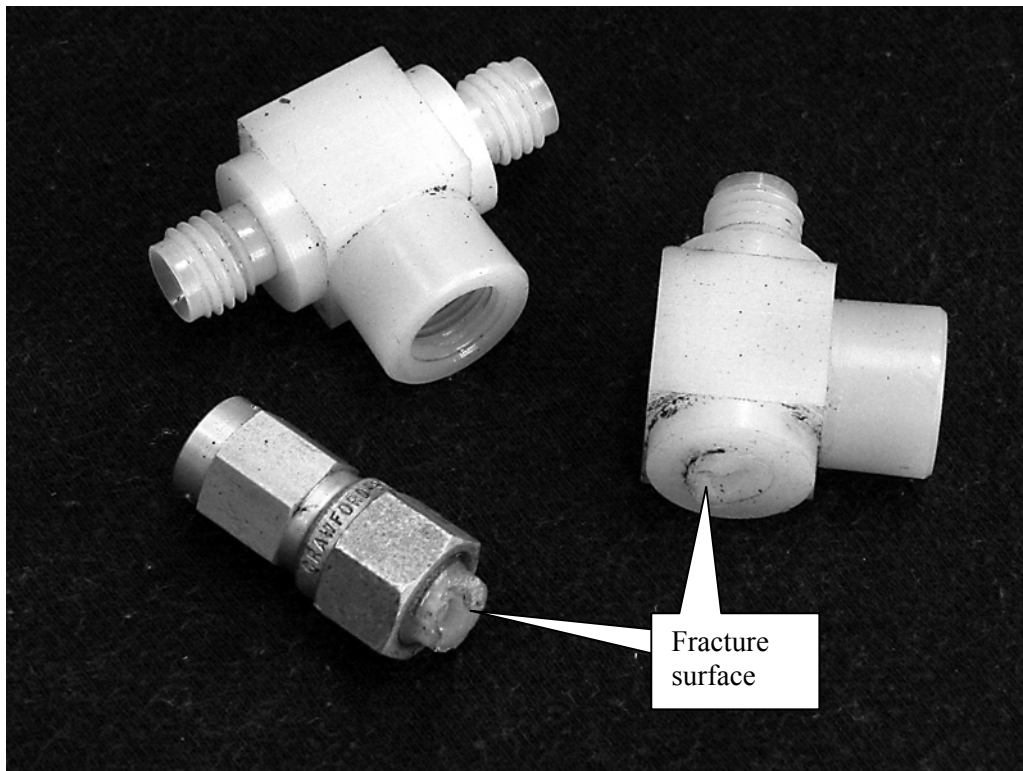
- 1.4.6 Examination of the rear of the instrument panel showed that a nylon TEE fitting on the rear of the engine torque gauge had fractured, and that engine oil had escaped from it down the rear of the instruments and beneath the cabin floor. The TEE fitting, which incorporated a bleed valve, connected the torque gauge to the flexible plastic oil line which transmitted oil pressure from the engine reduction gearbox (see figure 2).

Figure 2
Nylon TEE fittings from the torque and oil pressure gauges of ZK-HRV

- 1.5.2 The broken nylon TEE fitting from ZK-HRV was examined by a specialist materials consultant. He reported that the fracture appeared to have occurred rapidly, and in a downward direction. He commented that the fitting had been manufactured with sharp corners at changes of section, rather than with radiused corners, and that failures could occur more easily where stresses concentrate at such sharp junctions. The fracture had originated at a sharp corner at the base of a thread. He was unable to test the material for age-induced degradation, but was of the opinion that such degradation was likely.

- 2.4 The cause of the fracture of the TEE fitting was not determined. The specialist's report indicated that the manufactured sharp corners of the fitting made it more susceptible to fracture, and that some age-related material degradation was likely. The fitting had probably been on the helicopter since new, for some 20 years. The fitting did not carry any significant external loads, however, and should have been only lightly stressed. The maximum internal force resulting from the oil pressure was calculated to be approximately 4.4 newton (1 pound). The back of the instrument panel was closed off, protecting components from accidental damage in service. The most likely circumstances to cause any loads on the fitting were when maintenance work was carried out on the instruments. While no recent maintenance activity involving the instruments had been recorded, there was a possibility of some irregular work being carried out behind the instrument panel, by other than qualified maintenance personnel, which may have inadvertently damaged the TEE fitting. No confirmation of this possibility was found, however.

5.1.1 Publish advisory information about the torque gauge oil line system on the Hughes 369 helicopter type, so that operators and pilots may better understand the significance of the system, and what the appropriate pilot response should be to an abnormal torque gauge indication in flight. (050/02)
