# AVIATION OCCURRENCE REPORT

**02-006** Partenavia P68B ZK-ZSP, engine power loss and off-field landing, 5 km southwest of Wairoa

15 May 2002

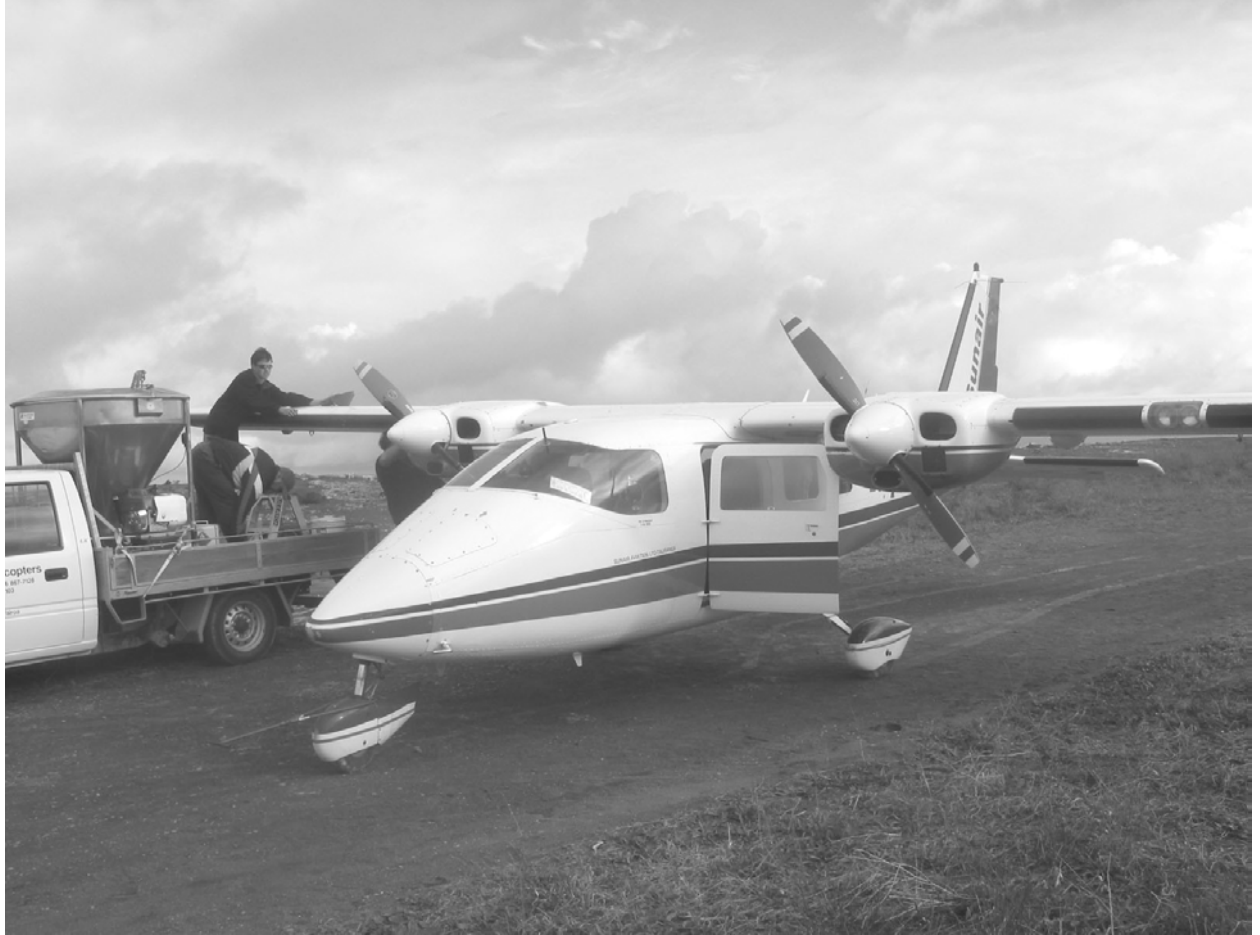
**ZK-ZSP after the precautionary landing**

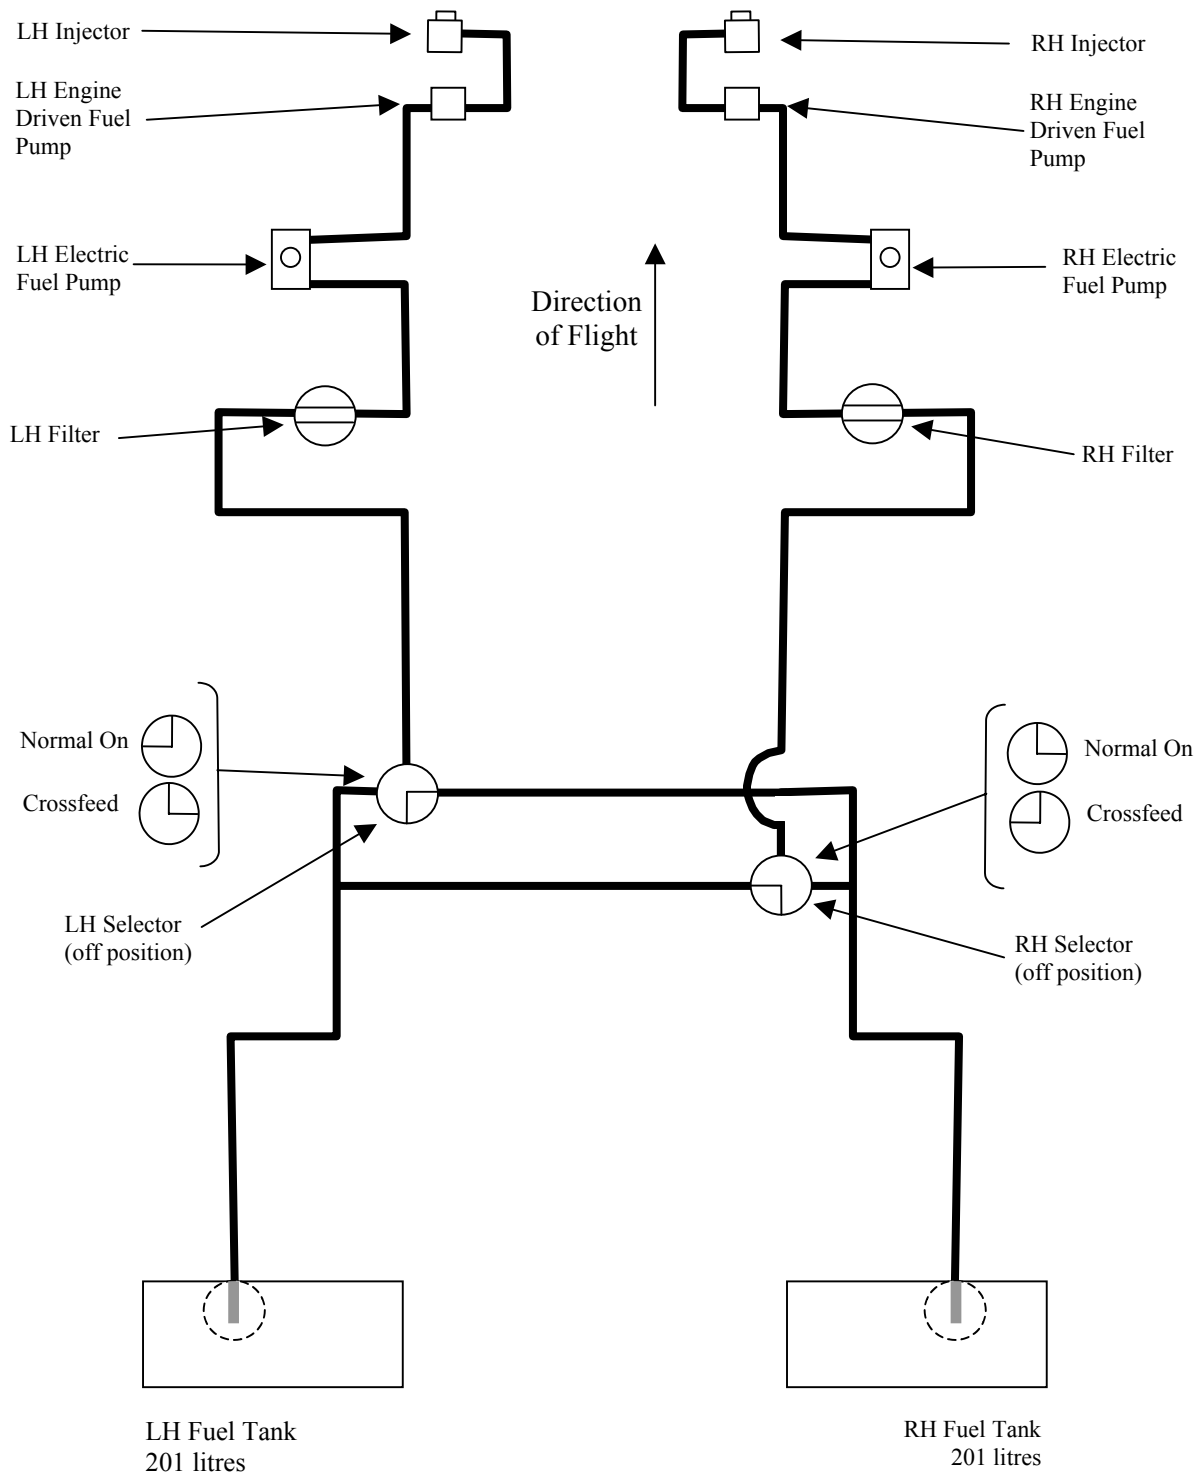
**Figure 1**  
**Normal Fuel System Schematic**

- 3.7 The transfer of fuel from the right fuel tank to the left tank was caused by a loss of synchronisation between the left fuel selector valve and the left engine fuel selector knob placard.

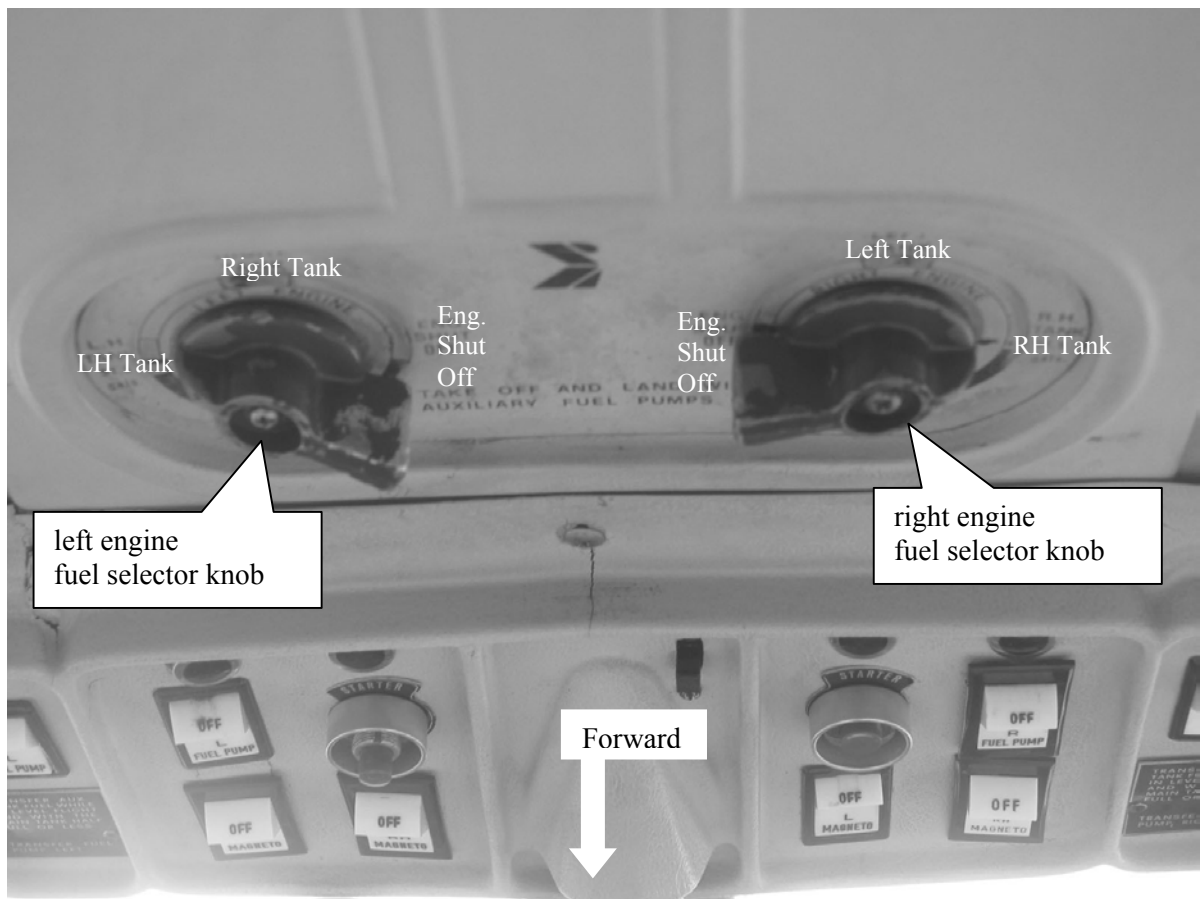
**Figure 2**  
**Cockpit Overhead Fuel Selector Knobs (markings enhanced for clarity)**

- 1.9.4 The right engine fuel selector knob was found pointing to the right tank position. The left engine fuel selector knob was pointing toward the left tank position, but displaced towards the right tank position.

- 2.4 Although the fuel valves had detents signalling each selection, the fuel selector knobs did not have corresponding detents. Pilots could not normally feel the valve detents when rotating the fuel selector knobs, but relied on visually checking the selection on the fuel placard. This was a coarse visual selection, but one that relied on ideal system rigging. Over time, normal control cable wear and stretch would allow some mis-rigging to occur.

- 4.1.1 immediately advise all New Zealand Partenavia P68 operators about the potential for inadvertent tank-to-tank fuel transfer, and to ensure ease of movement of the cockpit fuel selector knobs. On receipt of the pending Vulcanair P68 service bulletin, require operators to implement the actions recommended, to obtain the necessary synchronisation between the cockpit fuel selector knobs and wing fuel selector valves. (033/02)
