AVIATION OCCURRENCE REPORT

02-007 Piper PA23-250D Aztec and Piper PA34-200T Seneca II, ZK-DIR
and ZK-MSL, near miss, about 25nm southwest of Napier

10 June 2002

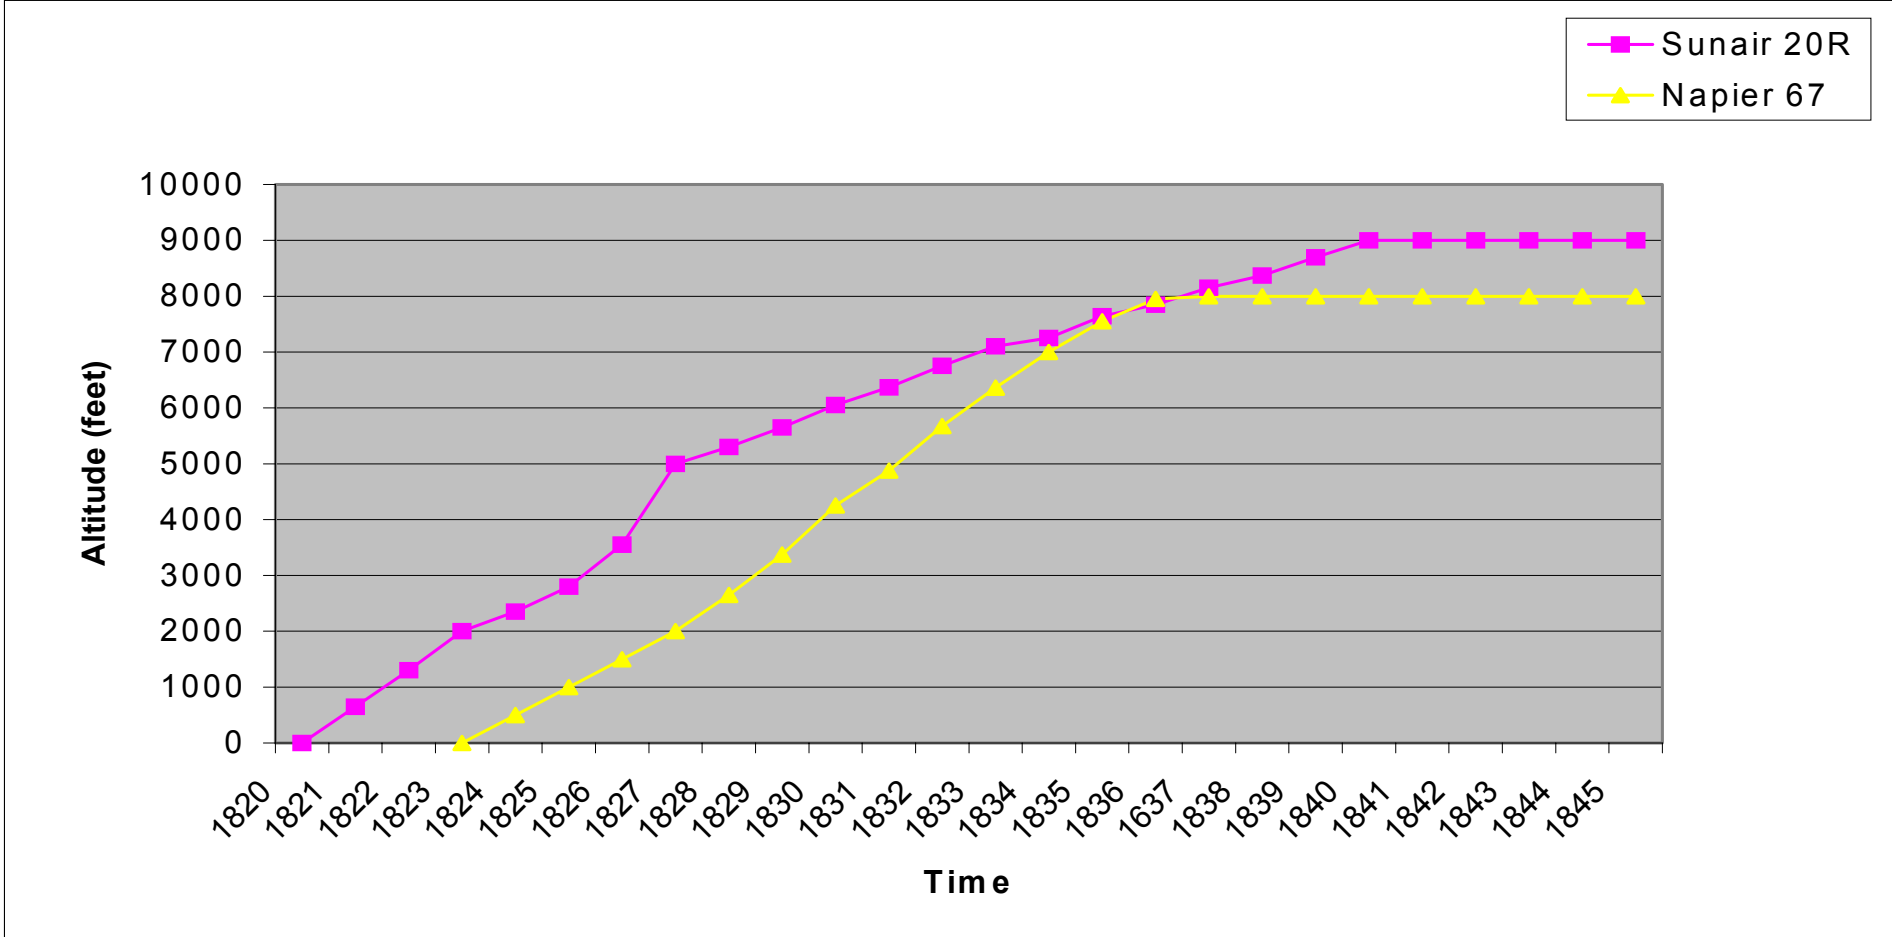
**Approximation of Aircraft Climb Profiles
(based on radar and pilot reports)**

- 2.9 Analysis of the ATC tapes and radar data clearly indicated that after Sunair 20R passed 5000 feet and Napier 67 was cleared unrestricted to 4000 feet, neither pilot adhered to their clearance requirements for the remainder of their climbs (refer to figure at page 5). The rate of climb for Sunair 20R slowed to an average of about 330 fpm, while Napier 67’s average rate of climb increased to about 680 fpm after passing 4000 feet. As a result the vertical separation steadily reduced until the 1000 foot minimum was infringed at about the time Sunair 20R passed 7500 feet and Napier 67 passed 6500 feet. The 2 aircraft were possibly climbing through 7500 feet to 8000 feet at about the same time.

- 2.11 The higher groundspeed of Napier 67 supports the observation that some excess climb energy was converted into forward speed, and resulted in it steadily gaining on Sunair 20R as both aircraft approached 25 nm.

- 2.12 The lower groundspeed of Sunair 20R in the climb, 85 kts reducing to 75 kts, would indicate that aircraft performance was decreasing significantly as it approached cruise altitude. The 10 kt reduction in groundspeed coincided with the pilot being instructed by Ohakea Control to expedite the climb to 9000 feet.
