## AVIATION OCCURRENCE REPORT

02-008      Piper PA31-310 Navajo ZK-NPR, landing gear failure to extend,  
Napier Aerodrome

24 June 2002

**TRANSPORT ACCIDENT INVESTIGATION COMMISSION  
NEW ZEALAND**

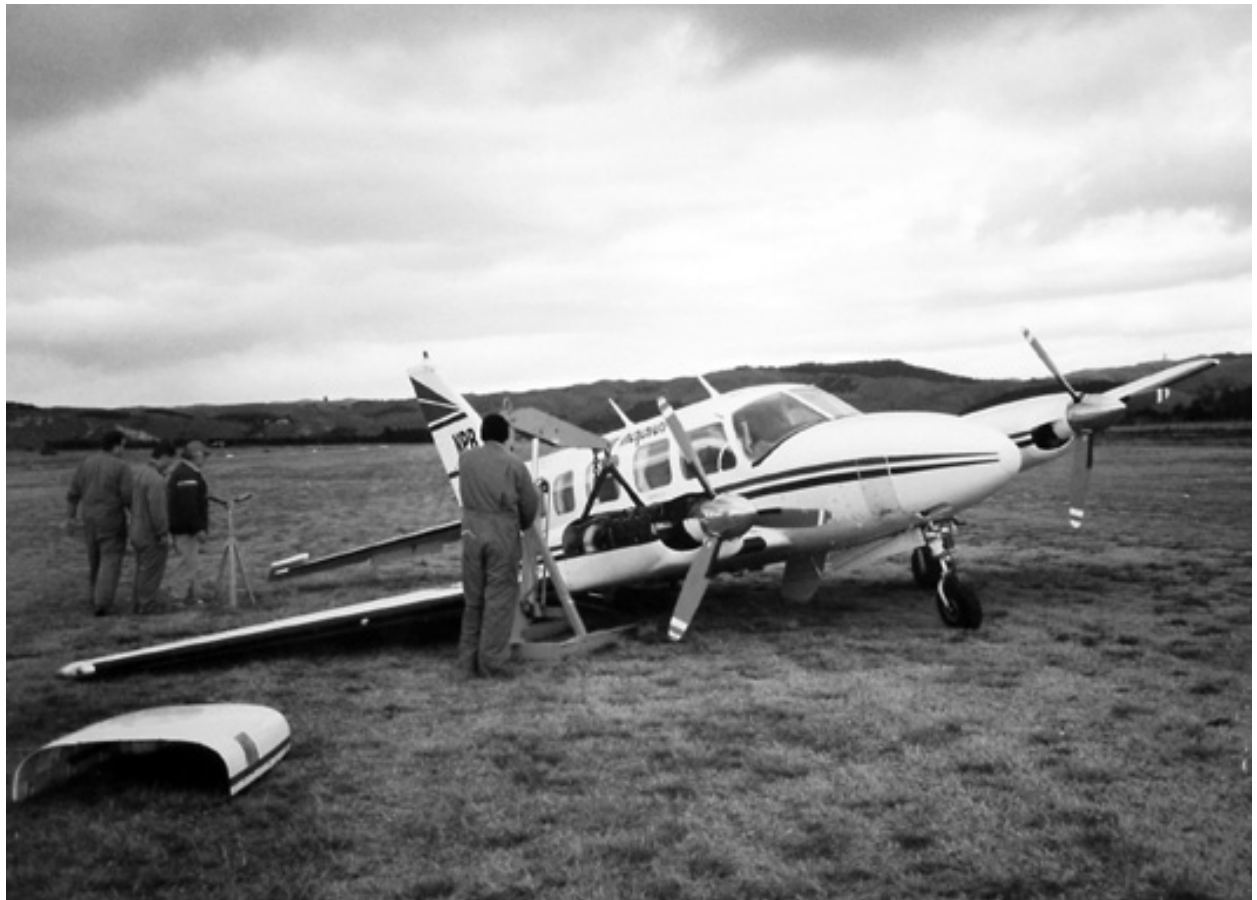
**Figure 1**  
**ZK-NPR at Napier**

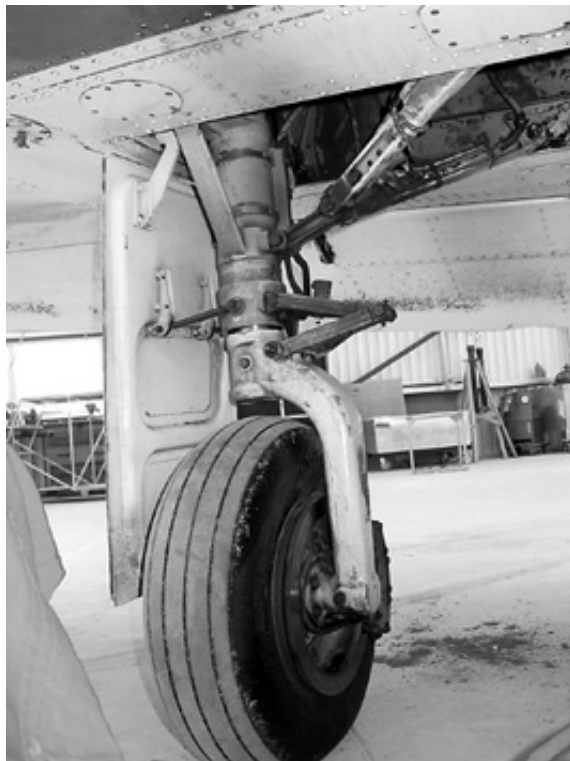
**Figure 2**  
**Right undercarriage, showing flat oleo strut**

- 2.4 Subsequent examination of the aircraft showed nothing amiss with the right undercarriage, except that the oleo strut had lost its pressure. This had occurred at some stage during the flight, because the pilot had found it normally inflated during his pre-flight inspection. It was unlikely that he could have found out about the flat oleo strut because the take-off was normal, and the undercarriage retracted without incident. Even if he had known about the flat oleo strut, it would have been unlikely to alter subsequent events and actions taken, since a flat oleo strut was not known as a potential cause of an undercarriage malfunction.

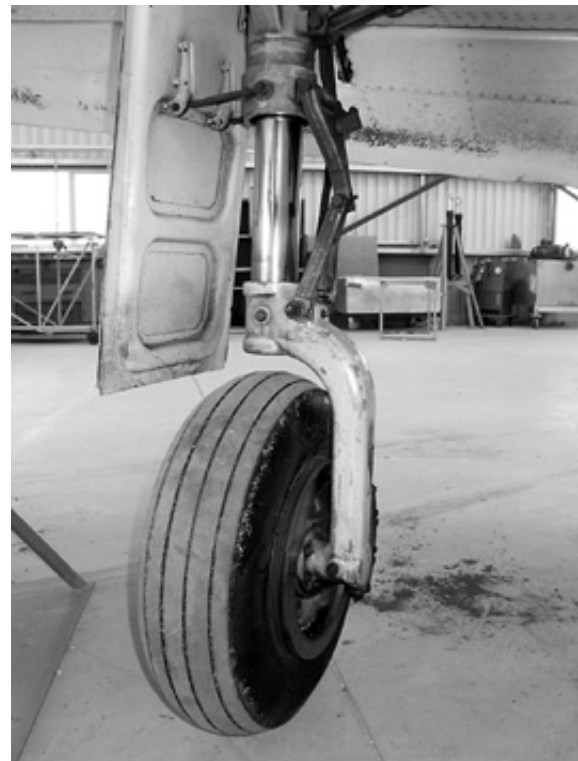
**Figure 3**  
**Right undercarriage, oleo strut extended**

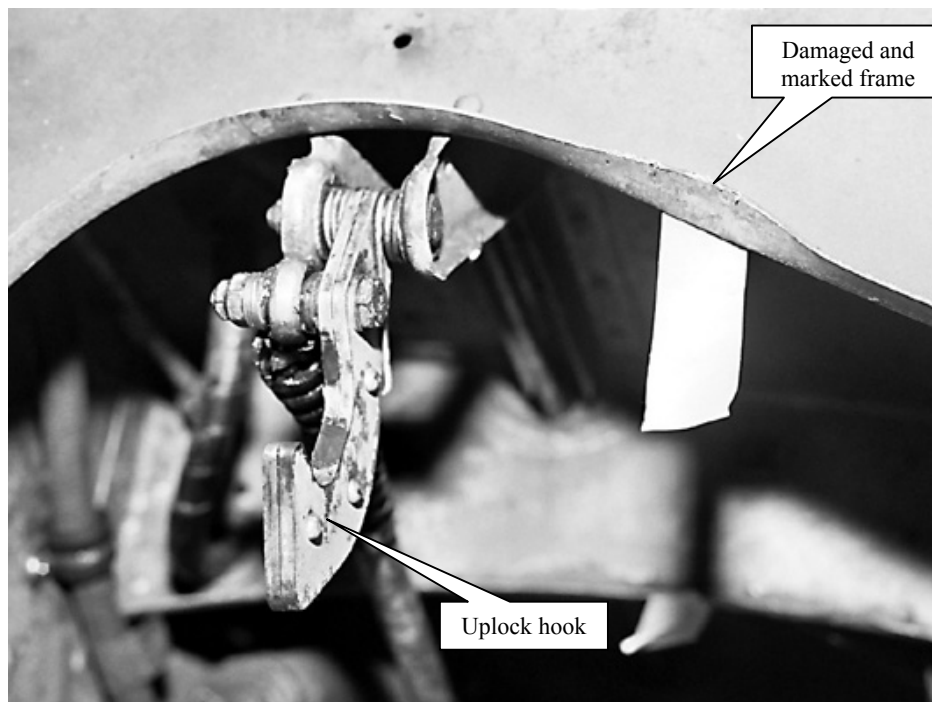
- 1.4.3 Two frames within the wing wheel bay showed fresh marks and minor damage. Matching witness marks (see figures 4 and 5) were found on the upper scissor-link (connecting the upper and lower leg parts to allow strut suspension movement while preventing rotation), and on the lower leg casting. When the undercarriage was subsequently retracted, it was evident that these marked components came into contact while the undercarriage was supported by the uplock hook, and the oleo strut was compressed by 2-3 cm, the maximum movement allowed by the hook against its spring.

**Figure 4**  
**Right wheel bay, showing uplock hook, damaged frame and marks from lower leg**

- 2.5 The matching witness marks within the right wing wheel bay and on the right undercarriage leg clearly showed that the oleo strut, while supported by the uplock hook, had become compressed during the flight. Normally, the pressure in the oleo strut would hold it out at full length. The subsequent tests, which replicated the compressed strut condition, showed that this occurrence defeated the ability of the uplock hook to release the leg during the undercarriage extension cycle, unless the strut could be returned to its normal full length.

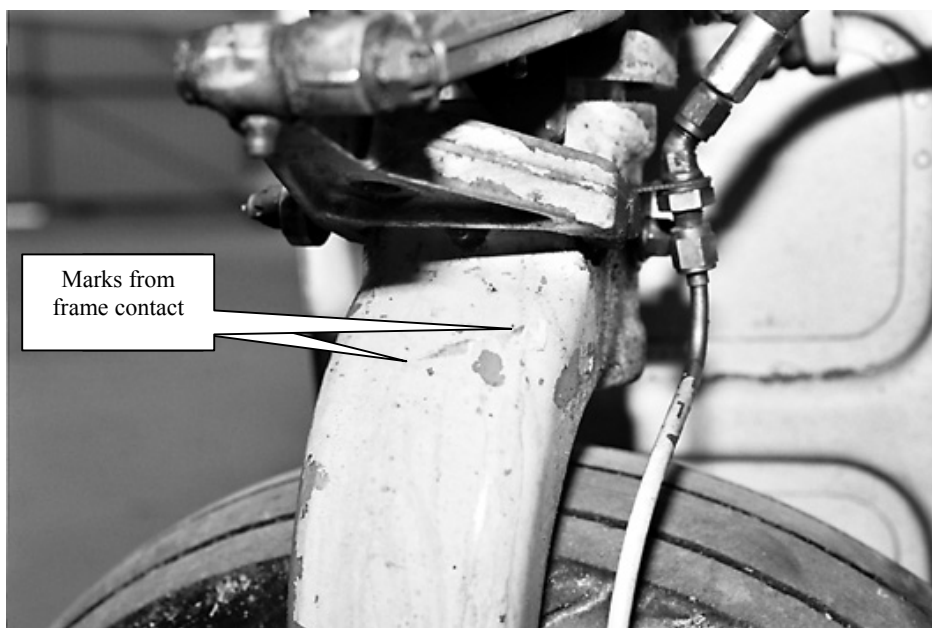
**Figure 5**  
**Right lower leg, showing matching marks from frame contact**

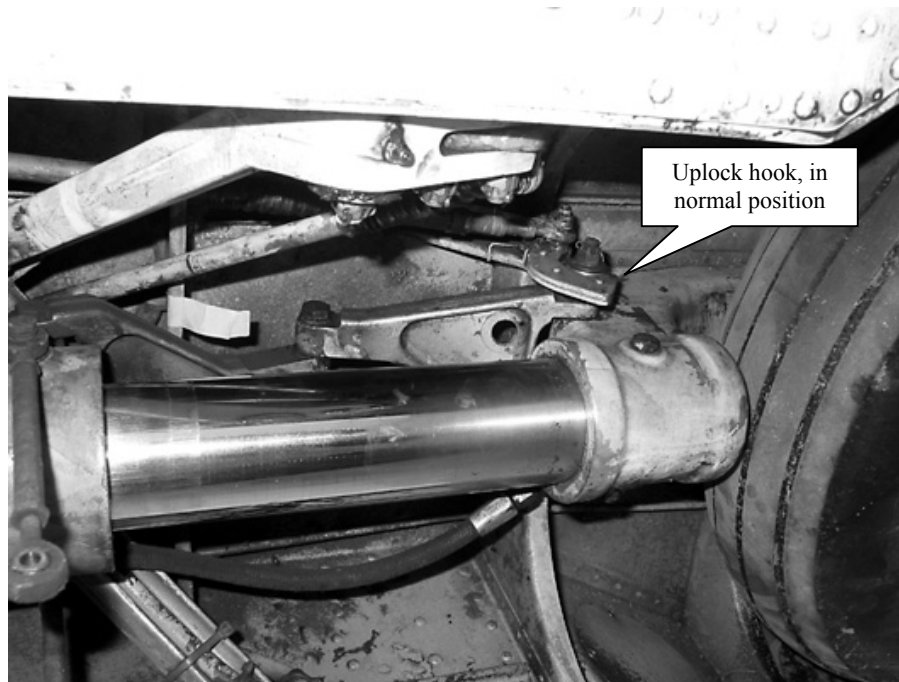
- 1.4.5 While the right undercarriage was retracted, and suspended on the uplock hook, the oleo strut was compressed by hand to the extent allowed by the movement of the hook against its spring. (see figures 6 and 7) This strut compression was easily accomplished, and brought the matching witness marks together within the wheel bay. With the strut so compressed, the undercarriage was selected down to no avail. The left and nose legs extended normally, but the right leg could not be released by the uplock hook, since all the hook travel had already been taken up by the compressed strut. When the oleo strut was decompressed by hand to its normal position, the right leg could again be extended normally.

**Figure 6**  
**Right undercarriage retracted, on uplock hook – oleo strut normally extended**

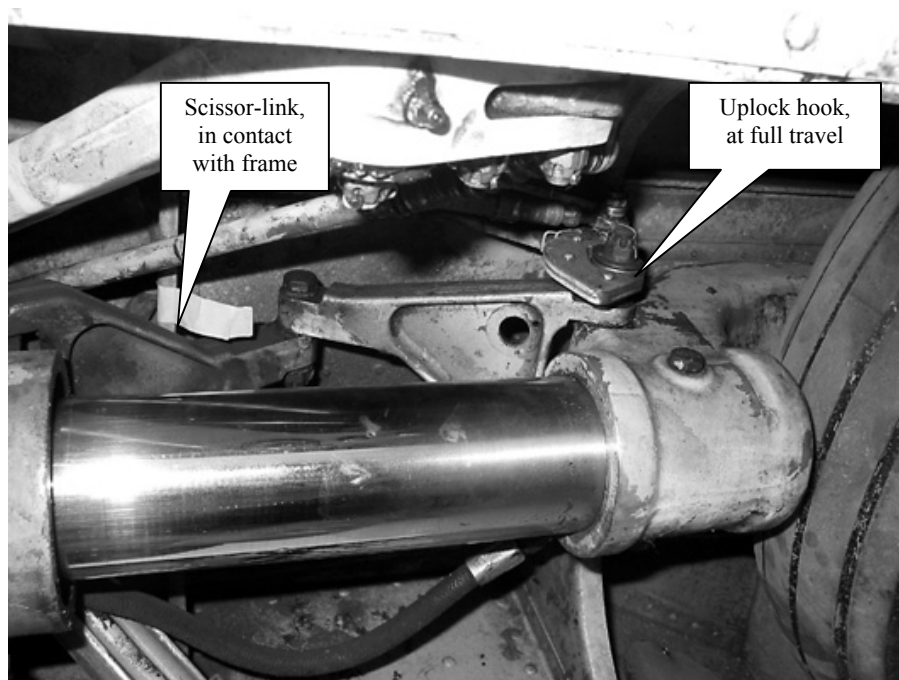
**Figure 7**  
**Right undercarriage retracted, on uplock hook – oleo strut compressed**
