AVIATION OCCURRENCE REPORT

02-010

**Boeing 747-419 ZK-NBS flight NZ 2, in flight flap separation
over Manukau Harbour by Auckland International Airport**

30 August 2002

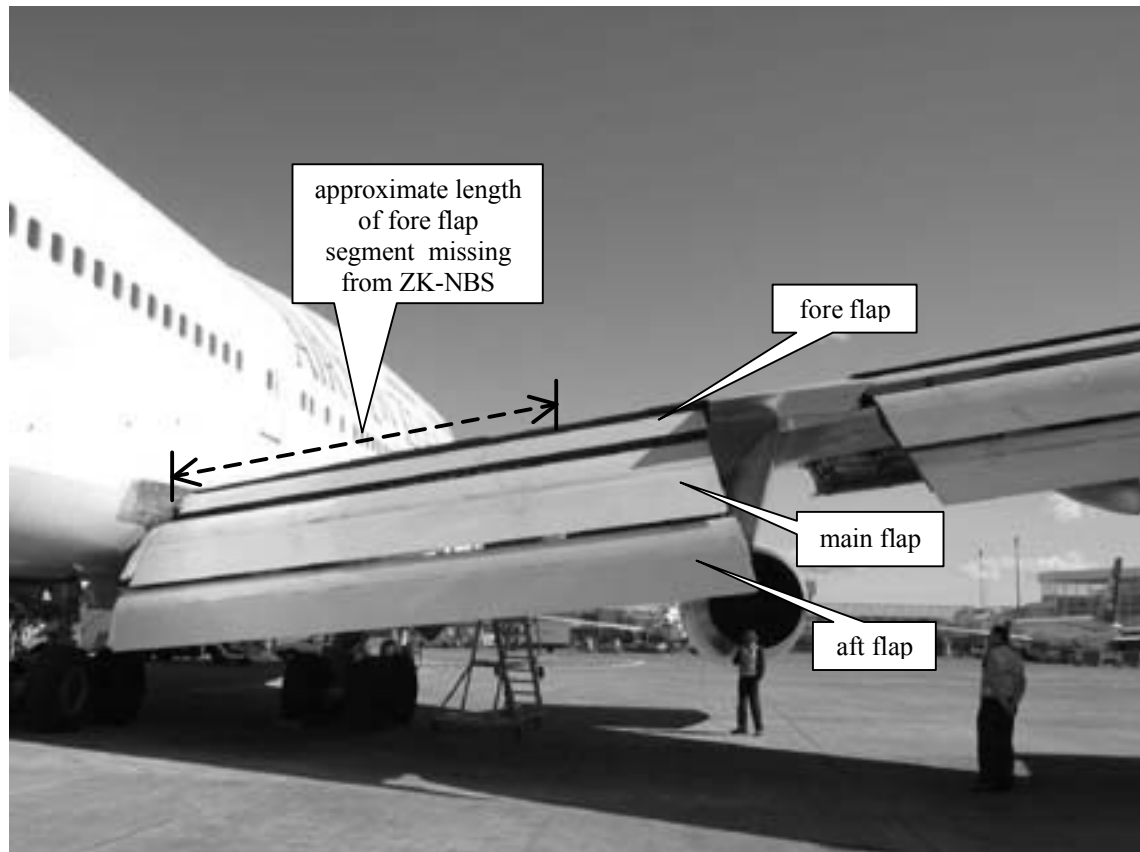
Figure 1
Boeing 747-400 right inboard trailing edge flaps

1.10.1 About 70% of the innermost segment of the right inboard trailing edge fore flap separated from ZK-NBS during the departure from Auckland (see Figure 1). The outermost flap segment was found skewed about 20° and remained attached to the aircraft, being bolted to the outer fore flap carriage by way of its fitting. The inner fore flap link attachment bolt and bearing remained attached to the flap carriage. A fractured end segment of the fore flap link (see Figure 6) was found inside the inner flap track fairing (canoe).

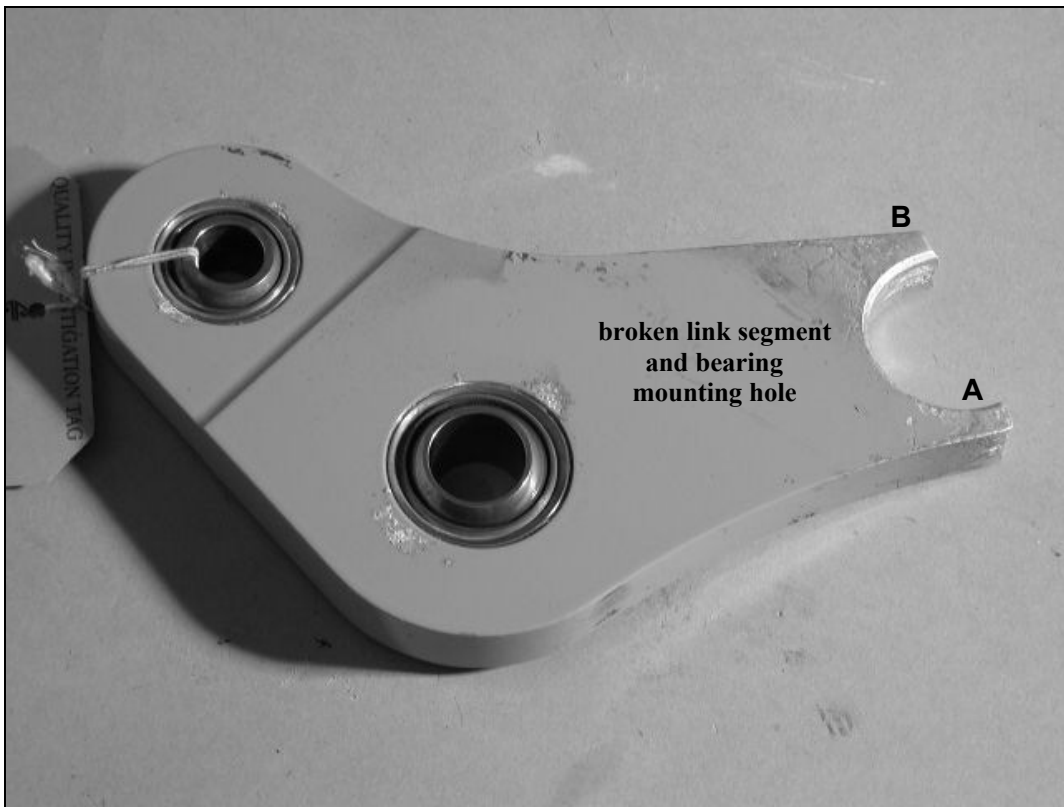
Figure 4
Failed fore flap link from ZK-NBS

1.13.2 The link failed at either side of the bearing-mounting hole (see Figure 4) where the bearing attached the link and fore flap to the inner fore flap carriage assembly. Significant features were that whereas one side had failed in overload, the area of overload on the other side was less than 25% of the fracture surface, and that a pre-existing stress corrosion crack covered over 75% of the surface (see Figures 6 and 7).

- 1.13.9 An initiation process similar to that of fracture “A” probably caused the cracking at the bore side of fracture surface “B” (see Figures 4 & 6). The cracks were predominately caused by fretting fatigue.

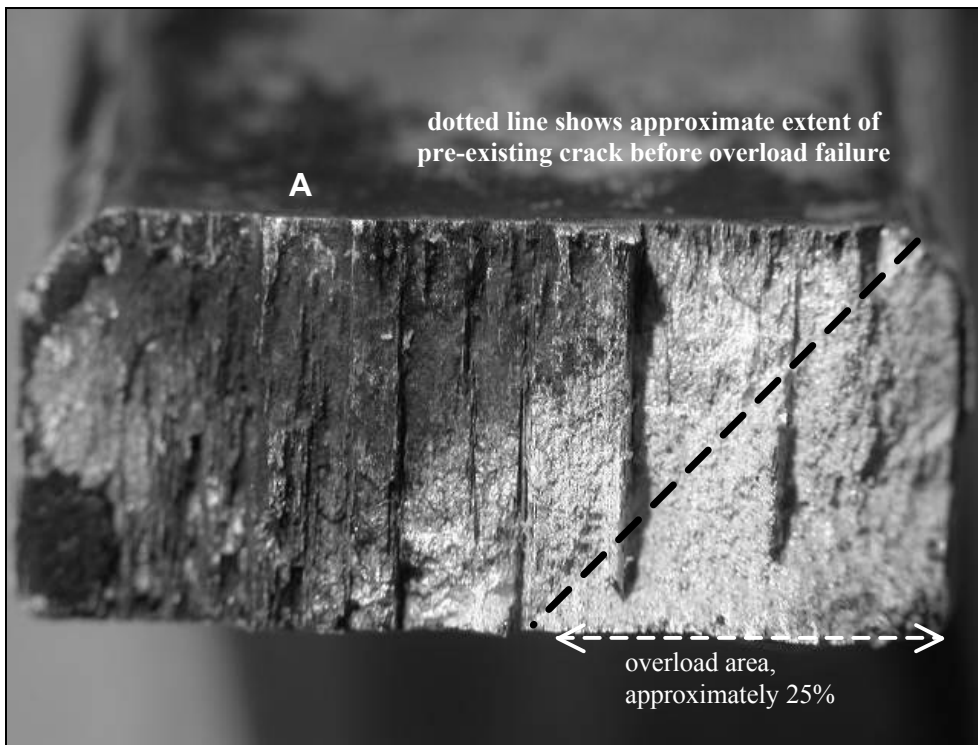
Figure 7
Failed link piece fracture surface A

1.13.6 The metallurgist said it was highly unlikely that the link failure occurred from incorrect installation or the incorrect use of the material. Fracture surface "A" (see Figures 4, 6 & 7) was the major failure and it had a number of initiation points along the width of the link, indicating that the loading on the component was even. The fracture sequence was stress corrosion cracking, followed by corrosion fatigue, followed by fatigue and then overload.

- 1.13.8 The stress corrosion cracking in fracture surface “A” spread across the entire section and the metallurgist said it was highly probable the cracking started as fretting corrosion fatigue cracks. A significant amount of fretting debris was present in the area indicating that fretting had occurred and that fretting damage was present in the area.
