AVIATION OCCURRENCE REPORT

02-011

Bell 206B JetRanger III ZK-HRC, forced landing following reported power loss on approach, Huka Falls, 3 km north of Taupo

2 October 2002

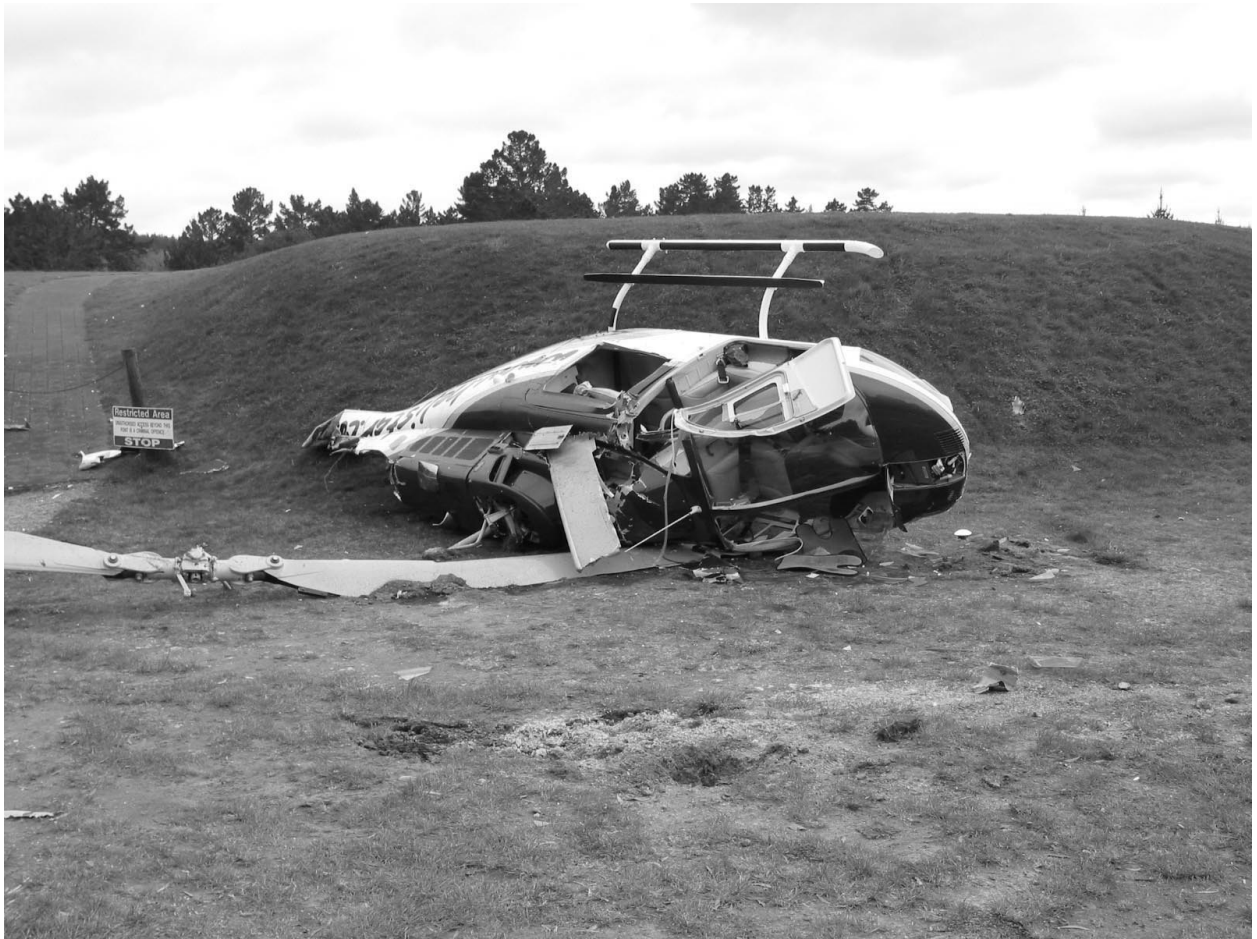
ZK-HRC accident site

- 1.4.1 ZK-HRC was lying on its right side at the base of the landing pad and had sustained considerable damage during the accident. There was a strong smell of fuel present and fuel was observed to be dripping from the tank drain, which had previously been plugged by fire service personnel. The main rotor assembly had broken near the top of the mast and lay next to the fuselage. A section of a main rotor blade had separated and struck the forward left side of the cabin. One of the main rotor blades had struck the rear of the helicopter, forward of the tail boom attachment, and severed the tail boom and tail rotor assembly, which lay about 10 m from the fuselage. The engine cowling was compressed preventing initial access to the engine.

- 1.4.4 Two parallel tracks ran from near the eastern edge of the landing pad, across the centre of the pad and terminated at the helicopter. The width of the tracks matched the dimension of the helicopter's skids.
