AVIATION OCCURRENCE REPORT

02-013

Piper PA34-200T Seneca II ZK-FMW, undercarriage collapse
after landing, Ardmore Aerodrome

12 November
2002

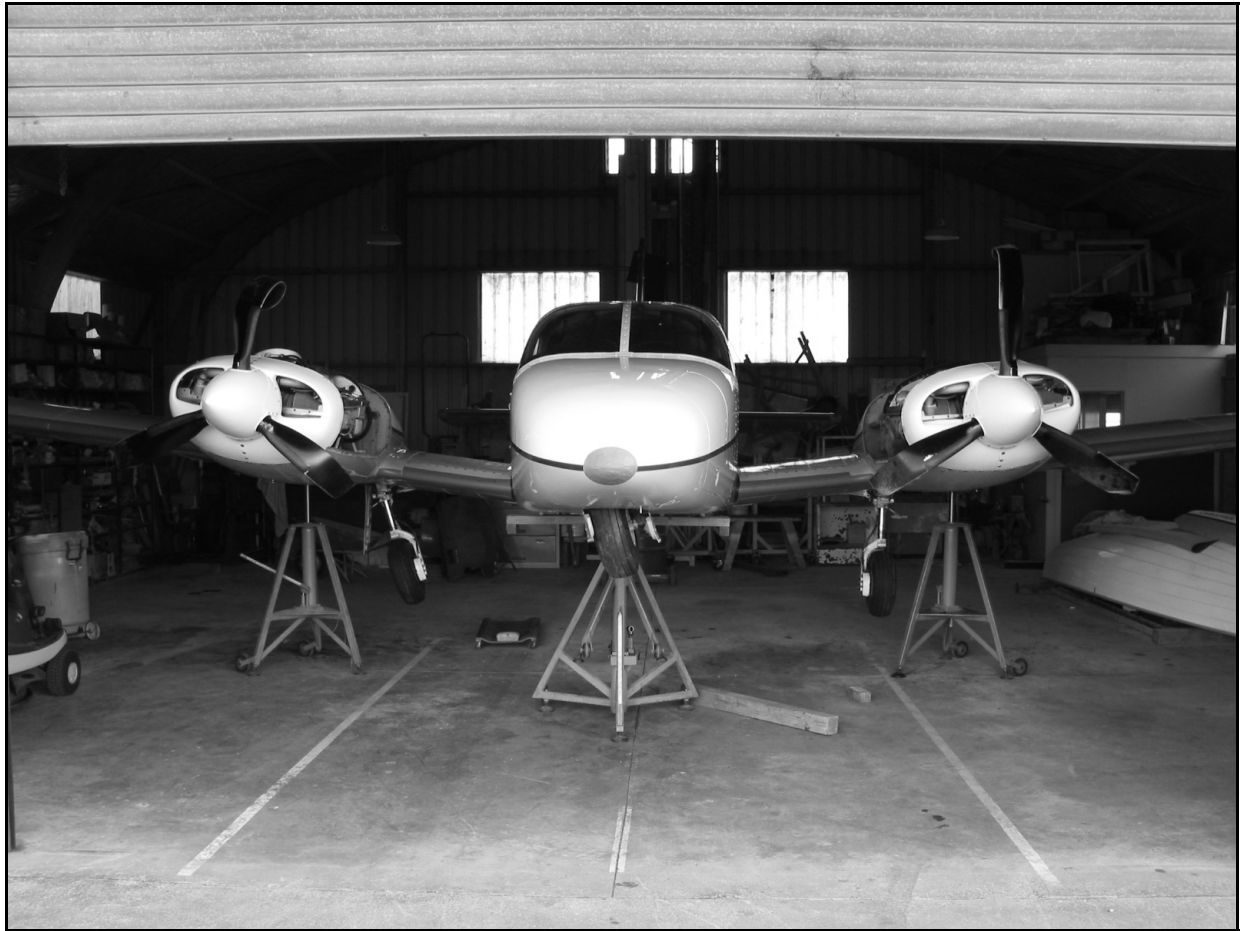
ZK-FMW after removal from the runway area

1.2.2 The aircraft had scraped along on part of its belly and left wing, causing lower panel and antenna damage. The left undercarriage door was torn off and the wing fuel tank ruptured. The right undercarriage was partially collapsed and there was damage to the support structure. The nose undercarriage was collapsed and the doors scraped.
