RAILWAY OCCURRENCE REPORT

02-107 express freight Train 530, collision with stationary shunt locomotive,
New Plymouth

29 January 2002

**TRANSPORT ACCIDENT INVESTIGATION COMMISSION
NEW ZEALAND**

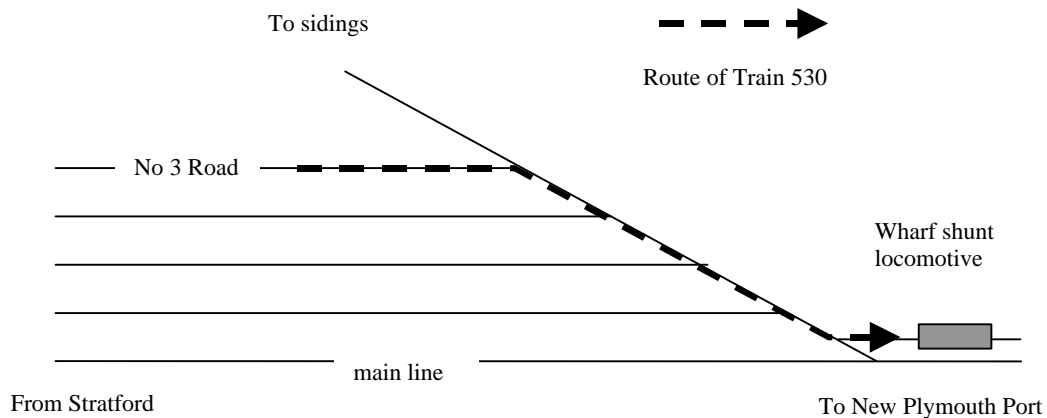
Figure 1
Diagram of north end of New Plymouth yard (not to scale)

- 1.1.6 As Train 530 approached New Plymouth, the locomotive engineer called the terminal team leader to advise of his imminent arrival. The team leader advised him that the train would be berthing on 3 road, and that all points were correctly set. The locomotive engineer was asked to pull well down, as the wagons on his train were to connect with the wharf shunt. The wharf shunt locomotive was parked unattended and stationary on the shunting leg, at what was referred to as the north end of the yard at the time.

- 1.1.7 The locomotive engineer said later that he thought he was about 4 locomotive lengths (about 70 metres) away from the team leader when he “just relaxed too much and dozed off for a minute second”. The next thing he knew was a call on the radio to “Stop”, but he was about 3 locomotive lengths past the team leader by then and was heading towards the shunt leg where the wharf shunt locomotive was parked. He immediately “slammed it in to emergency, slammed the independent brake on”, but was unable to stop the train before it collided at low speed with the shunt locomotive. There were no injuries and minor damage only was sustained by the locomotives.

- 1.2.2 The berthing of main line trains was arranged in consultation with the Team Leader and the Rail Operator in charge of each shunting service, to avoid conflicting movements.
- 1.2.3 The maximum speed for trains travelling within the loop and sidings at New Plymouth was 25 km/h.

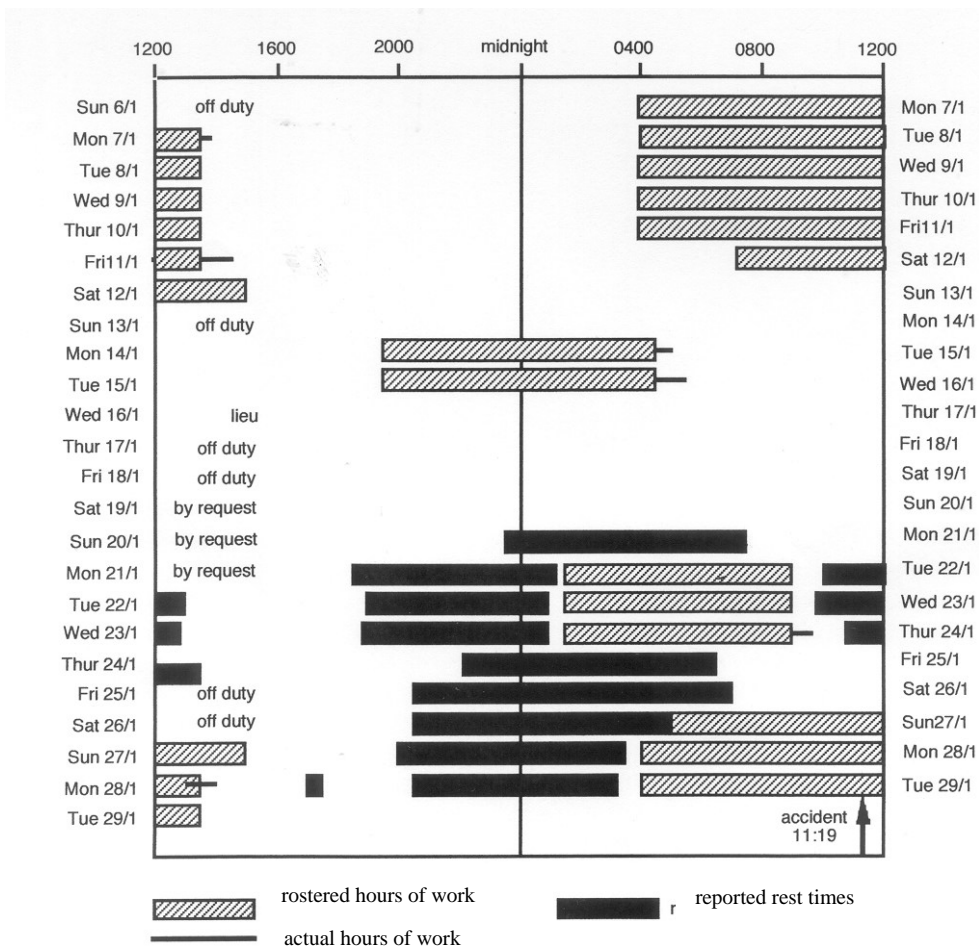
Figure 2
The work and rest patterns for the locomotive engineer over the 3 weeks prior to the collision

- 1.5.5 In the 16 days before the incident the locomotive engineer was rostered on duty for 7 days for a total of 60 hours. His 9 days off were either by request or through rostering requirements. The rostered and corresponding actual hours worked by the locomotive engineer are shown in the following table:

- 2.4.21 The locomotive engineer's sleep diary showed that, during the 0130 start shifts, he was either napping or in bed for restorative sleep periods of 9 hours, 9 hours 10 minutes and 11 hours 5 minutes respectively between the shifts, although, on the night leading into the first shift, he had only managed 6 hours 45 minutes in bed before he commenced duty. It is possible that he had not achieved quality sleep for those durations and as a result commenced this portion of his roster with a sleep debt from the first night that accumulated during the remaining shifts.

- 2.4.22 On the mandatory days off the locomotive engineer had recorded 10 hours 30 minutes and 8 hours 30 minutes respectively in bed but it is possible that he did not achieve sufficient quality restorative sleep during those times to repay in full the cumulative sleep debt from the previous 3 shifts. As a consequence the remaining sleep debt was carried over into the next portion of his roster, the 0500 and 0400 starting shifts.
