RAILWAY OCCURRENCE REPORT

02-110

Tranz Alpine passenger express Train 801, collision between locomotives and passenger rolling stock, Christchurch

5 April 2002

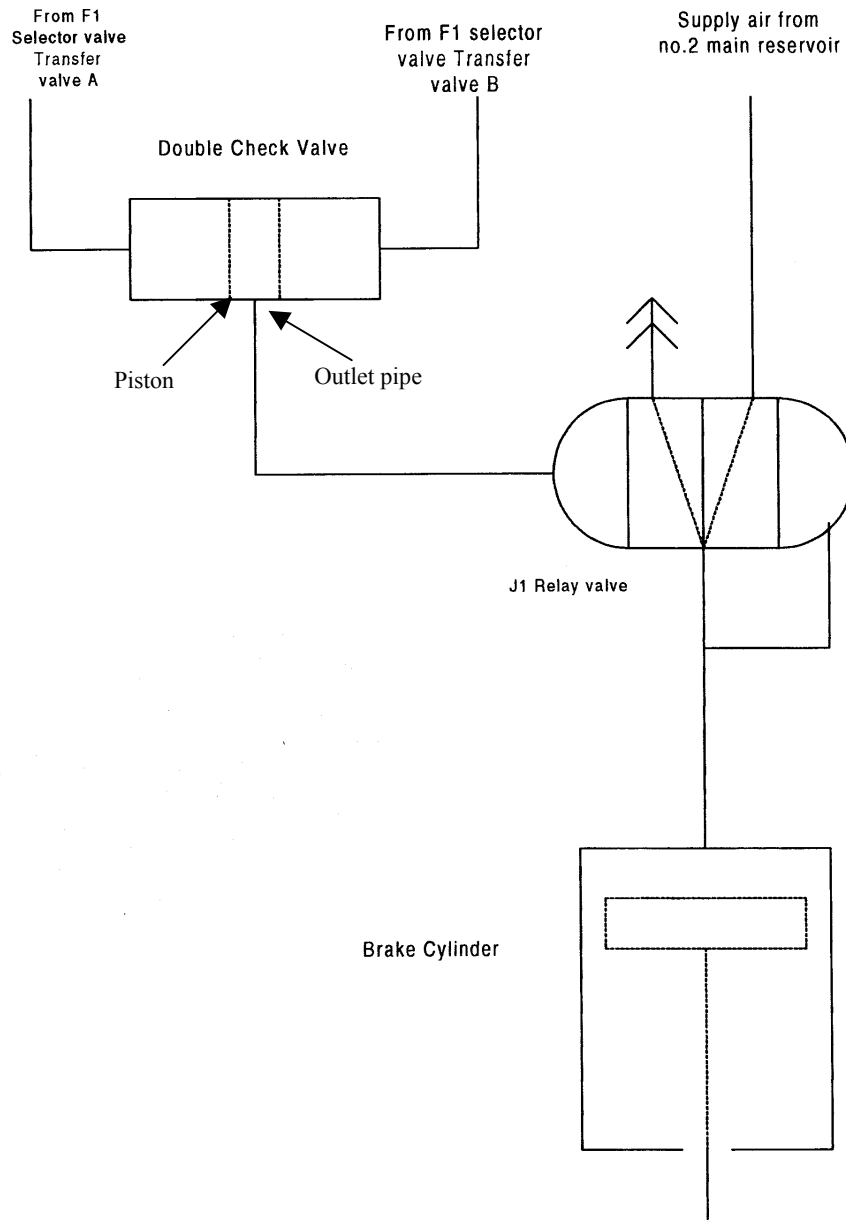
Figure 2
Schematic of J1 relay valve and double check valve on a Westinghouse 26 L airbrake system.
Drawn in Trail/Fault Condition
(diagram courtesy of Tranz Rail)

- 1.9.2 These locomotives were immediately confined to the locomotive depot for the problems to be diagnosed and rectified.
- 1.9.3 During extensive testing the fault was simulated on DCP 4945 when the controls were set for the trail position. During a brake application initiated from the lead locomotive, the double check valve had the same air pressure applied to both sides of the piston but there was minimal air flow from the outlet port to the J1 relay. As a consequence, the brakes were slow to apply to the trail locomotive (see Figure 2).

- 1.9.4 The double check valve of DCP 4945 was stripped and on examination it was found that:
- The piston was slightly wider than the outlet port and when positioned centrally prevented air flow to the J1 relay valve

- There was no bleed off groove adjacent to the outlet port to facilitate air flow should the piston stop in the mid position
 - The component fitted was suitable for a 26L 4-pipe braking system but was not the correct component for a 26L 3-pipe braking system with a horizontally-mounted check valve.

- 2.2.1 The random nature of the reported poor braking performance made an accurate diagnosis extremely difficult. The problem only occurred when the piston in the double check valve of the trailing locomotive was in a central position, preventing airflow from the double check valve outlet port. As a consequence the brakes on the trailing locomotive were slow to or did not respond. This could also occur while hauling a train but probably would not be noticed because of the braking contribution from the trailing vehicles.
- 2.2.2 The double check valve fitted was the appropriate component for any 4-pipe system and when vertically mounted on a 3-pipe system. However, it was not suitable for the 3-pipe system on a DC/DCP class locomotive because the double check valve was mounted horizontally due to physical constraints. This component may have been used in the DC/DCP class locomotive

- 3.1 The double check valve was not suitable for the 26L 3-pipe braking system on DC/DCP class locomotives.
- 3.2 The brake operating efficiency test conducted immediately after the collision did not reveal any deficiency in the locomotive braking system of DCP 4559 and DCP 4830, but was not the appropriate test when the braking performance of a locomotive was in doubt.
- 3.3 The faulty F1 selector valve, which was replaced on DCP 4830 after a full air brake code test, did not contribute to the collision.
- 3.4 The incorrect component in the double check valve was also responsible for other poor braking performance incidents involving DCP locomotives.
- 3.5 The manner in which the locomotive engineer approached the stationary passenger cars would have resulted in a successful couple-up had the brake failure not occurred.

- 1.9.5 After consultation between Alstom and Tranz Rail, the outlet port of the double check valve was elongated so that it was 3 mm wider than the piston. The double check valve was reassembled and when retested the fault could not be reproduced.

- Unsuitable double check valves can usually be modified by the elongation of the outlet port to 3 mm wider than the shuttle. However, this modification must not prevent the free movement of the piston in the bore.

Where a double check valve is found to lack the feed groove, use a pencil grinder or similar to elongate the internal side of the outlet port so that it is 3mm wider than the width of the piston. Smooth off any rough edges around any port that has had the modification carried out and ensure that the piston moves freely over the whole length of its travel within the double check valve.
