RAILWAY OCCURRENCE REPORT

02-112 passenger fell from the Rain Forest Express, Tunnel 29, Nihotupu
Tramline, Waitakere

4 May 2002

Report 02-112
passenger Train 1337
passenger fell from train
Nihotupu Tramline, Waitakere
4 May 2002

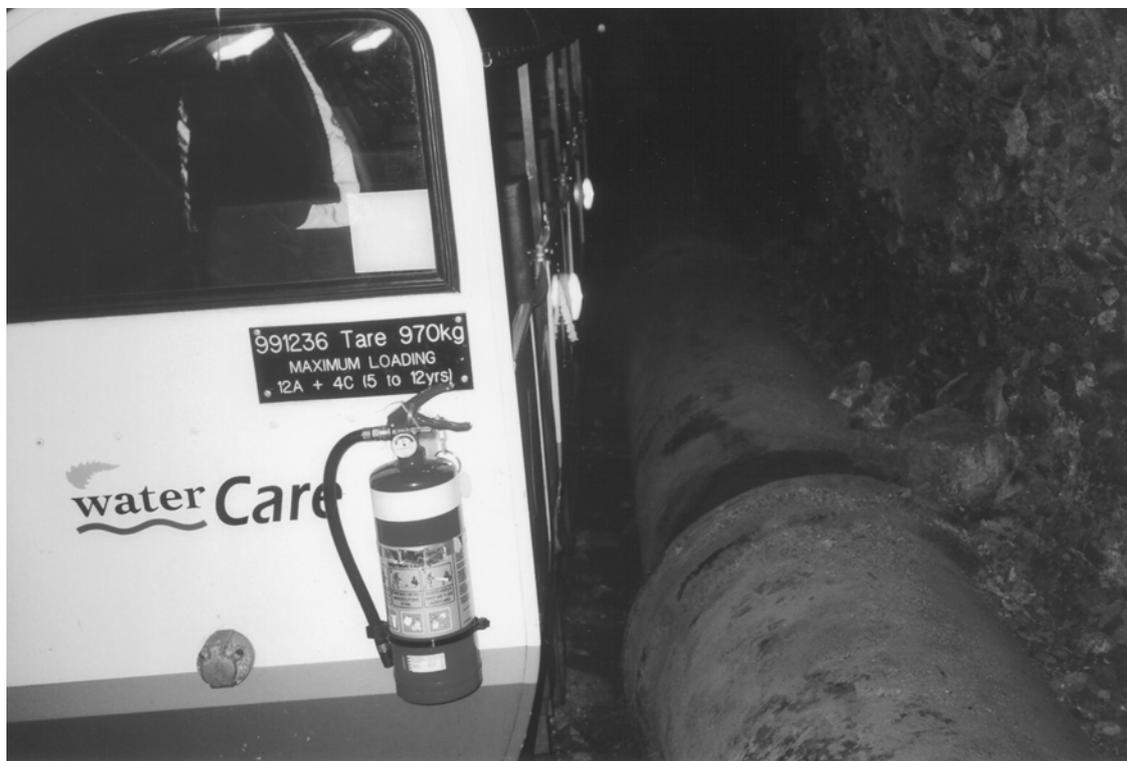
Figure 2

1.3.2 A 610 mm cast iron water pipe ran alongside the tramway through Tunnel 29 and at the point where the child fell, the distance between the pipeline and the side of the carriages was about 100 mm (see Figure 2).

A passenger carriage alongside the water pipe at the point at which the child fell

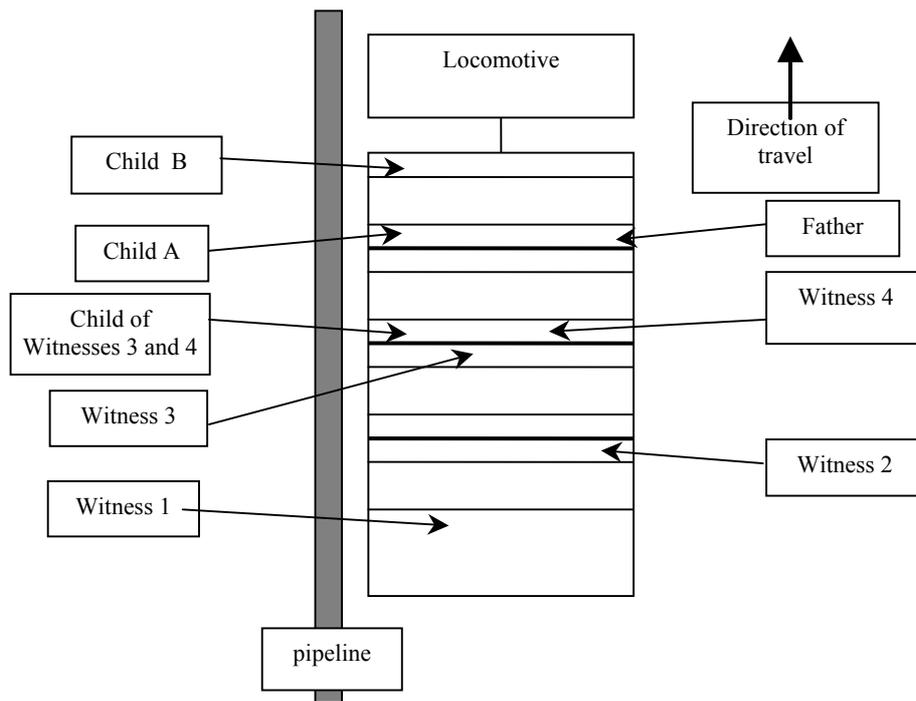
Figure 3
The seating plan showing where witnesses 1 to 4 were sitting in the leading carriage

1.4.1 When the train left Seaver Camp, the injured child (child A), his father and brother (child B) had occupied the front compartment of the leading carriage immediately behind the locomotive. Child A was sitting on the open or pipeline side of the carriage beside his father facing forward while child B was sitting opposite and facing the rear of the train (see Figure 3).

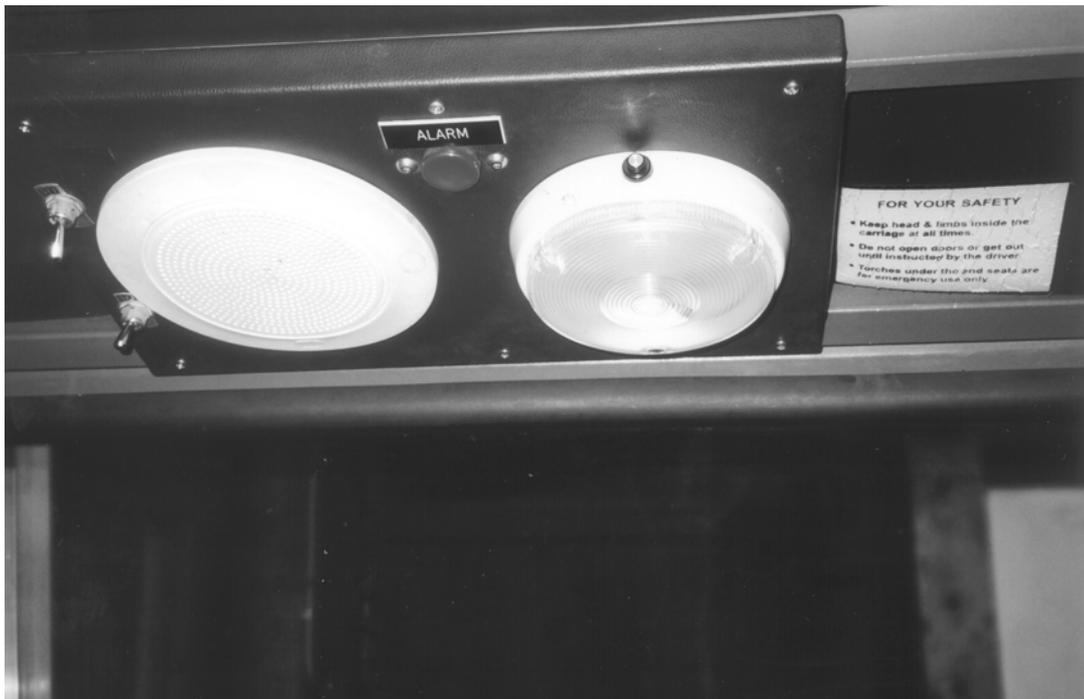
Figure 4
The ceiling of the passenger compartments

- 1.9.5 There was an internal light, an alarm button, and intercom speaker on the ceiling of each compartment (see Figure 4).

was also displayed on the ceiling (see Figure 4) in each compartment, adjacent to the interior light and alarm button.

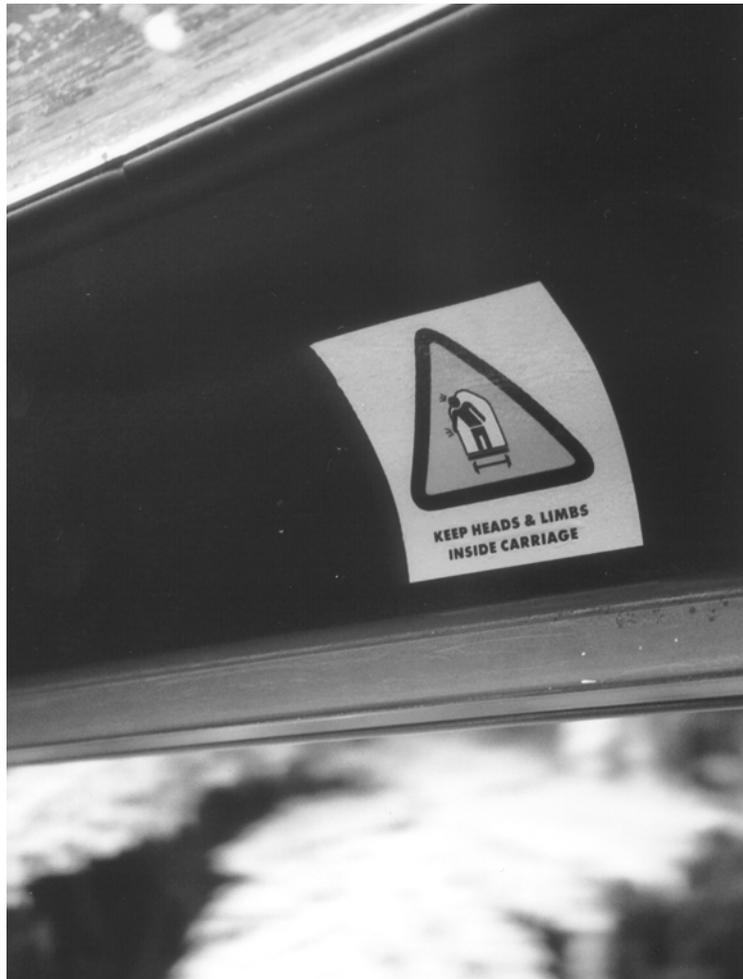
Figure 5
Additional warning signs on the ceiling of the carriage compartment

- 1.9.7 Additional warning stickers were also placed along the carriage ceilings (see Figure 5).

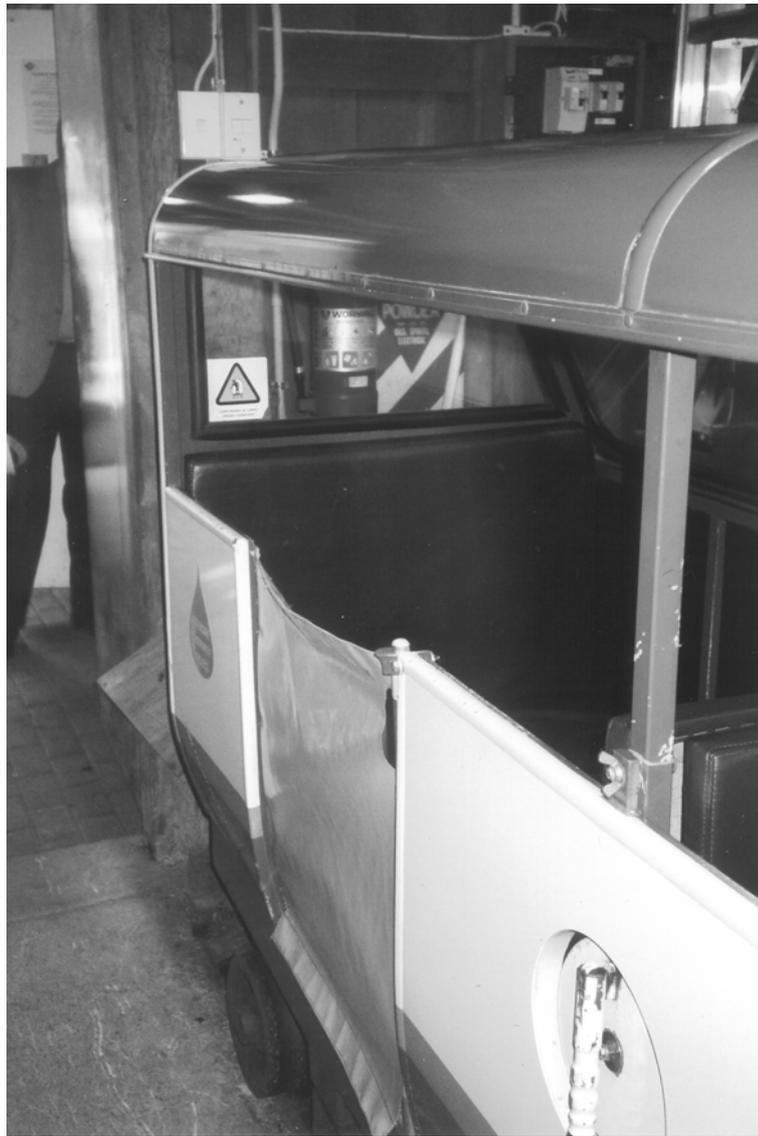
Figure 6
The compartment on the pipe line side of the carriage

1.9.9 The side of the carriage opposite the pipeline was fully enclosed with perspex windows. There was a gap of 400 mm between the top of the carriage side on the pipeline side of the train and the compartment ceiling.

1.9.10 Access to each compartment was through a doorway about 550 mm wide. The door was 600 mm high and consisted of a heavy-duty vinyl screen, which was riveted to the carriage at one side to act as a hinge. The opposite side of the screen was stiffened by an aluminium tube which was fitted over a stainless steel spike that was secured to the carriage chassis at its base to restrain the bottom of the tube. A latch, which was attached to the side of the carriage, was fitted over the top of the tube to secure the door when it was closed (see Figure 6). There was no strengthening across the top of the vinyl door.
