## RAILWAY OCCURRENCE REPORT

02-130      express freight Train 220, derailment, Rukuhia

18 December 2002

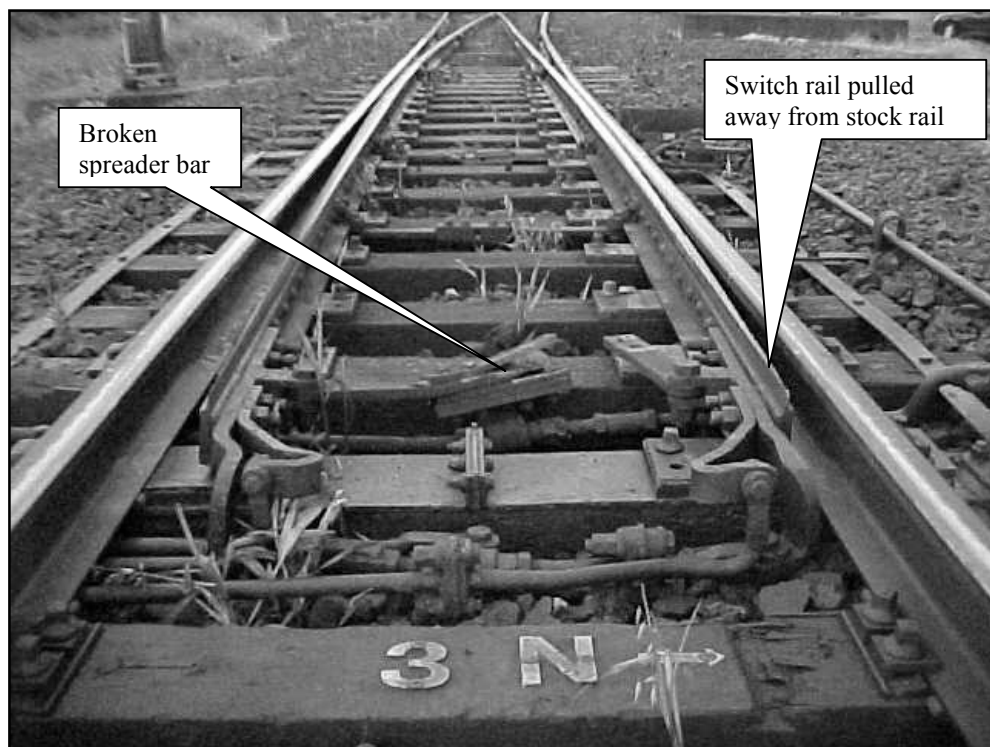
- 1.1.1 On Wednesday 18 December 2002, Train 220 was a scheduled northbound express freight service from Wellington to Auckland on the North Island Main Trunk (NIMT). The train consisted of electric locomotives EF30042 and EF30094 and 31 bogie wagons, with a gross weight of 1139 t and length of 524 m.
- 1.1.2 At about 2230, as the train approached Rukuhia, dragging brake rigging on the fifteenth wagon in the consist (ZK 350) impacted with the spreader bar of the mainline turnout at the south end of Rukuhia. The impact broke the spreader bar, which connected the switch rails, and pulled the right-hand switch rail away from the stock rail (see Figure 1).

**Figure 1**  
**The south end points at Rukuhia, looking north, following the derailment**

- 1.1.3 The resulting gap between the curved stock rail and displaced switch rail forced the wheels of following wagons to try to take 2 diverging roads simultaneously, resulting in the train parting and 11 wagons derailing.
- 1.1.4 The locomotive engineer estimated that Train 220 was travelling between 75 and 80 km/h when approaching the mainline turnout at the south end of Rukuhia.
- 1.1.5 At the time of the derailment, while passing through Rukuhia station, the locomotive engineer heard a loud hissing sound. He looked at the head end display unit<sup>3</sup> of the train end monitor system and saw a brake pipe pressure value of 230 kPa, indicating to him that either a hose had blown or the train had parted. At the same time he also saw that the vacuum circuit breaker was

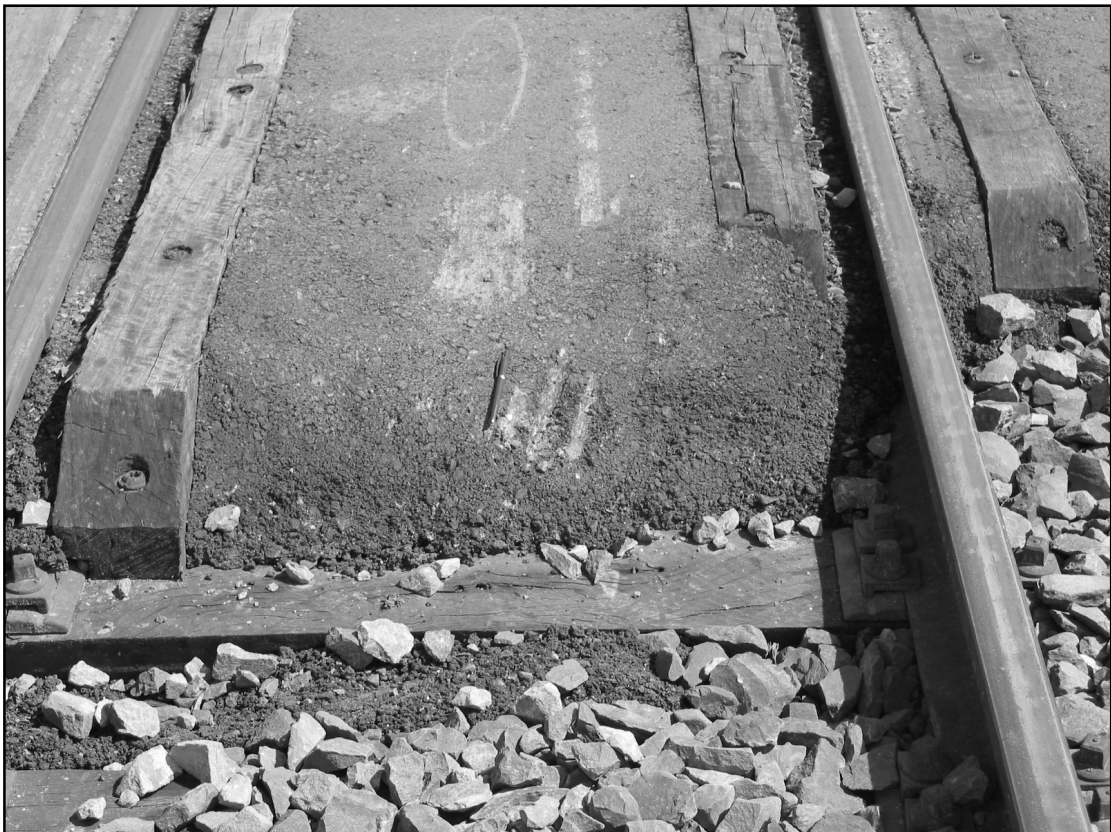
- 1.2.1 Seventeen wagons remained on the front portion of the train, with 2 wagons immediately behind ZK 350 derailed. There was a gap of approximately 550 m separating the front and rear portions of the train. The first 9 wagons of the rear portion were derailed and foul of the crossing loop. The rear portion had stopped with the trailing bogie of the fifth wagon from the rear of the train at the point of derailment (POD), 533.517 km NIMT. The roadway over Rukuhia Road level crossing was blocked by the rear of the train.
- 1.2.2 While there was some minor ballast disturbance south of Rukuhia consistent with a bouncing brake rod, the first significant strike mark was on the south edge of the seal at Rukuhia Road level crossing some 27 m before the POD (see Figure 2).

**Figure 2**  
**Strike marks at Rukuhia Road level crossing**

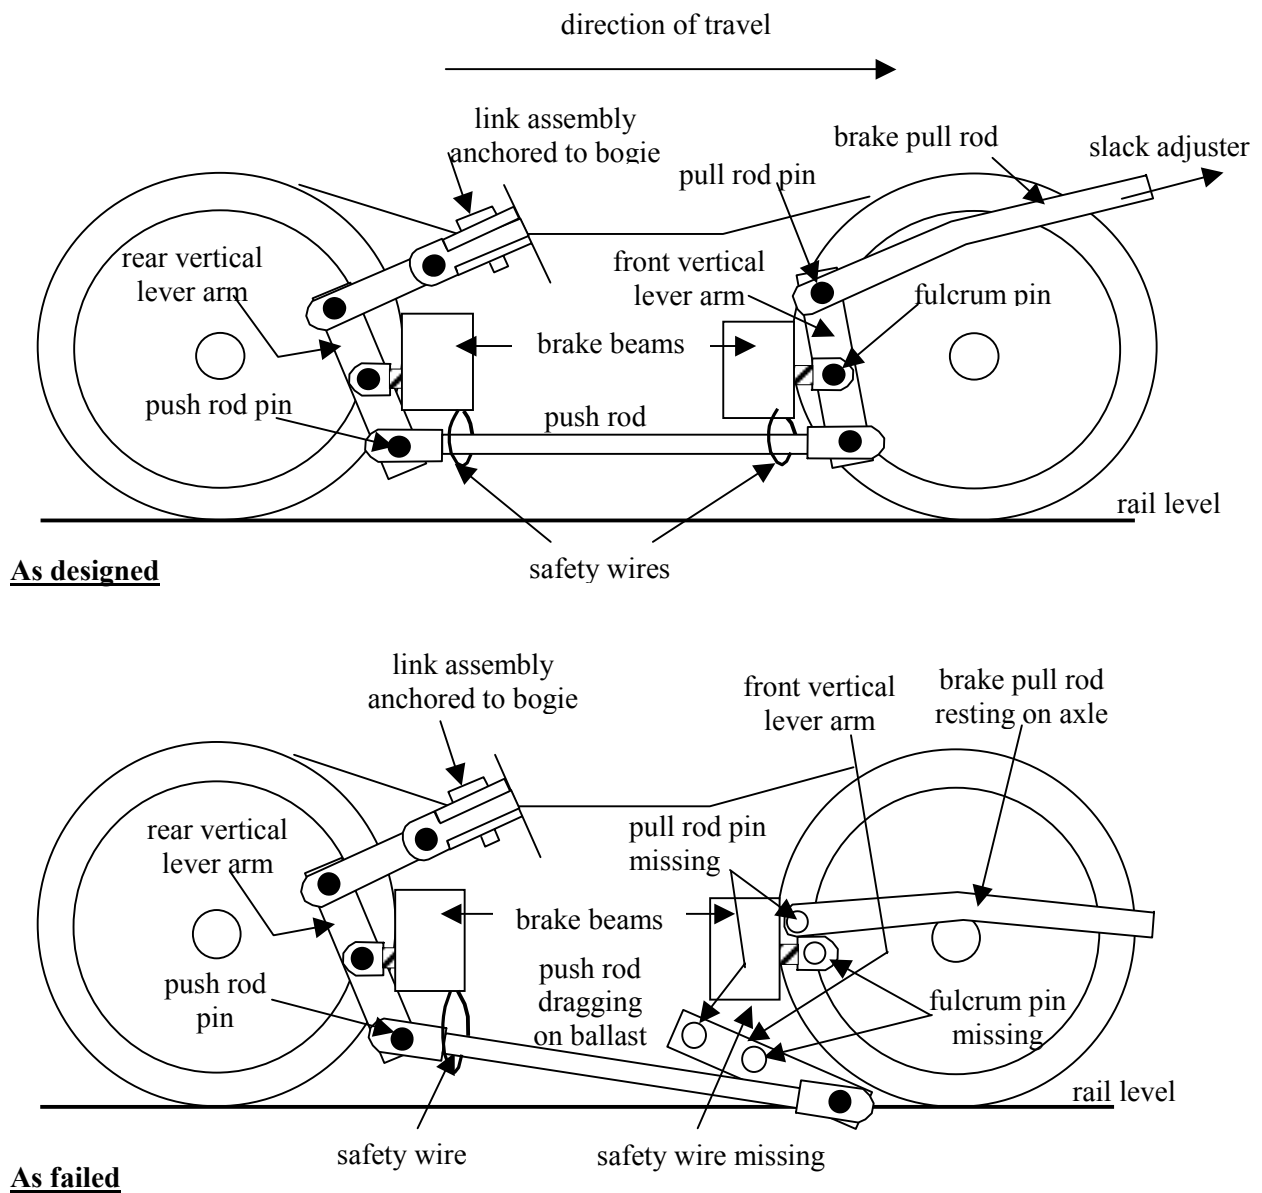
**Figure 3**

1.3.1 Wagon ZK 350, which had the dragging brake rigging, was the last wagon on the front portion of the train remaining on the track. The trailing bogie's leading end brake rod was in contact with the ballast. The trailing end of the brake rod remained attached to the wagon.

#### **Diagrammatic section of the trailing bogie showing the brake gear as designed and as failed**

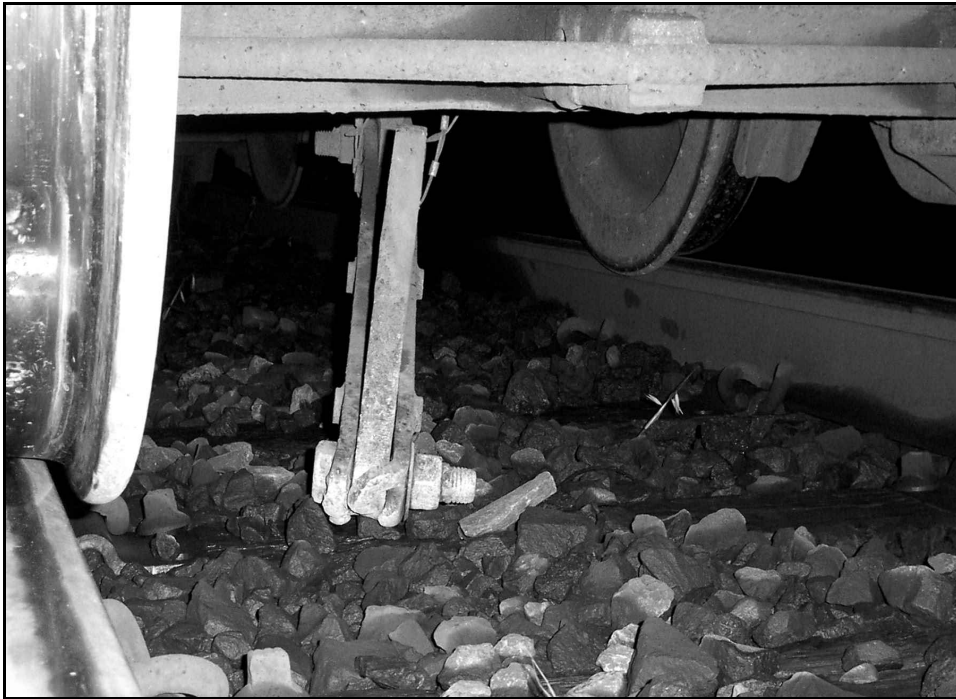
- the leading brake beam (fulcrum) pin connecting the vertical lever arm to the brake beam fork was missing, allowing the push rod to hang down
- the leading vertical lever pin connecting the brake pull rod was missing
- the safety wire on the leading end of the bogie to support the push rod in the event of a pin coming out was missing
- the bolt and welded nut connecting the push rod and the leading vertical lever arm was intact (see Figure 4)
- the brake pull rod from the slack adjuster to the vertical lever was resting on the axle and the rod had worn 38 mm or about 50% of its original dimension (see Figure 5)

**Figure 4**  
**Dragging brake gear on trailing bogie of wagon ZK 350**

- 2.4 The dragging brake rod resulted from the loss of the fulcrum pin assembly. This was a known weakness as indicated by FMI 3024 Issue B. While the push rod pin connecting the brake vertical lever and push rod had been replaced by a welded bolt and nut, the fulcrum pin and pull rod pin modifications had not been completed in accordance with current instructions. Had all the modifications been completed on ZK350 at its next B-check, as expected by the end of 2000, it was likely that this incident would have been avoided.

- 2.5 The split pin retaining the fulcrum pin on the leading end of the trailing bogie had failed allowing the fulcrum pin to fall out and the brake rigging to drop. It was likely the split pin was worn but had not been detected during the 3 most recent B-checks, and would not be expected to be found during a pre-departure A-check.

- 4.1 Following the incident, Tranz Rail and Alstom prepared a joint procedure to control the hazard of dropped brake rigging on wagons by:
  - creating a Brake Rigging Depot Maintenance work order for every wagon in the fleet

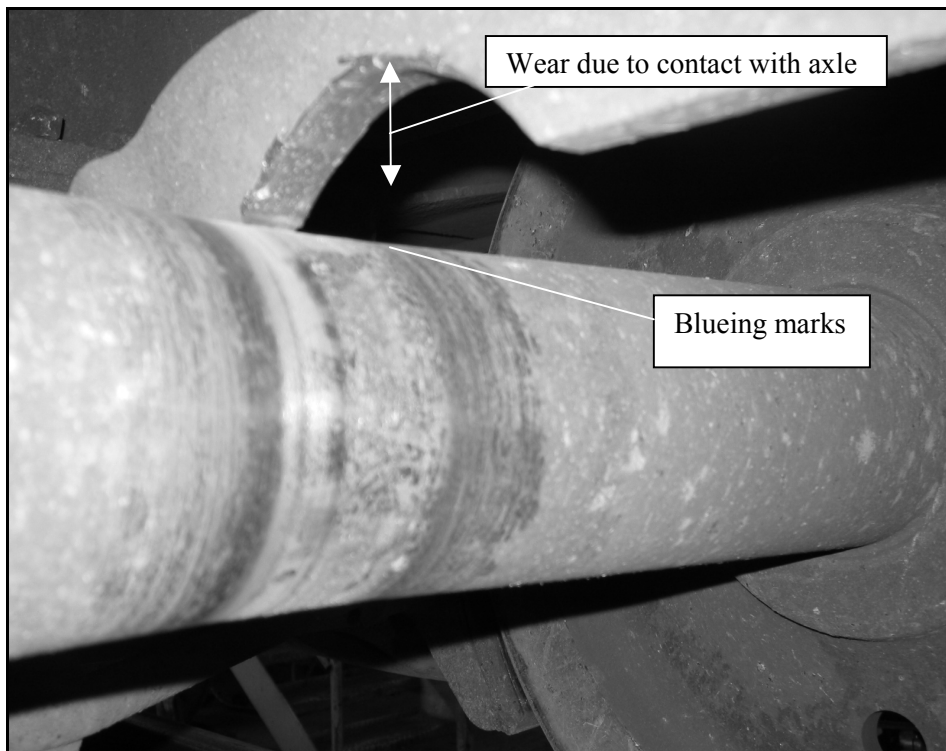
**Figure 5**  
**Blueing marks on the axle and wear on the pull rod from contact with the axle**

- 2.6 The safety wires were intended to restrain the brake rod until the failure was identified and repaired, but without the safety wire, the pull rod rested on the leading axle and slowly wore through and eventually allowed the push rod to drop sufficiently to allow it to strike the points spreader bar at Rukuhia. The amount of wear on the pull rod indicated that it had been resting on the axle for some considerable time.

- 3.5 The time at which the safety wire became detached could not be established, however the wear on the push rod would indicate that it had been missing for some time.

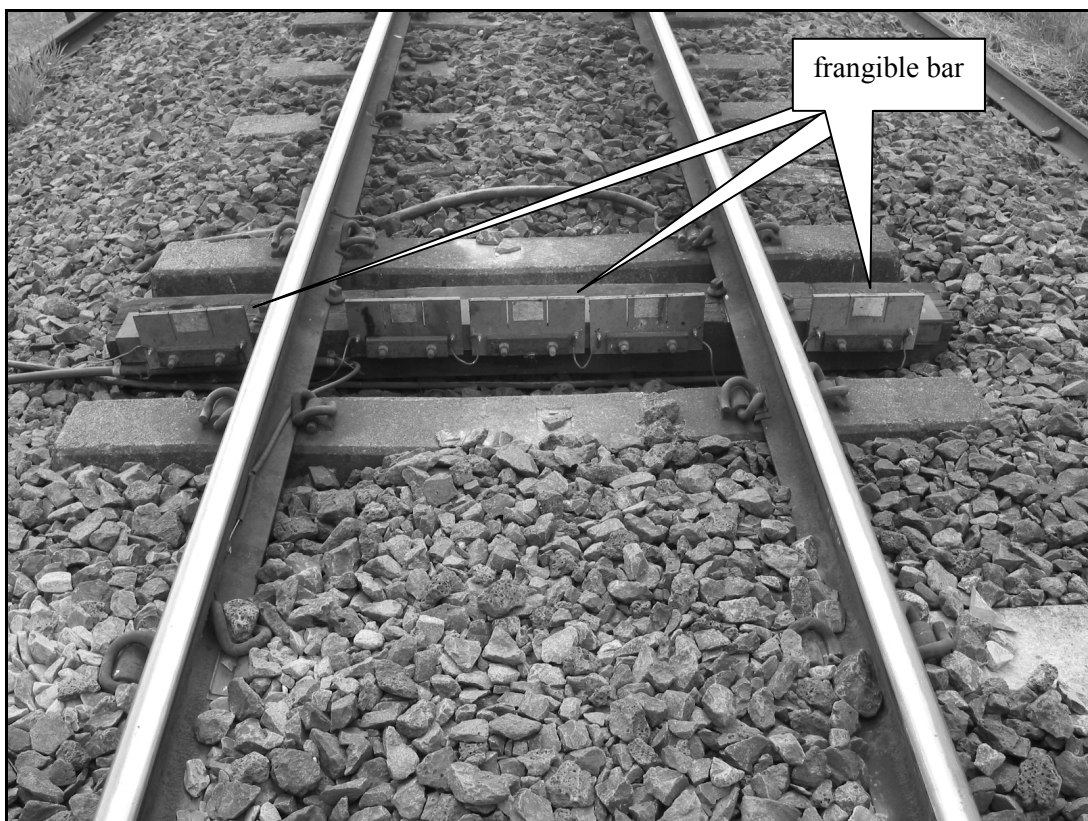
1.5.2 At the time of the incident, there were 16 stand-alone DED units and 3 combined Heat/DED units between Taumarunui and Hamilton. The closest DED south of Rukuhia was a combined Heat/DED unit located between Te Kawa and Te Awamutu, some 24.5 km before the POD (see Figure 6). The DED was operational when Train 220 passed over it, but no strike from dragging equipment was recorded.

**Figure 6**  
**Combined heat/dragging equipment detection unit located near Te Kawa**
