**Report 02-201**

**bulk log carrier**

***Jody F Millennium***

**grounding**

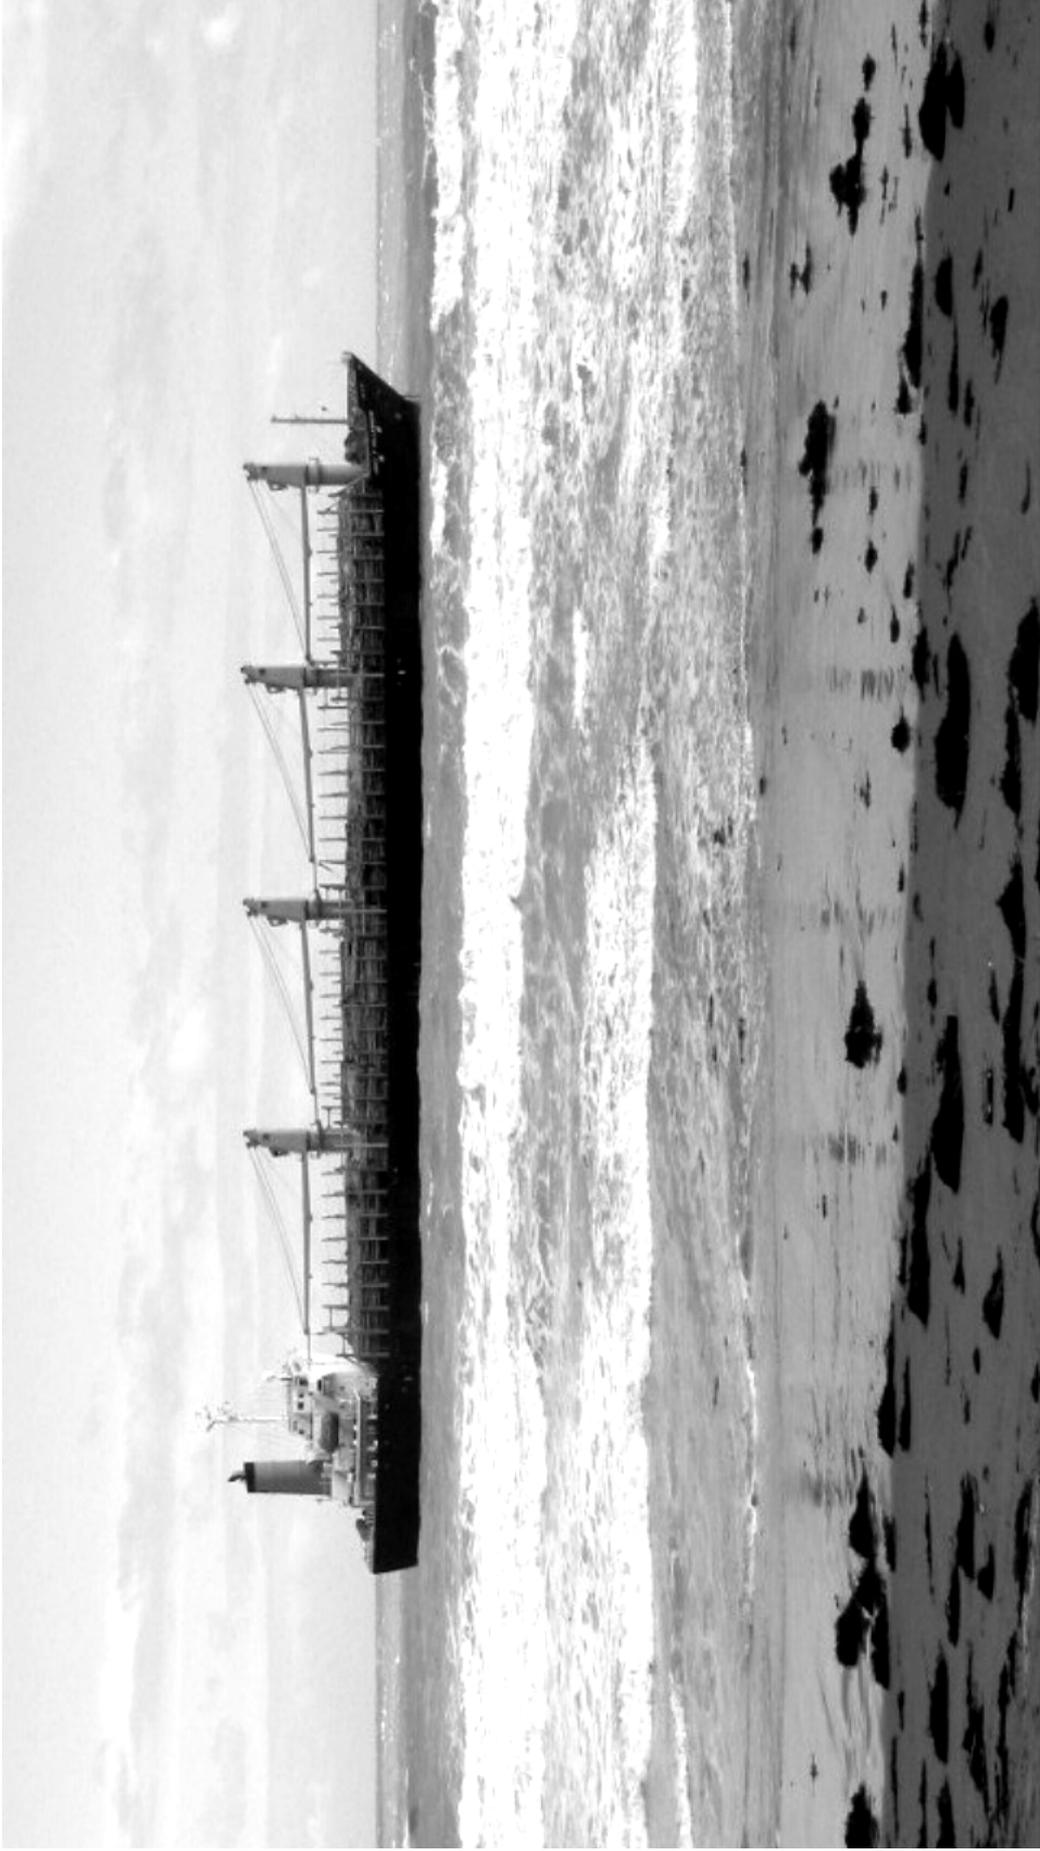
**The *Jody F Millennium* aground off Waikanae Beach - Gisborne**

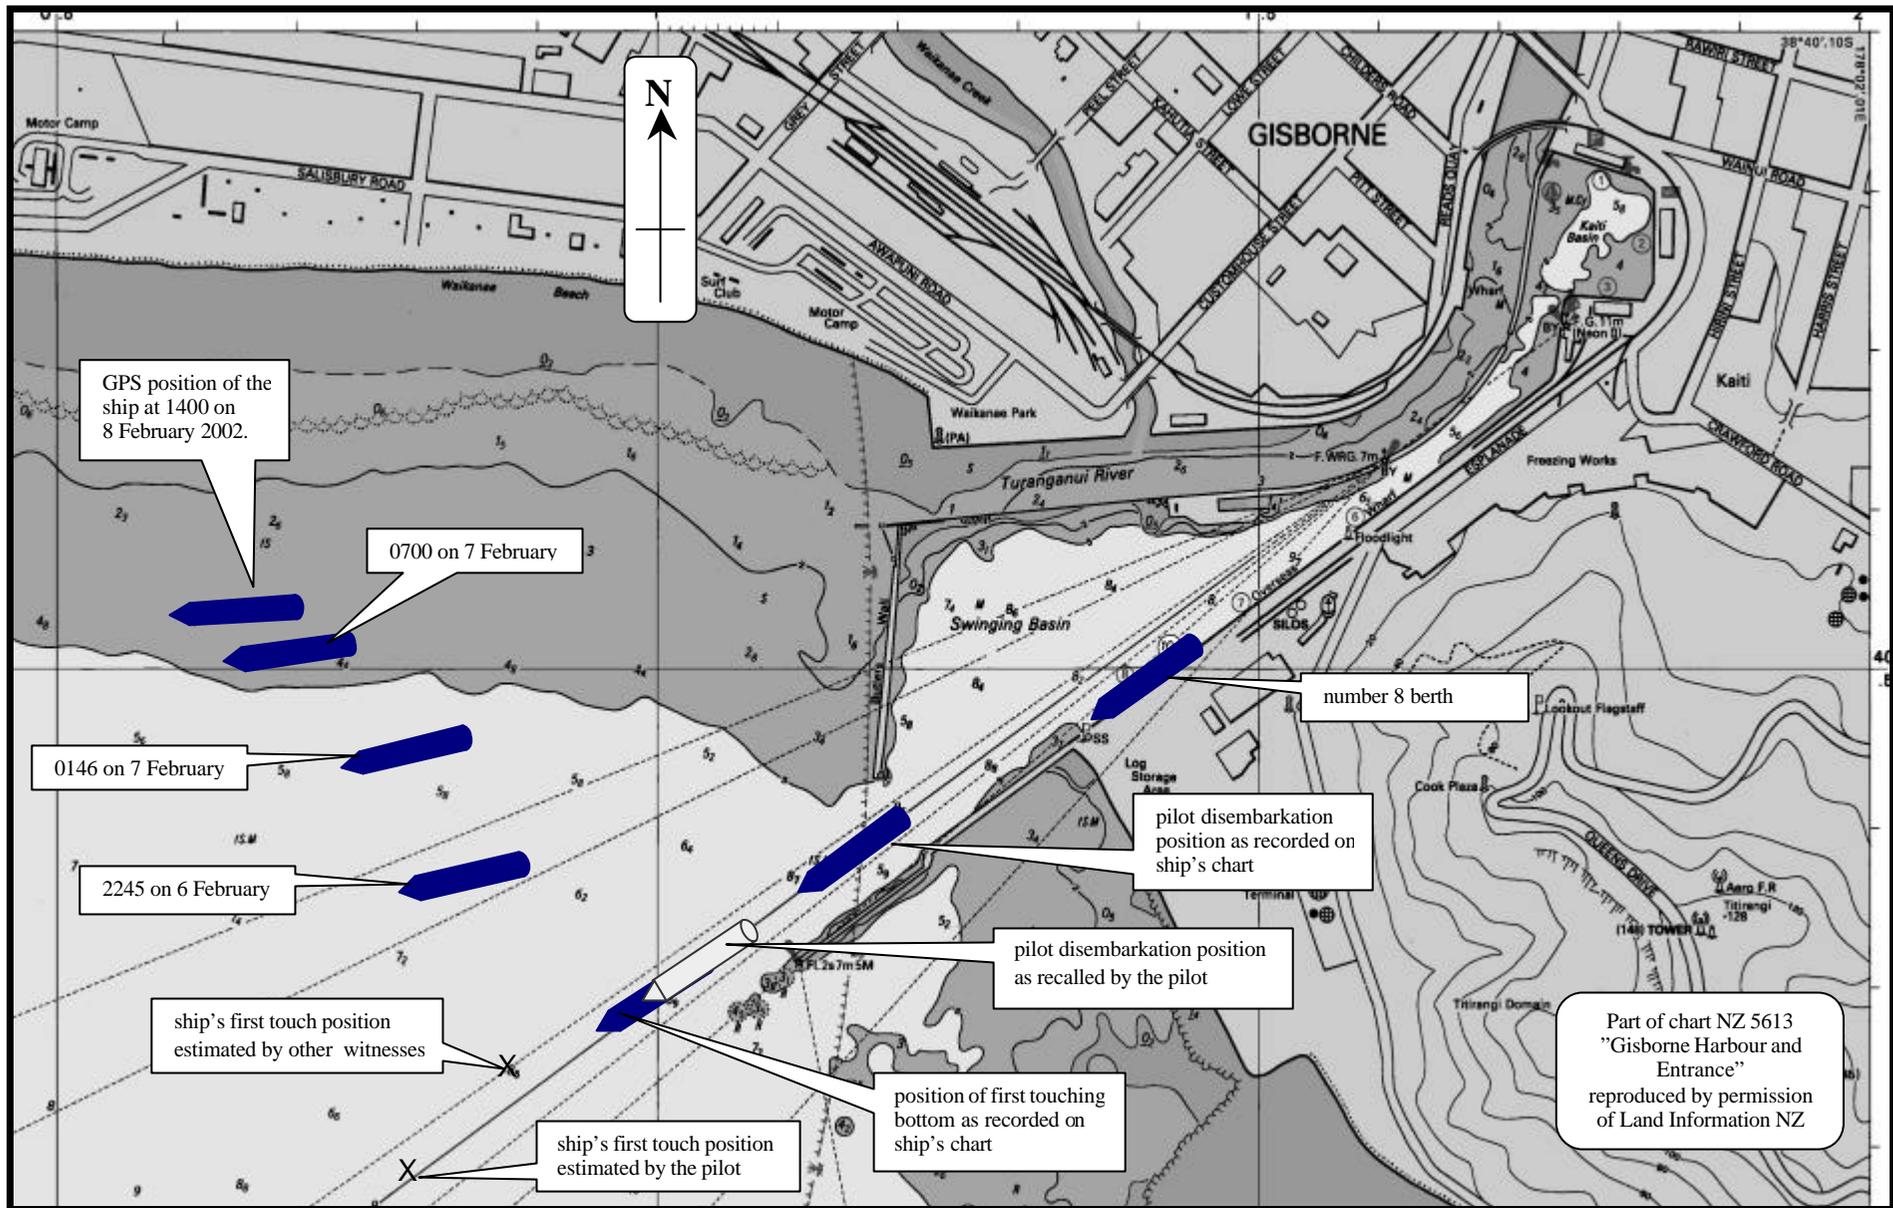
**Figure 1**  
***Jody F Millennium* estimated grounding positions**

- 1.1.20 At 2152, as the ship, on a course of 235° (T), emerged from behind the southern breakwater, a large swell struck the port shoulder of the ship pushing the bow to starboard and causing the ship to roll, first to starboard and then to port (see Figure 2, position 5). The master said he felt that the ship touched bottom forward, initially on the port side and then on the starboard, whereas the chief officer on the forecastle thought it had touched aft. The master increased speed and ordered the helm hard to port in an attempt to maintain position in the channel but the ship had lost forward momentum and was pushed by the wind and sea towards the starboard side of the channel.

- 1.1.21 Without sufficient forward momentum, the master was unable to steer the ship and it was driven further on to shoal ground outside the channel, despite attempts to free it using the main engine. The master informed the pilot, on the VHF radio, that the ship had grounded. The pilot suggested that the master put the engine astern, but when this was done, there was excessive vibration and so it was again stopped. The pilot instructed both tugs and the pilot launch to go out to the ship but owing to the weather conditions, which were observed by the pilot and service vessel crews to be 6-metre swells, they were unable to get alongside the ship and were unable to provide any effective assistance. The pilot suggested that the master drop the anchors. The master ordered the mate on the forecastle to let go the port anchor; this was soon followed by the order to drop the starboard anchor. Shortly after letting go the anchors, the forward crew had to abandon the forecastle because of waves crashing over the bow.

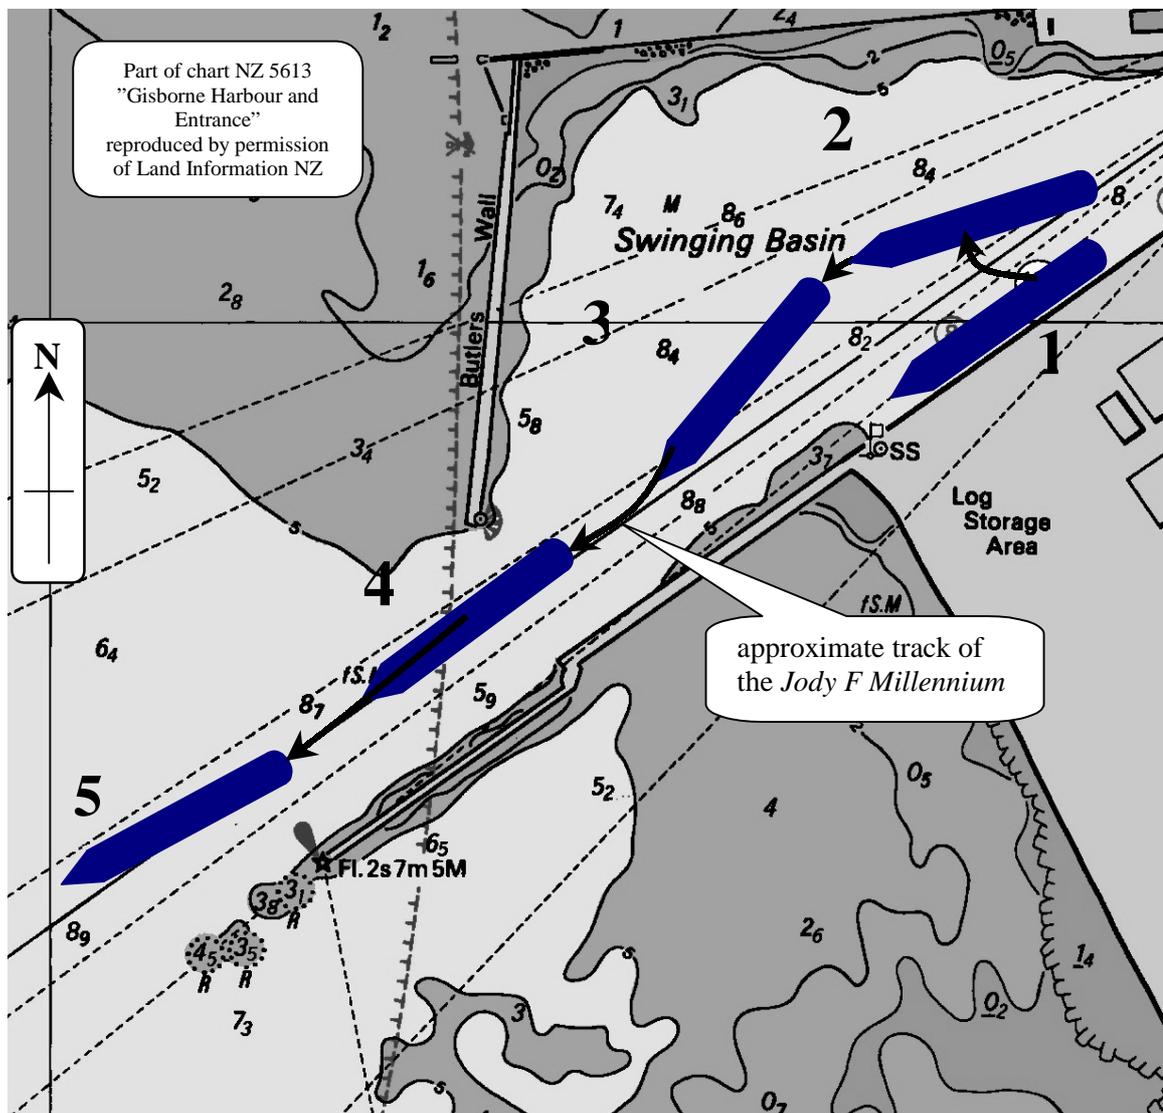
Figure 2  
Swinging basin and breakwater configuration showing approximate track of the *Jody F Millennium*

- 1.1.19 At 2146, the ship's engine speed was again reduced to dead slow ahead to enable the pilot to disembark. The time of the pilot disembarking was recorded in the bridge movement book as 2150, and a position noted on the chart alongside the end of Butlers Wall (see Figure 2, position 4). The pilot stated that he disembarked at the end of the southern breakwater. The pilot remained in the pilot launch, stationed on the leading line to watch the ship transit the approach channel, and ready to advise the master if required.

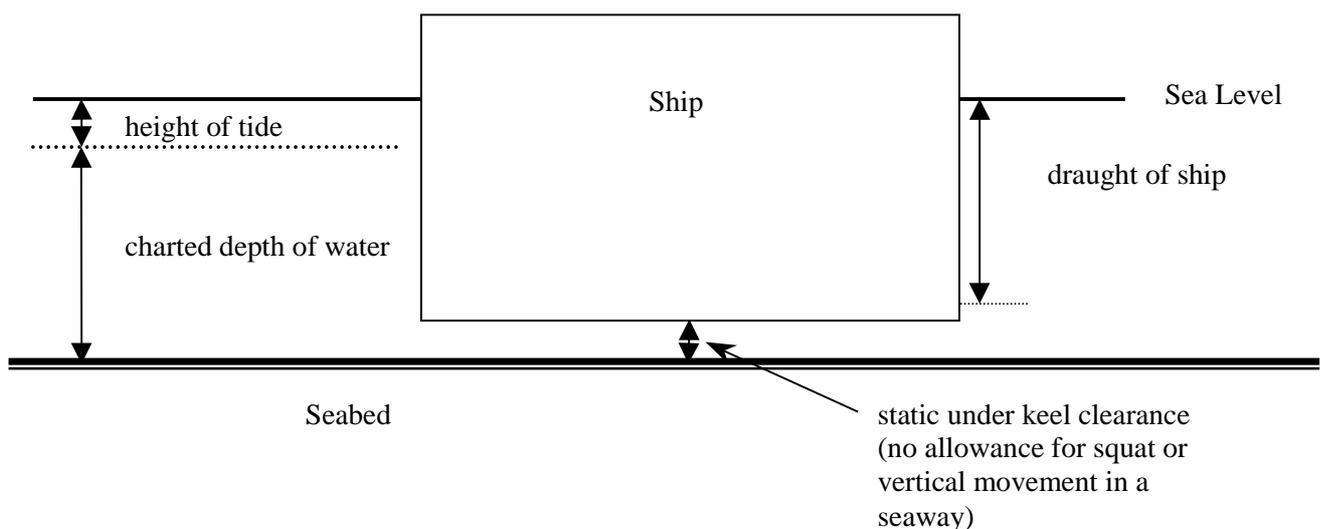
**Figure 5**  
**Illustration of determination of under keel clearance**

- 1.5.8 On its departure, the under keel clearance of the ship, using the draught observed by the chief officer and the pilot, and making no allowance for squat or vertical movement of the ship in the seaway, was:

plus	estimated minimum channel depth	10.0 m
		height of tide	0.8 m
			-----
		total depth of water	10.8 m
	minus	ship's maximum draught	9.5 m
			-----
		estimated under keel clearance	1.3 m

- 1.5.9 In a seaway, a ship is partially supported along its length by a number of waves and does not rise and fall the entire height of the waves. The loss of draught through sea and swell is estimated to be one third of the significant wave height. Estimates of the sea and swell height

were between 2 to 3 m and 6 m on the evening of the accident, an average of 4.25 m. Therefore, the estimated increase in draught due to the sea and swell would be 1.4 m. When applied to the under keel clearance, a negative 0.1 m clearance results.

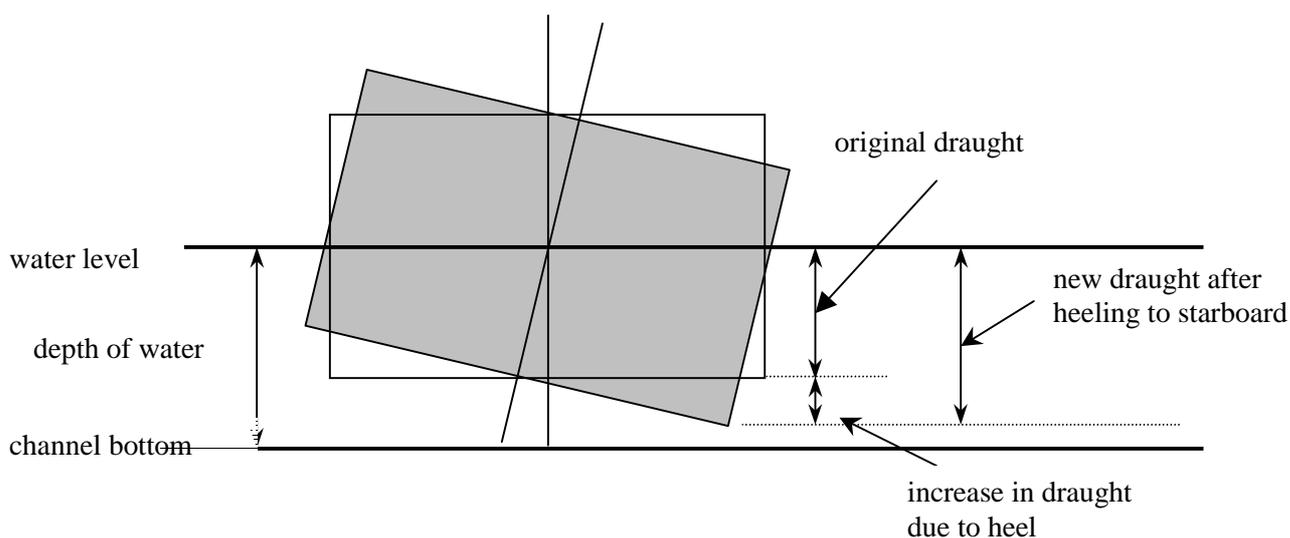
**Figure 6**  
**Illustration of increase in draught due to heel**

- 1.5.10 The pilot estimated that at the time of departure from the wharf, the swell was 2 to 3 m. Allowing a height of 2.5 m and a corresponding increase in draught of 0.83m, there would be an under keel clearance of only 0.47 m, less than 5 percent of the maximum draught.
- 1.5.11 Increases in the ship's draught could be expected due to squat and heel, further increasing the negative clearance. The increase due to squat is difficult to calculate and dependent on speed and vessel characteristics. Generally a master estimates the squat though experience with his vessel. At the speeds used, squat would be minimal. The increase in draught due to heel however is more easily calculated. An angle of heel of 5 degrees would increase the draught of the *Jody F Millennium* by almost a metre.

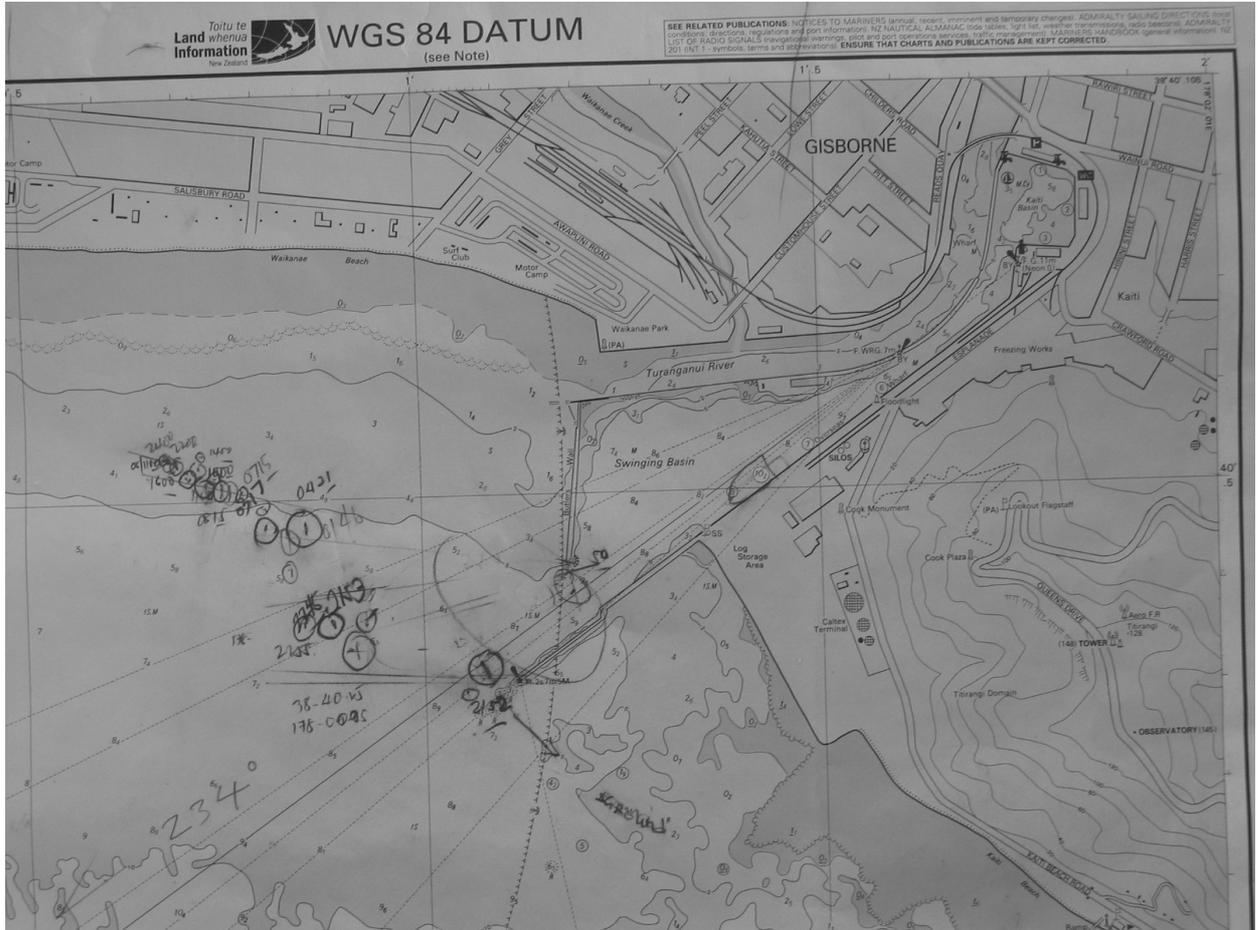
**Figure 7**  
**Photograph of part of the ship's navigational chart (NZ 5613) showing positions and times as recorded by ship's crew**

- 1.7.4 The pilot was under the impression that the time elapsed between him disembarking and the call from the master was considerably longer than that estimated by the other witnesses. Consequently, his estimation of the ship's position at the time of grounding was further down the channel in a position 510 m bearing 242°(T) from the southern breakwater light.

- 1.7.5 The estimated position of the ship by both the pilot and the majority of the other witnesses was based on the time the master informed the pilot that the ship had grounded. The call was overheard by the crews of the pilot launch and the tugs, and by the lines gang supervisor. However, immediately after first touching bottom, the master spent several minutes taking corrective action attempting to regain control of the ship before he called the pilot.

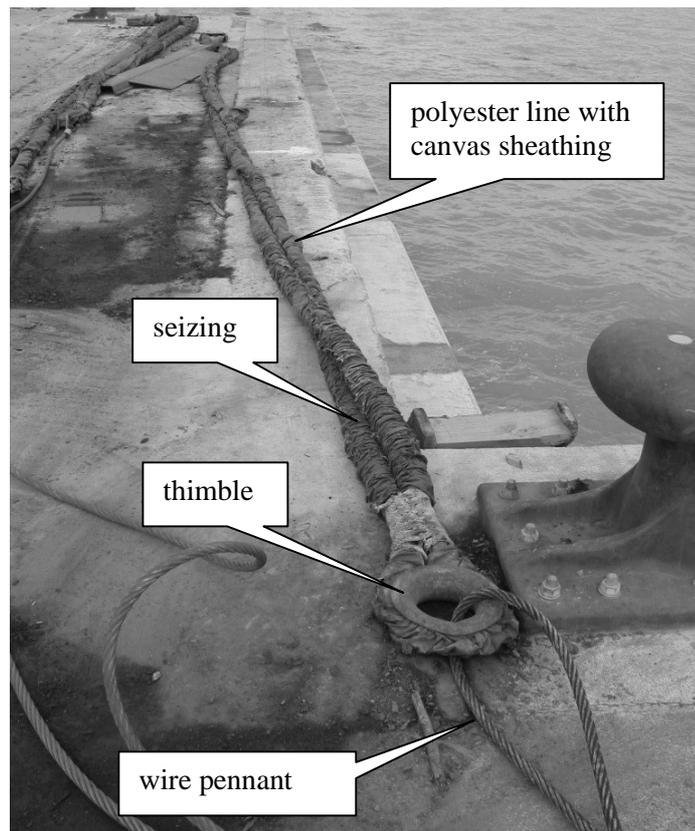
**Figure 9**  
**Shore mooring line**

- 1.5.5 Of the total of 8 shorelines that parted, 5 parted at the wire and 3 parted at the lanyard. The hull of the ship was pounding against the wharf fenders with the potential for damage to both the ship and the wharf. In light of the foregoing, the pilot thought that the only possible solution to prevent damage to the ship or wharf, or possible injury to the personnel, was for the ship to sail into the bay, anchor and wait until the conditions improved. The ship's agent communicated this decision to the master, who thought that this decision was an order from the port authorities to leave the berth. However, the master later said that he could see no alternative to leaving the berth and was also concerned that he would be held responsible for any damage to the port facilities had he remained alongside in contravention of this perceived order.

- 1.9.4 Shore moorings were a combination of a 32 mm 9x16 steel core wire pennant, a spring of 80 mm polyester rope and 40 mm lanyards. Wire was used at the shipboard end because of its resistance to chafe, which occurred where the wire passed through the shipside fairleads. Wire is strong but has little elasticity; the polyester rope spring was attached to compensate for this lack of stretch. The polyester line was formed of a continuous loop that was seized around large thimbles at each end, and at one-metre intervals along its length. To reduce general wear and tear and to help minimise actinic degradation, a canvas sheath covered the polyester line. The thimbles were fitted at each end of the polyester rope loop to prevent chafe between the wire and the rope at one end and to allow the free passage of the multiple parts of the lanyard at the other. The lanyard was used to tighten the mooring system; it was rove around one of the shore bollards and through the thimble, and tensioned using a small tractor.

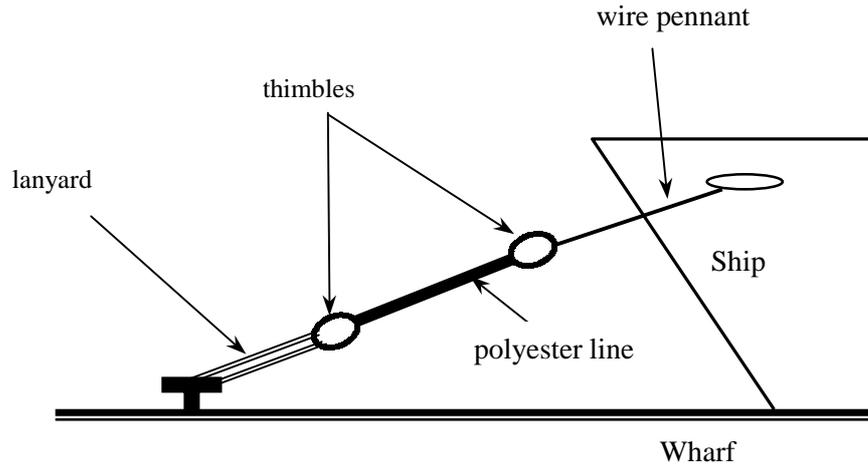
**Figure 10**  
**Shore mooring line configuration**

- 1.9.5 When a ship was being made fast, tractors tensioned the forward and aft shorelines, simultaneously heaving on the lanyards to ensure they had equal weight on them before the lanyards were secured to the wharf bollards. Tension on the mooring lines counteracted the effect of the swell, surge and wind and helped to minimise the ship's movement up and down the wharf. During the time a ship remains alongside a wharf it rises and falls with the tide and its waterline changes with cargo and ballast loaded and unloaded. The tension on the mooring lines changes as the height of the ship changes in relation to the wharf. On 5 February, the shore mooring gang supervisor called 2 of his men to tension the shore moorings on the *Jody F Millennium*.

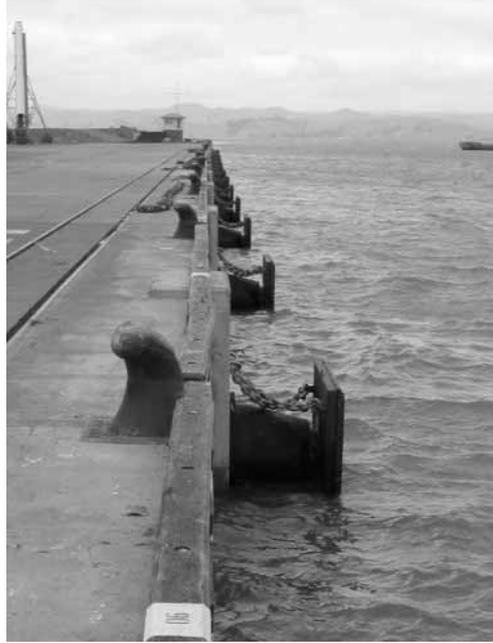
**Figure 11**  
**Fendering at number 8 wharf**

- 1.9.9 Large, sprung, flat-faced fenders protected number 7 and number 8 wharves. The outer face of the fender was constructed of a hard, rubber-like composition that, although providing protection for the wharf and ship, allowed the ship to slide across the face of the fender. Spring was provided by large rubber mountings which compressed to absorb the lateral energy of a ship when it bounced against the fender.
