MARINE OCCURRENCE REPORT

02-203

Harbour tug *Purau*, loss of control and grounding, Lyttelton

1 March 2002

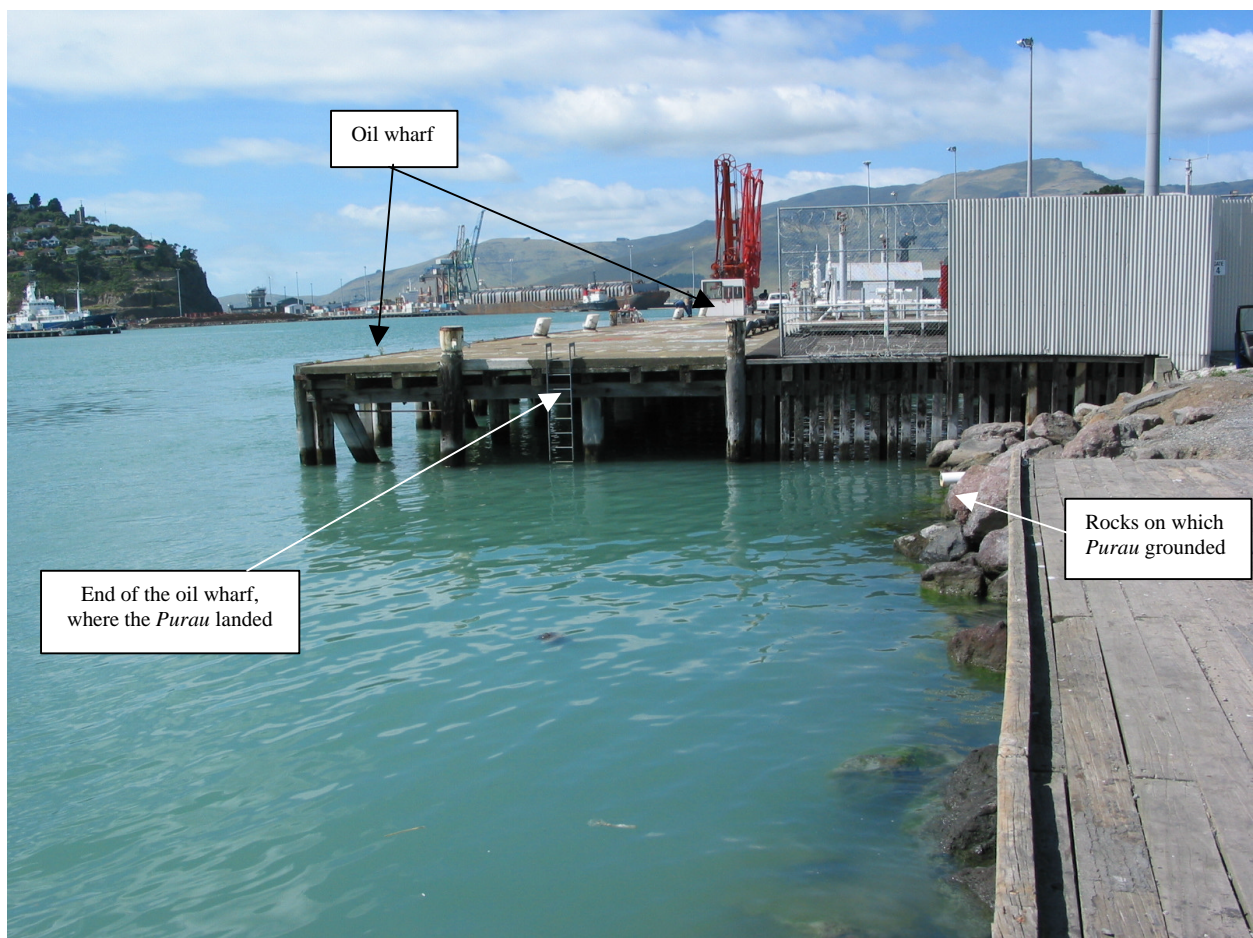
Figure 2
View of the end of the oil wharf showing where the tug *Purau* grounded

- 1.6.1 There was a spring tide at the time of the accident. Low water was predicted at 1310, with a height of 0.1 m above chart datum. It was noted by a number of the witnesses that the water level was particularly low at the time of the accident.
- 1.6.2 The wind was north to north-east at about 10 knots, with a rippled sea and no swell. The weather was generally fine.
- 1.6.3 Rocks removed from the port’s bulk coal facility had been tipped along the shore on the western side of the oil wharf, which created the steep rocky shoreline. Following the accident, the port company sounded the area and confirmed that the bottom rose uniformly and steeply from a depth of about 6 metres to the waterline, in a gradient similar to that shown above the waterline in Figure 2.

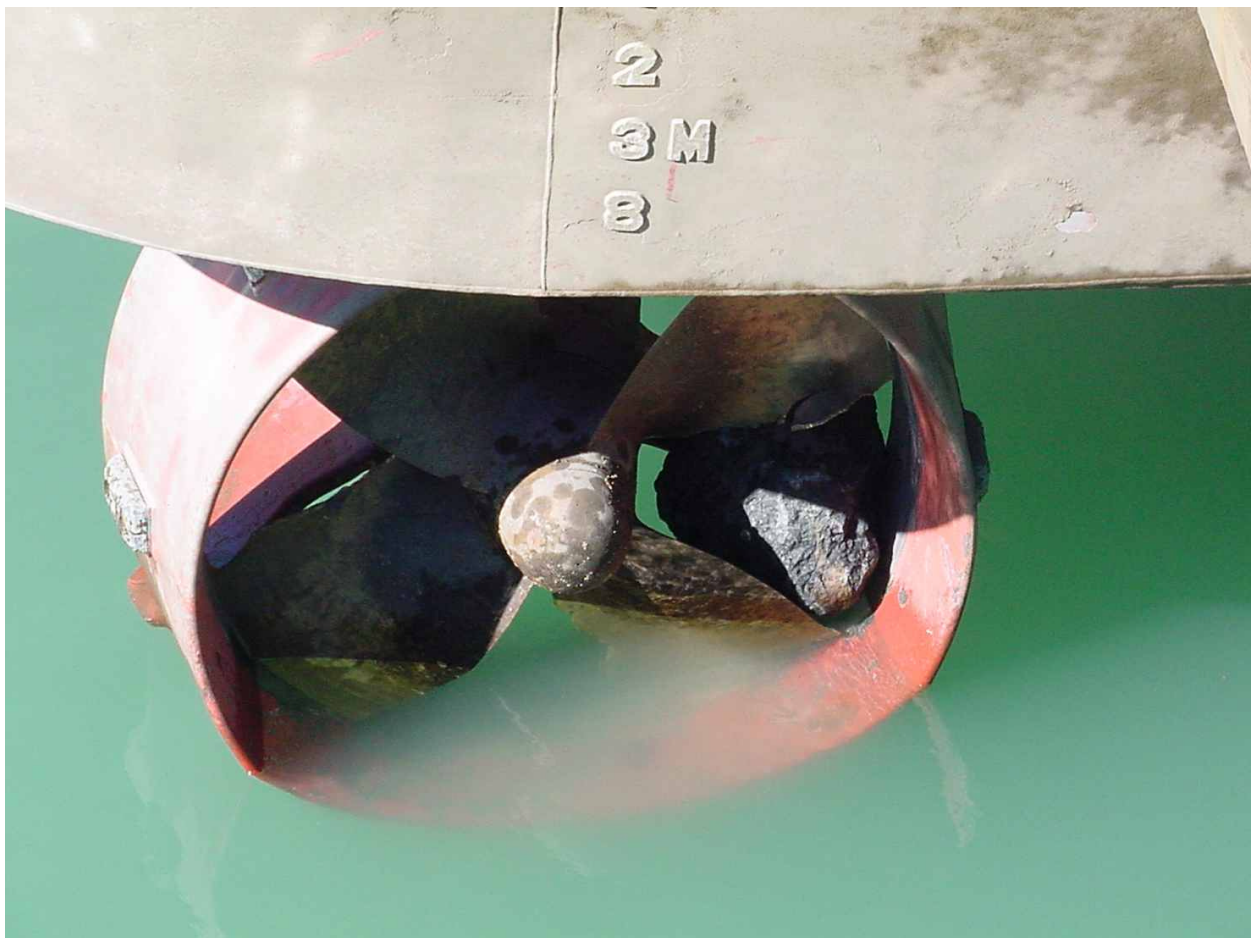
- 1.1.12 Divers inspected the *Purau* later that day and found a large rock stuck in the starboard nozzle and significant damage to the starboard propeller blades (see Figure 3). The tug was dry docked the next day.

Figure 3
Starboard unit showing the rock jammed in the propeller

- 1.5.1 For clarity, positions on the nozzle refer to the unit when it is in the fore and aft line and is thrusting water astern and propelling the tug ahead. When examined in dry dock, the whole circumference of the inner plating of the starboard nozzle had been stripped of paint in way of the propeller and there were scratches that radiated outwards on the paint remaining on the thrust side of the nozzle. The damage on the outside of the starboard nozzle was limited to the lower outboard side of the propeller drive boss and the lower outboard nozzle stay on the suction side of the nozzle. The leading edges of the starboard propeller blades were deeply serrated. The port nozzle outer plating on its inboard side had deep scratches and a sacrificial anode had been torn off. The propeller blades had minor nicks along their leading edges but these might have been pre-existing damage. There was no evidence on the port nozzle that rocks had passed through it.

- 2.12 The damage sustained to the starboard propeller and the rock found lodged in the nozzle would indicate that the propeller was rotating on grounding. Had the engine been de-clutched, it would not have stalled.

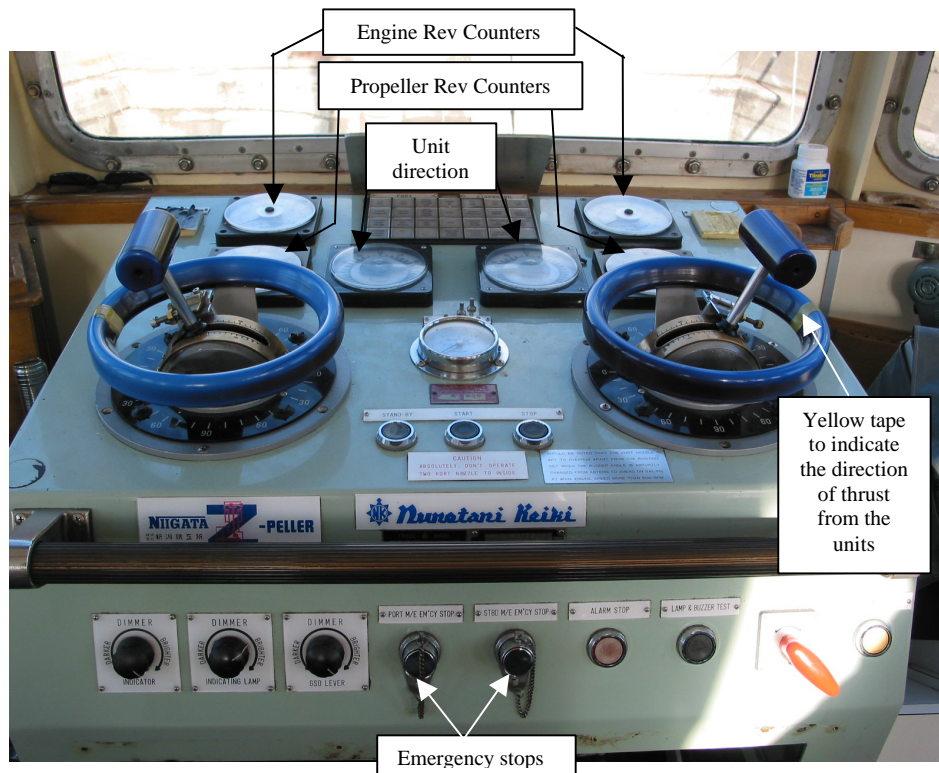
Figure 4

The control console of the *Purau* showing the speed control levers on the stops and the wheels opposed. The thrust from each unit is outwards on its respective side

1.2.5 The steering control for each unit was via a hand wheel on the respective side of the bridge console (see Figure 4), which controlled the direction of the azimuthing nozzles. The engine speed control was a “T” shaped lever in the centre of the steering control wheel. With the units set to propel the tug ahead, the speed control lever was pushed away from the operator to increase the engine speed. The graduations on the speed control lever were:

- 1.2.12 The speed control levers on the *Purau* were free and easily moved. If knocked, they were able to pass the detent at “0” and the momentum of the lever carried it through the whole range of the throttle setting to 10, assisted by the weight of the “T” shaped handle.

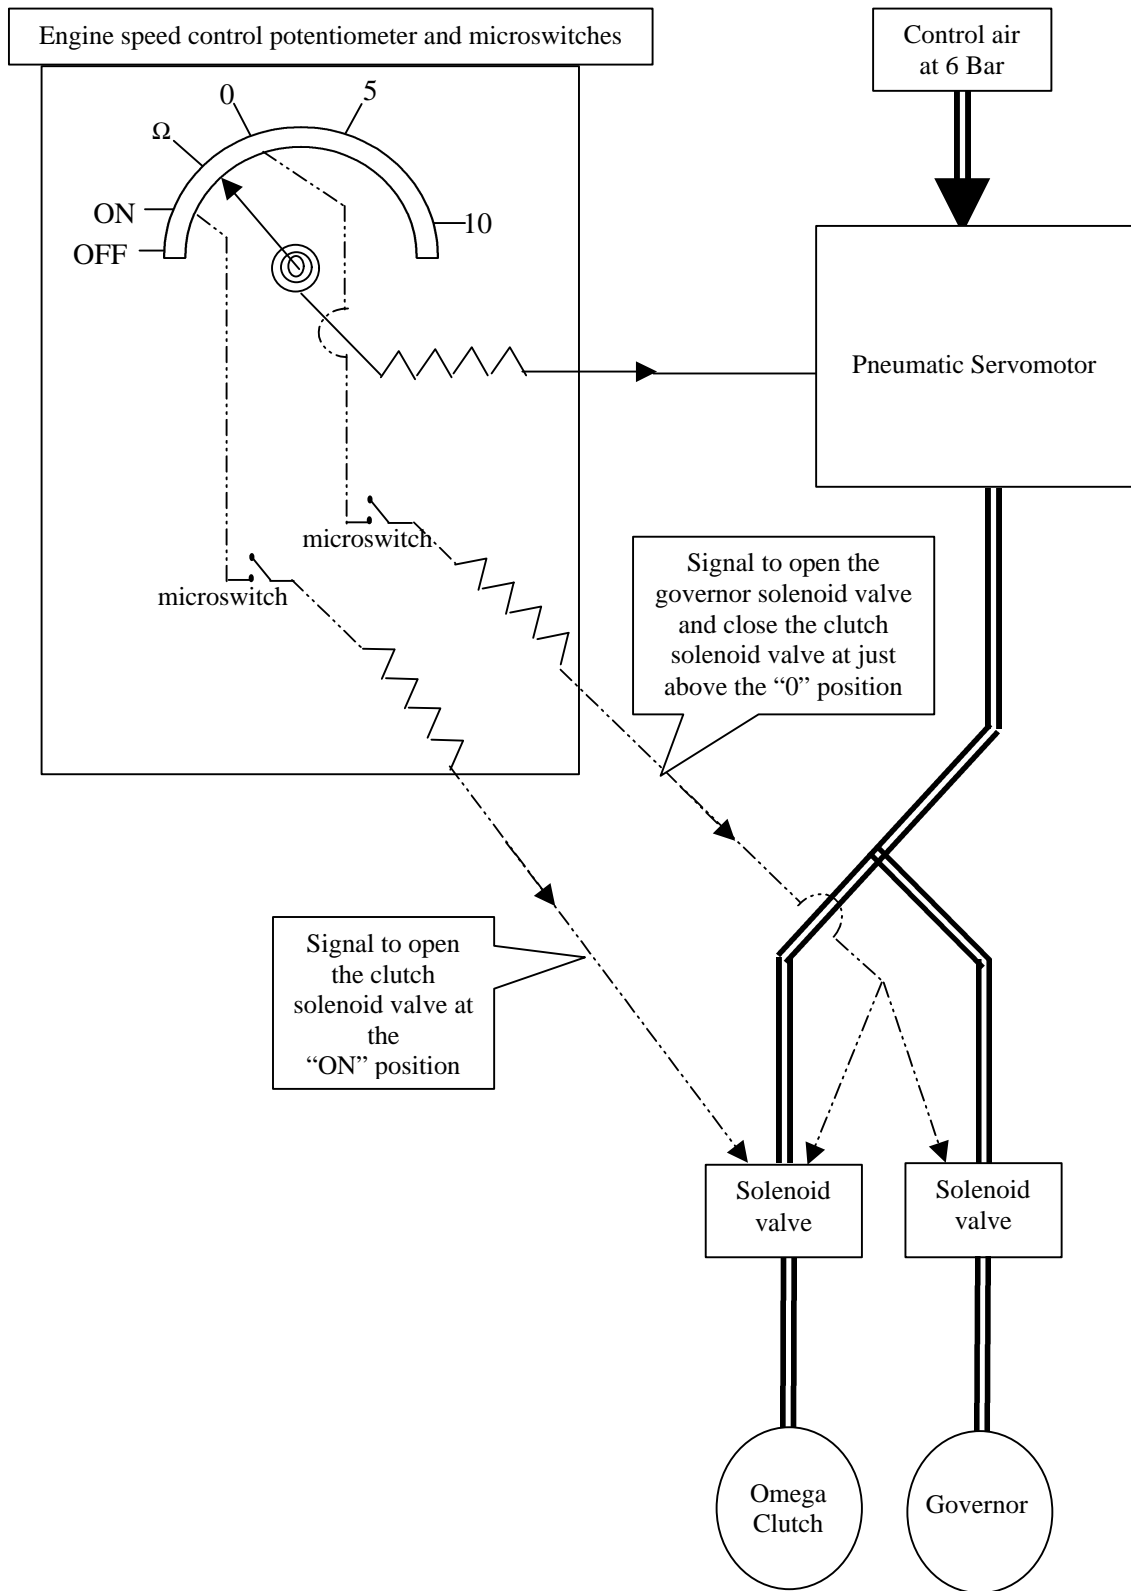
Figure 5
Schematic of the electronic/pneumatic control system for the *Purau's* Omega clutch and governor

1.2.7 If there was a disruption in the supply of control air after the first microswitch had engaged, the clutch would default to fully engaged and the engine would remain at, or if it was above the “0” position, reduce to the idle revolutions setting of 400 rpm. There was no evidence that there was a failure of the control air during this accident.

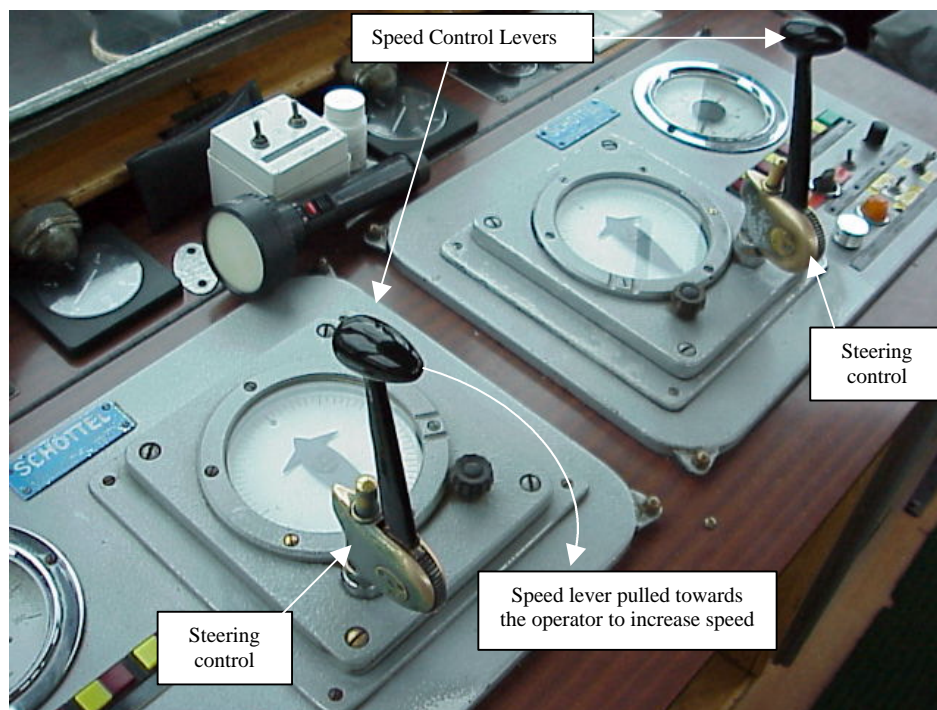
1.2.9 The other port company tug, the *Godley*, was also fitted with ASD units. Its steering and speed controls were brass ship-shaped knobs located on the bridge console (see Figure 6). These controlled the direction of each of the azimuthing nozzles to provide steerage and manoeuvrability of the tug. The engine speed control was a lever extending up from the aforementioned brass knob. With the units set to propel the tug ahead, the speed control lever was pulled towards the operator to increase the engine speed; the opposite direction to that on the *Purau*.

Figure 6
Controls of the *Godley* with the thrust from each unit astern i.e. the tug moving ahead and the speed control levers on idle
