M A R I N E O C C U R R E N C E R E P O R T

02-208

bulk carrier *Westport*, collision, Onehunga, Manukau Harbour

21 November 2002

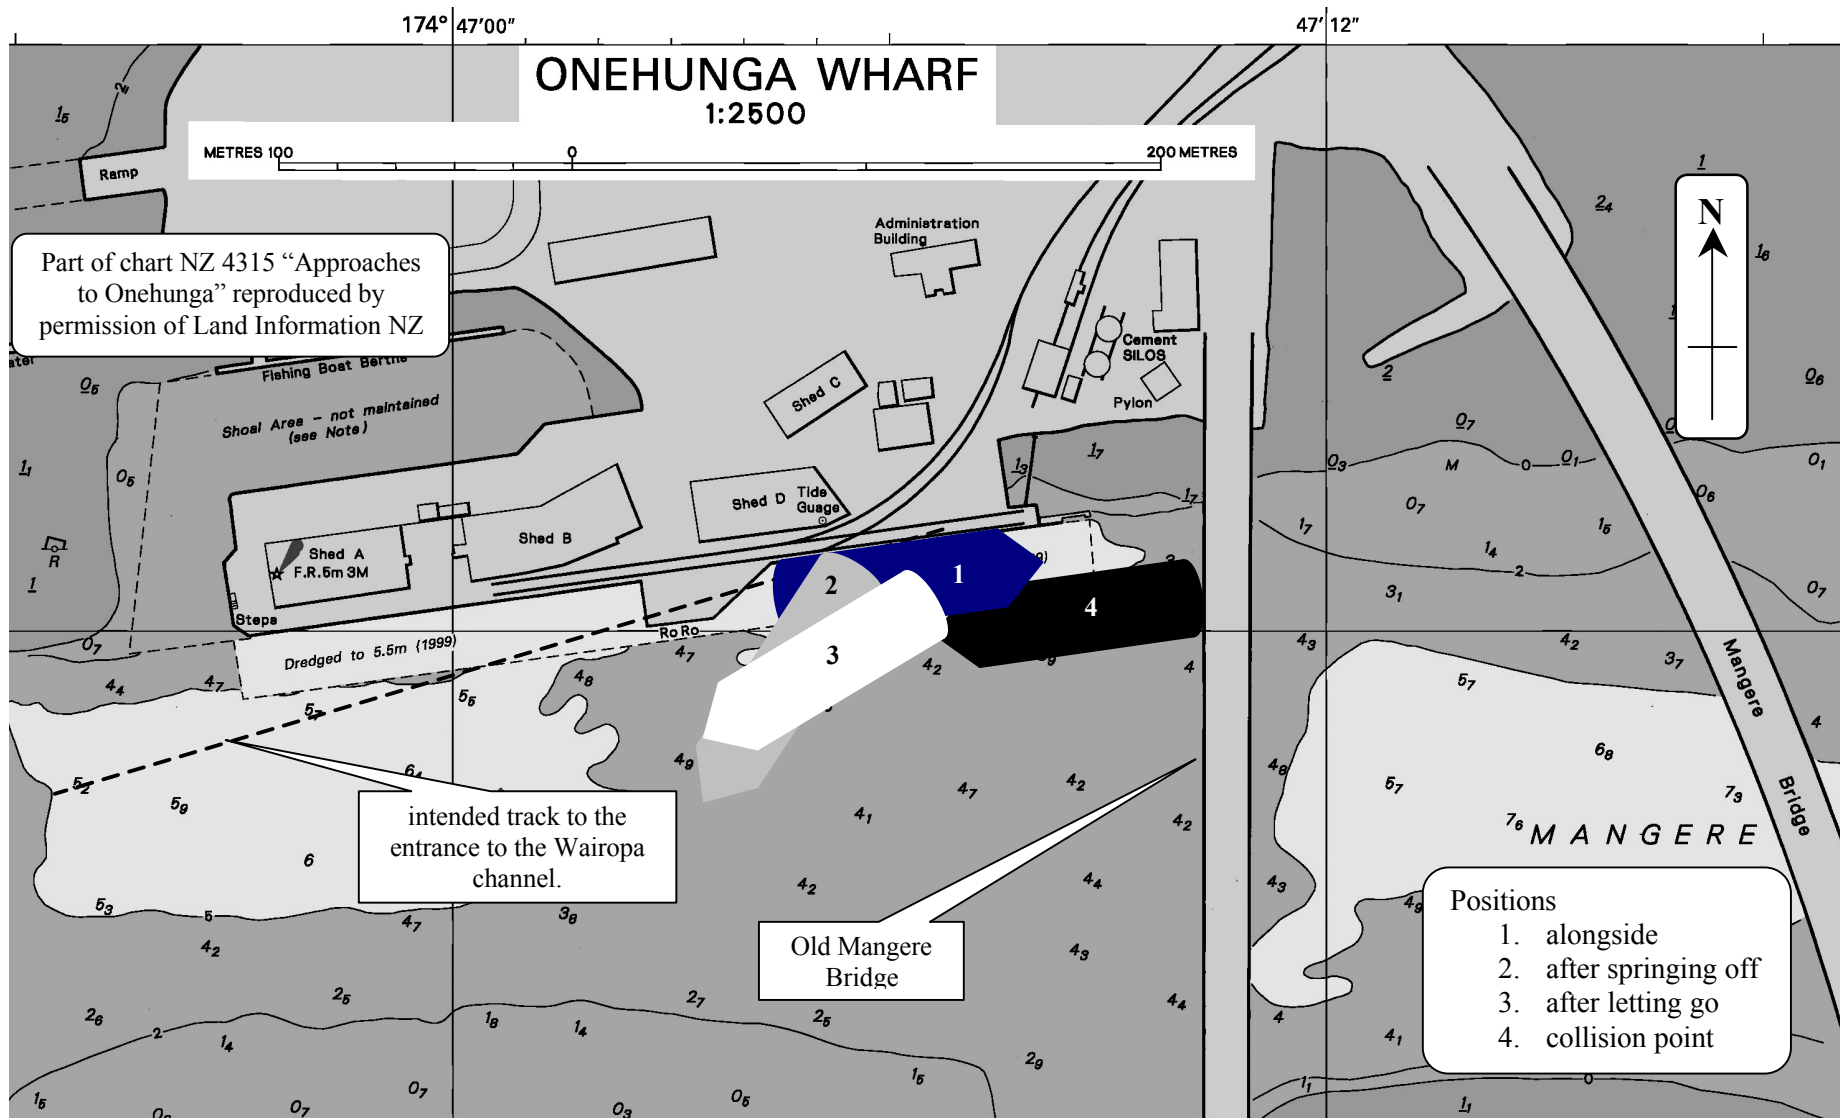
Figure 1
The approximate positions of the *Westport* during un-berthing

- 1.1.9 When the ship had swung through about 140°, the master ordered the back spring to be let go and engaged the propeller to "pitch 3" ahead (refer Figure 1, positions 2 and 3) with the intention of moving away from the berth and into the approach channel. The master ordered the helmsman to line the ship up with the centre of the channel.

- 1.1.13 The ship continued to gain momentum astern and at about 0938 on 21 November 2002, it collided stern first with the Old Mangere Bridge in the region of the second pier (refer Figure 1, position 4).

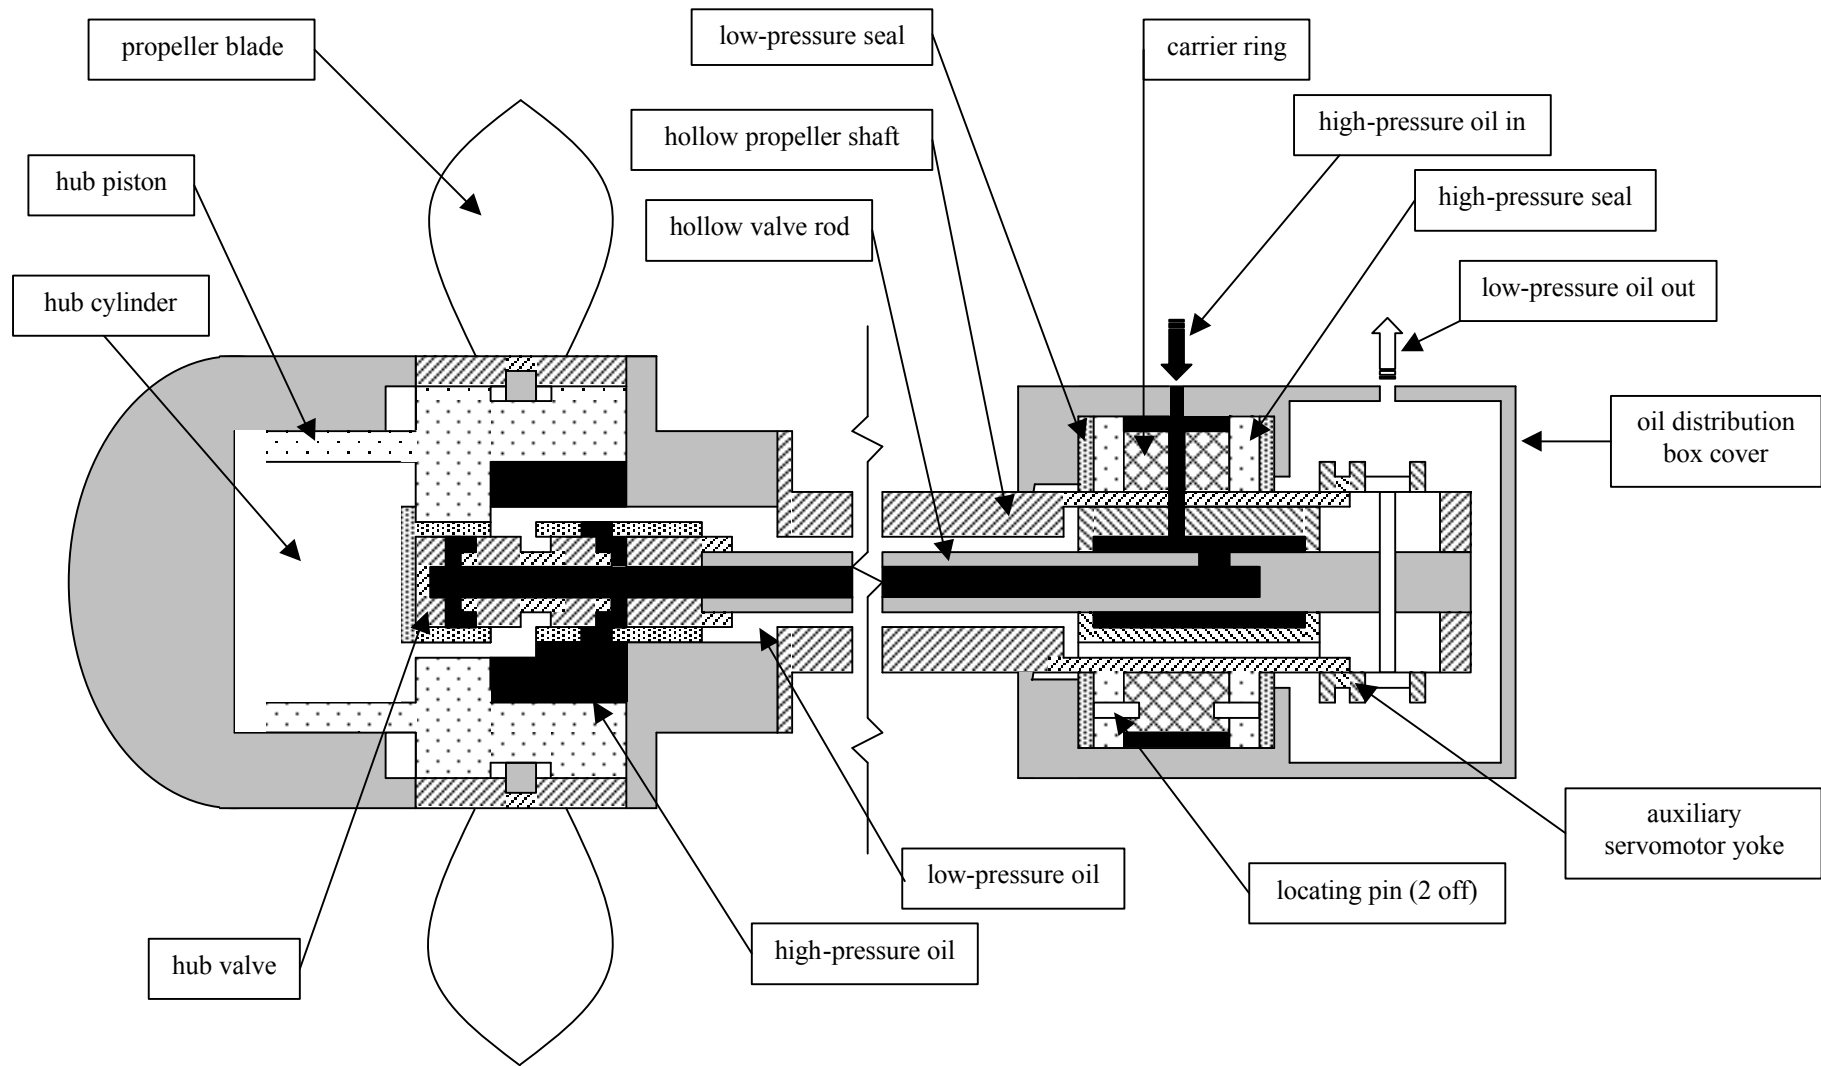
Figure 3
Diagram of controllable pitch propeller and oil distribution box, not to scale, simplified and expanded for clarity

- 1.4.3 The propeller comprised of 4 blades each bolted to the propeller hub. Inside the propeller hub there was a piston, which turned the blades to the required pitch setting (refer Figure 3).

- 1.4.4 The piston was moved when high-pressure oil flowed to either side of the piston. A directional valve in the hub controlled which side of the piston the high-pressure oil was fed to. The hollow valve rod from the oil distribution box controlled the movement of the valve (see Figure 3).

- 1.4.5 High-pressure oil entered a pressure chamber formed by the space between 2 high-pressure sealing rings in the oil distribution box. From here it flowed through a hole drilled in the propeller shaft, through the sleeve for the valve rod, into the hollow valve rod and thence to the hub. The lower pressure return oil flowed through the hollow propeller shaft outside of the valve rod back to the oil distribution box, and into a collection tank (see Figure 3).

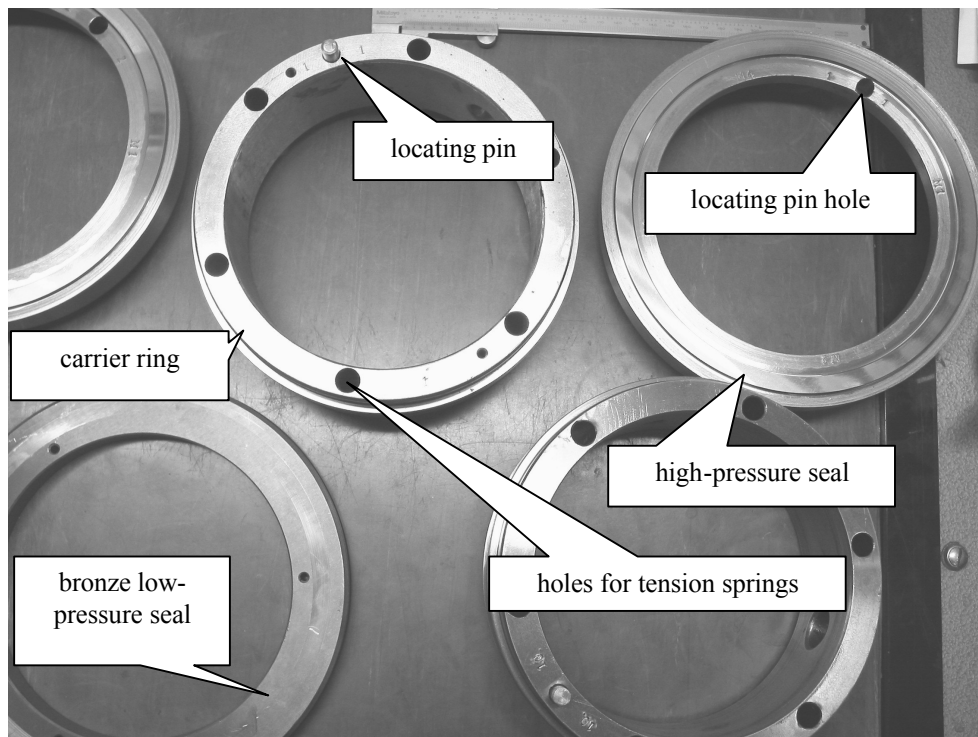
Figure 4
High-pressure oil seal components

- 1.4.12 The pressure chamber was formed by the space between the 2 metal high-pressure seals, which were kept apart by means of a carrier ring that was fixed to the outside of the propeller shaft. The carrier ring had a radially bored hole for the high-pressure oil to pass through, a series of 6 axial holes drilled through it for the expansion springs that held the 2 seals apart assisting the seal to form with constant tension, and a locating pin on each face, which locates the metal seals in place and ensures rotation with the shaft (refer Figures 3 and 4).

- 1.4.13 On the inner face of each high-pressure metal seal was a groove to locate the springs and an axially bored hole to accept the locating pin.
- 1.4.14 The high-pressure white metal seals bore onto bronze high-pressure/low-pressure seals, which fitted against the oil distribution box casing and were designed not to rotate. A low-pressure 'O' ring seal was fitted to the circumference of the bronze seal.

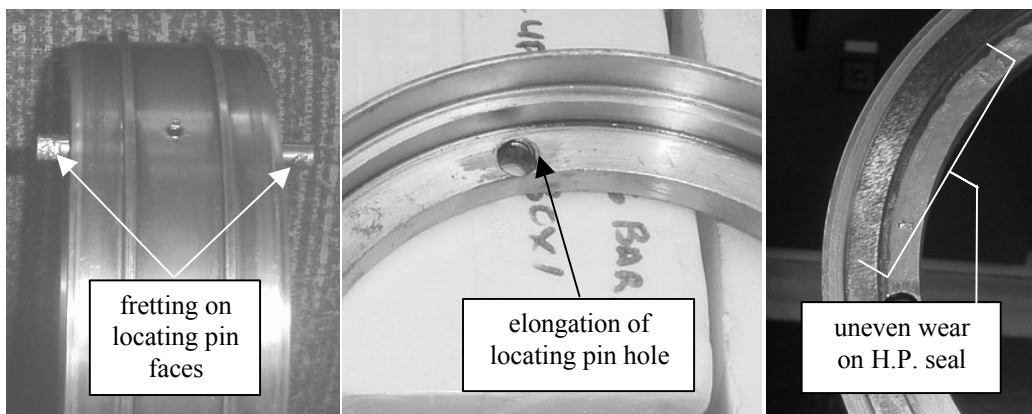
Figure 5
Examples of damage to seals and carrier ring

- 1.6.2 Polished wear marks on the outer face of the after static bronze seal ring indicated that it had possibly rotated in its housing.
- 1.6.3 Unusual wear patterns on the inner faces of both static bronze seal rings indicated minimal mechanical contact between them and the white metal sealing rings.

- 1.6.4 The hole for the locating pin on the forward high-pressure seal was elongated and a slight step had formed inside the hole. Both locating pins on the carrier ring showed signs of excessive wear and fretting on their faces. On examination it was possible to get the locating pin on the seal carrier to become lodged against the step causing the seal to adopt a small cant in its housing and thus not form a perfect seal.

- 2.12 The cant of the high-pressure seal introduced by the locating pin lodging on the small step and the uneven wear on the bronze seal faces were indicative of a probable small gap or incorrect seal contact between the components. Even a very small anomaly would have been enough to allow a loss of high-pressure oil through the seal, effectively bypassing the hub servomotor.

- 2.15 The small step in the locating pin recess was possibly formed at the time of re-assembly in 1997. For such damage to occur it is likely that the components of the seal were assembled with undue force. The step probably contributed to the failure sequence.

- 1.6.5 A complete new seal and seal carrier unit was installed in the oil distribution box and the system extensively tested. A range of pressures and temperatures were taken while the system was connected to the engines. The pressure for given movements from zero to 5% ahead or astern was 80 bar [8.0 MPa], whereas prior to the accident it had been reported as being 55 bar [5.5 MPa]. Due to the disparity in the 2 pressure readings, technical advice was sought from the KaMeWa office. The manufacturer suggested that the expected pressures in the system for these movements should be about 83 bar [8.3 MPa] but 80 bar [8.0 MPa] was considered to be acceptable.

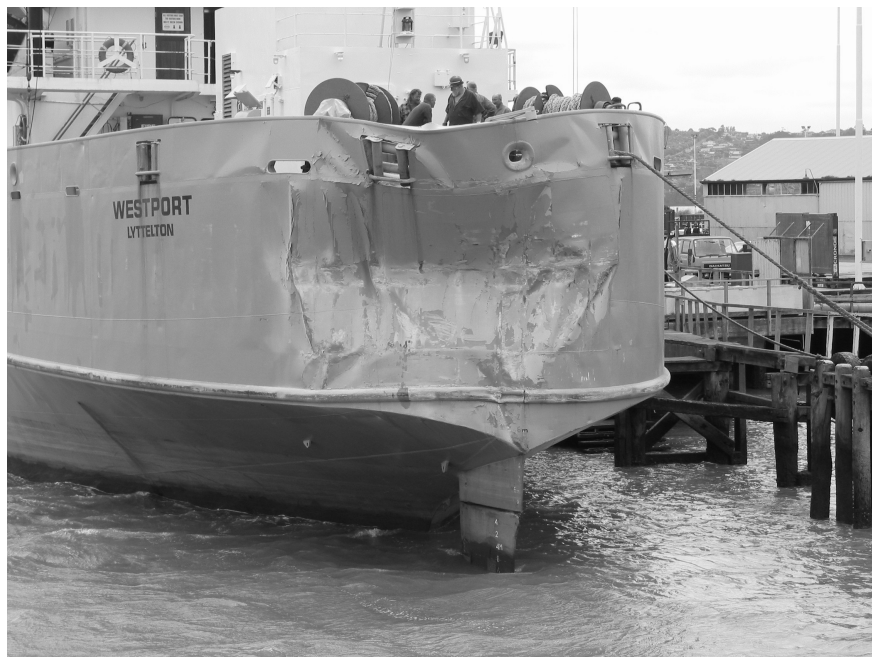
Figure 6
External damage to stern of *Westport*

- 1.9.1 The damage to the *Westport* was extensive but mainly restricted to the stern of the ship (see Figure 6).
- The shell plating in way of the port and starboard fresh water tanks, situated at the stern below the steering flat, was ruptured and the internal frames were buckled and torn.

- The after store steering space deck, shell plating and supports were buckled and torn. The aft upper deck and bulwarks were set up and buckled.
- The port after winch motor was torn off and the steering gear motors were displaced.
- The hydraulic motors for the steering gear were displaced.

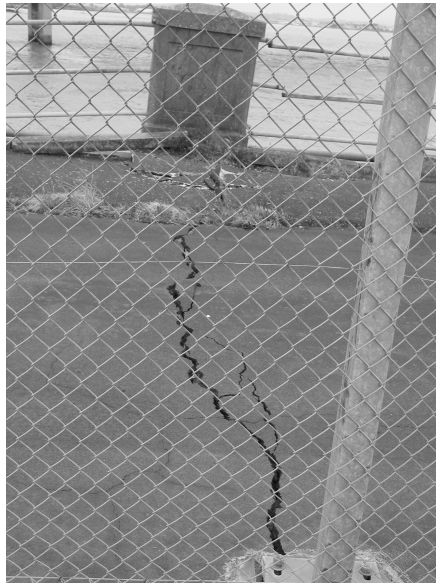
Figure 7
Damage to the old Mangere Bridge in the area of the second pier

1.9.2 The damage to the old Mangere bridge was extensive (see Figure 7):

- The second pier from the north abutment was pushed sideways by 500 mm and was badly cracked at both ends.
- The third pier from the north abutment suffered only minor damage, as did the north abutment.
- The outer beams on both sides of the bridge were damaged
- The decks and footpath of the bridge were cracked over a distance of 20 m.
- The safety handrail was also extensively damaged at the point of impact.
