AVIATION OCCURRENCE REPORT

03-001

Kawasaki BK-117 helicopter ZK-III, collision with tree tops at night, Tararua Range

14 January 2003

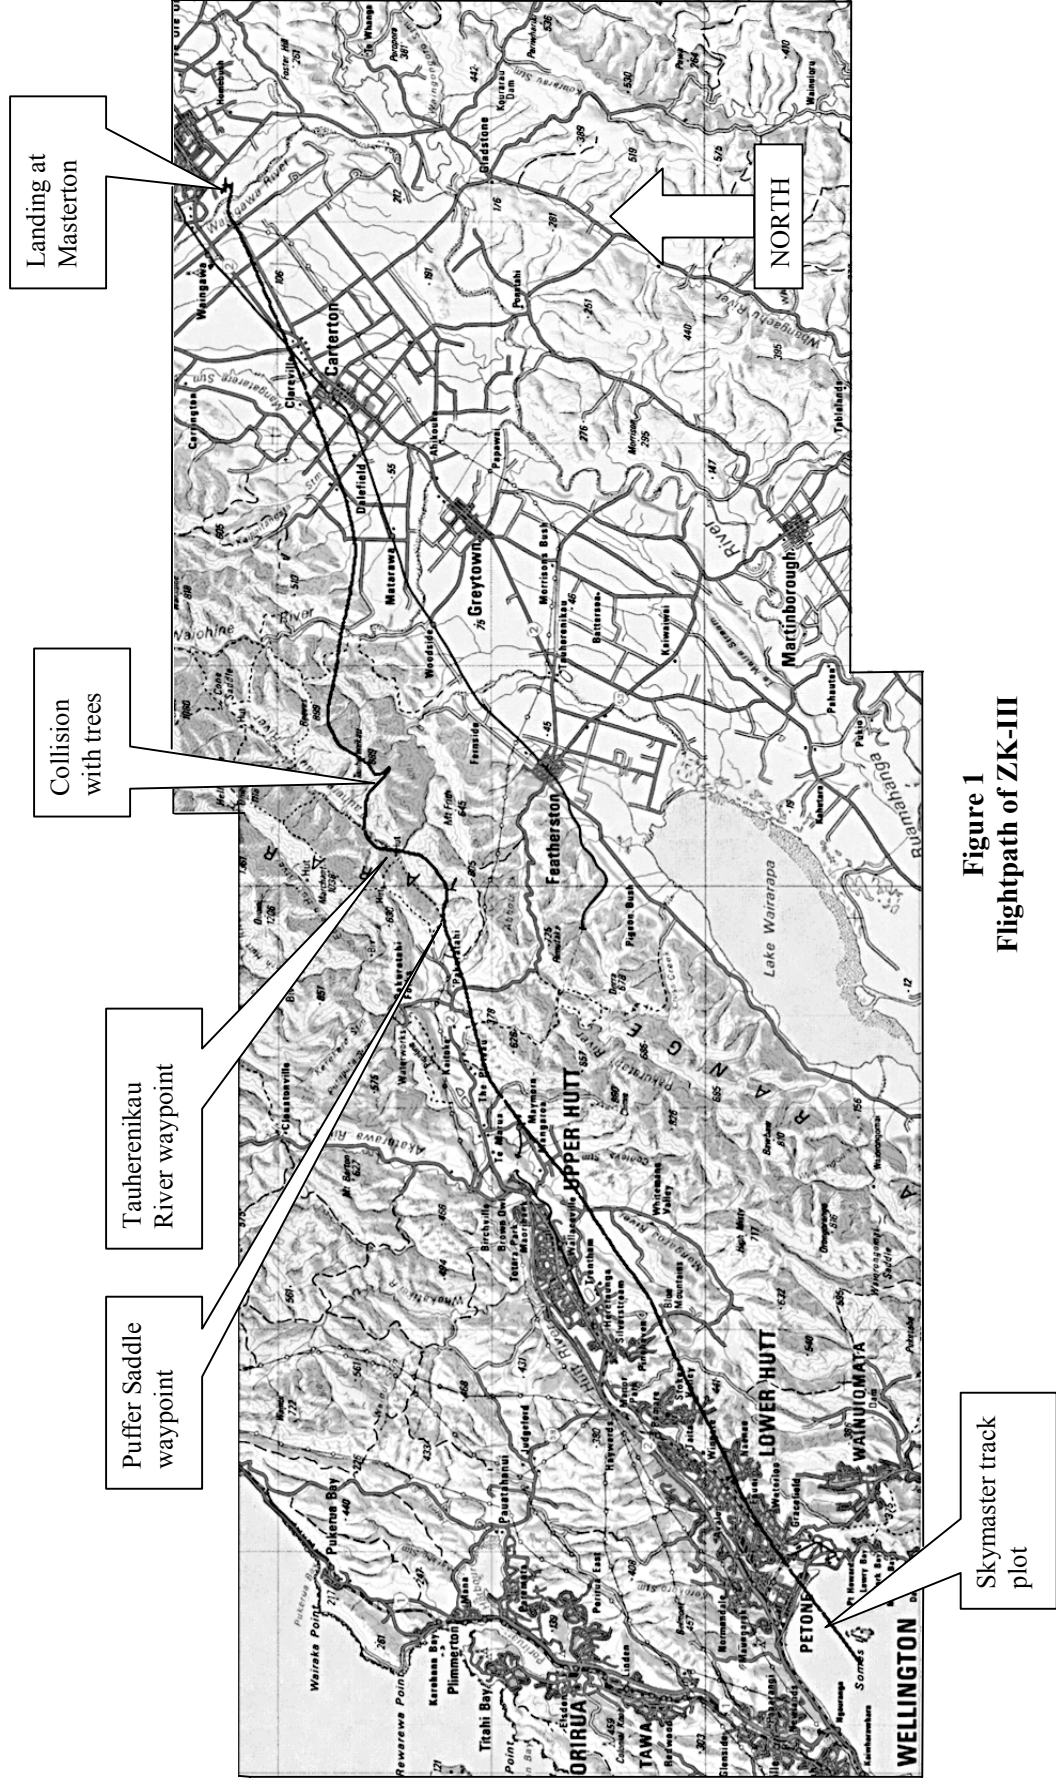
Figure I
Flightpath of ZK-III

- 1.1.12 The Skymaster log showed that the helicopter had overflown the Tauherenikau River waypoint by about 20 seconds and about 0.4 nm before the easterly turn started. The helicopter started climbing from about 2500 feet at 2214.59, at about 0.8 nm northeast of the Tauherenikau River waypoint, as the turn to an easterly heading was being completed. The groundspeed slowed from 115 knots (kt) to 89 kt, as the climb was established, and the collision occurred at 2215.50, at an altitude of about 2900 feet (GPS altitude), with the helicopter on a heading of 120 °magnetic (°M). Shortly after the collision the groundspeed had slowed to 22 kt, and by 2216.10 the helicopter had made a rapid left turn onto a heading of 320 °M, and had climbed to 3300 feet. A normal right turn followed, with the helicopter accelerating and climbing, and by 2217.00 it was heading 030 °M, at 3700 feet, with a groundspeed of 103 kt. The climb continued to just over 4000 feet as the helicopter turned towards Masterton. This was followed by a steady cruise descent to arrive at Masterton Aerodrome at 2227. The helicopter was hovered until shortly before the end of the Skymaster log at 2354.

- 2.6 The indication from the Skymaster log was that the pilot had overflown the Tauherenikau River waypoint by about 20 seconds, or about 0.4 nm, because that was where the turn to the east started. This small navigational overshoot effectively put the flight into danger. Such a small margin may be acceptable by day, with good light and visibility, but was insufficient on this night, with the prevailing low illumination and decreased visibility.
