AVIATION OCCURRENCE REPORT

Report 03-002, Cessna U206G ZK-EJG, engine failure after take-off, Ardmore Aerodrome

2 February 2003

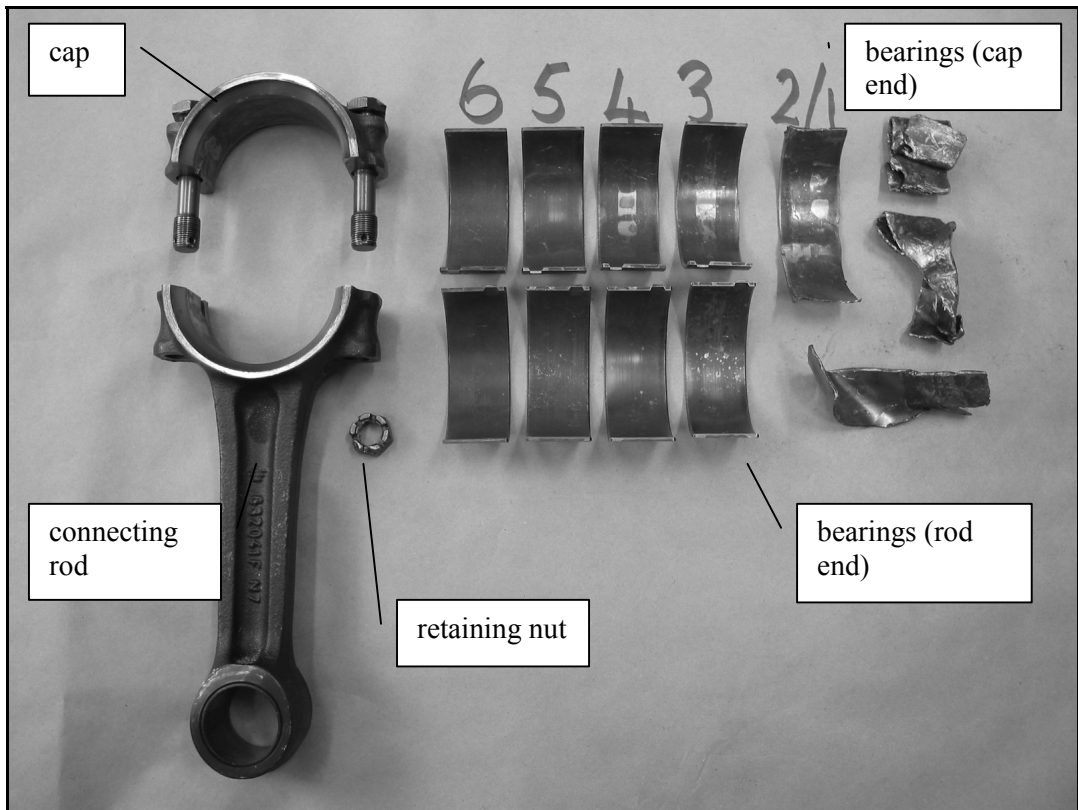
- 1.4.4 Examination of the retaining bolts for the numbers 1 and 2 connecting rods confirmed they all had failed due to gross overload. The adjoining faces of the big ends and caps displayed galling or rubbing marks and some deformation.

- 1.4.5 The 4 bearing shells from numbers 1 and 2 connecting rods had all been deformed to varying degrees and their original location could not be confirmed (see Figure 1). The least deformed bearing displayed rubbing marks on its inside surface and had been impacted and splayed out near the centre. The number 3 connecting rod bearings displayed similar marks, with the bearing that was adjacent to the cap (cap bearing) also splayed out at about its centre (see Figure 2). Number 4 connecting rod cap bearing also displayed the same type of damage but again to a lesser degree than the number 3 cap bearing. The number 5 and 6 bearings were not deformed but the number 5 cap bearing did have some rubbing marks on the inside of the bearing.

Figure 1
Connecting rod and shell bearings from ZK-EJG

- 2.3 The stoppage resulted from the caps for either number a failure of the big end of number 1 connecting rod or the caps from numbers 1 and 2 rods separating. The condition of the bearings for these 2 rods, and also the remaining rods, could indicate that the separation was initiated by a failure of a bearing; this led to excessive stress on a connecting rod and cap. Alternately, the stoppage could have been a direct result of a failure of a connecting rod, cap or a retaining bolt and nut, and not related to the bearings. However, there was no evidence of fatigue on any of these items, but the level of damage sustained may have erased any fracture surfaces.

- 2.6 The condition of the bearings was consistent with the wear occurring over a long period of time, possibly several hundred engine hours. While cracked or leaking cylinders can result from short flights with large and rapid power changes, they do not necessarily result in a catastrophic breakdown of lubrication to the connecting rods and bearings.

- 2.7 The origin of the failure could not be conclusively determined but could be attributed to several possible causes, including: material failure, manufacture, contamination, mishandling or a combination of these. Given the period over which the condition of the bearings degraded, the impending failure might have been detected by regular technical analysis of the engine waste oil. At the time of this accident testing of engine oil was at the discretion of the owner or operator; the testing of oil from turbine engines being more common. However, for a cost of about \$35 per test the oil from ZK-EJG could have been tested and a possible fault identified before catastrophic failure occurred.

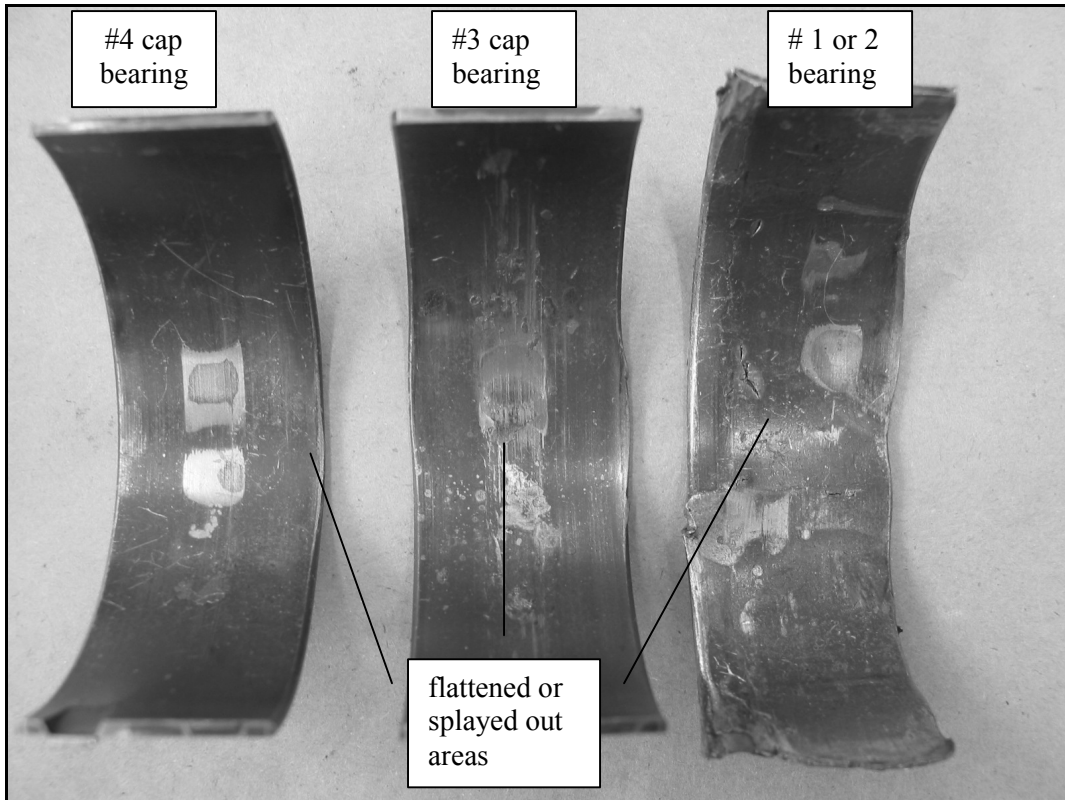
Figure 2
Cap bearings

- 2.4 The galling on the abutting faces of the caps and rods confirm that there was some movement of the caps before separation. This could explain the impact marking and splaying out of the cap bearings. Equally, the condition of the bearings may have been due to a breakdown in the lubrication of the parts. This could have resulted from contamination of the oil, for example through ingestion of foreign matter during operation, a blockage of oilways, or possibly from inappropriate handling. The inadequate lubrication could have resulted in the rubbing of the bearings, especially the cap bearings. The cap bearings then became impacted and splayed out, resulting in their failure.
