AVIATION OCCURRENCE REPORT

03-006

Convair 580, ZK-KFU, loss of control and in-flight break-up,
Kapiti Coast

3 October 2003

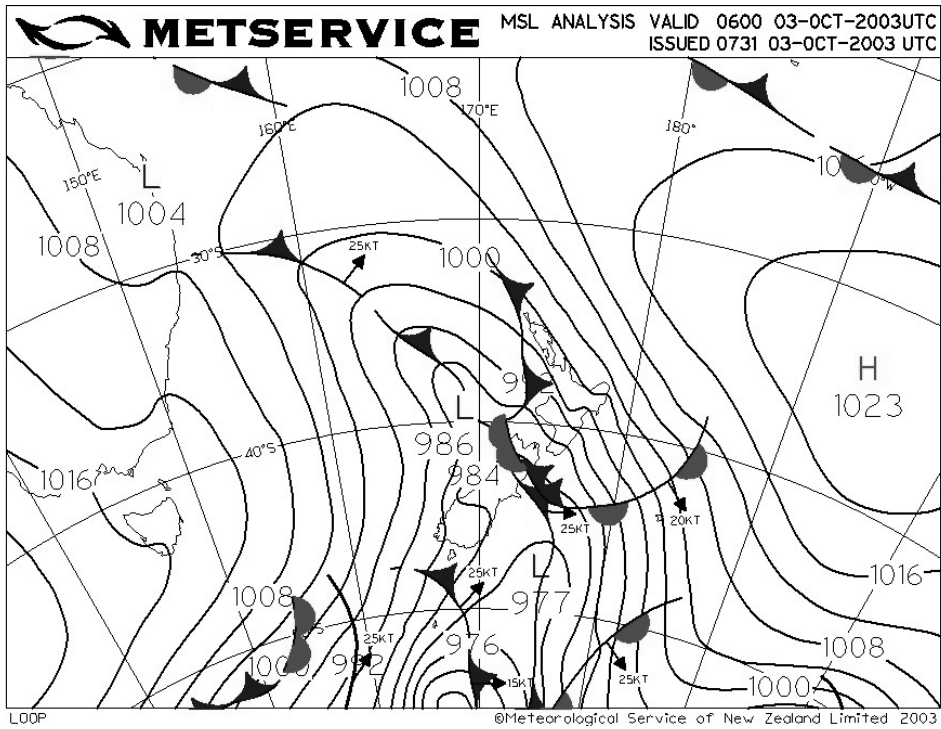
Figure 1
Mean sea level analysis chart issued at 1931 on 3 October 2004
(courtesy of MetService New Zealand)

During 3 October, an active trough of low pressure was crossing the country. In the evening, the trough extended from southeast of the South Island, across central New Zealand then to the area west of the North Island. (Refer Figure 1 for the Mean Sea Level Analysis Chart valid at the time of the accident.) A frontal band orientated northnorthwest – southsoutheast, embedded in the trough, moved southeastward across the North Island between 1800 and midnight. This front was preceded by a very strong and moist north to northwesterly flow. It was followed by a moist but slightly weaker northwest flow. A small wave depression or low appeared to form on the back edge of the front as it crossed the southern North Island between 2100 and 2300.

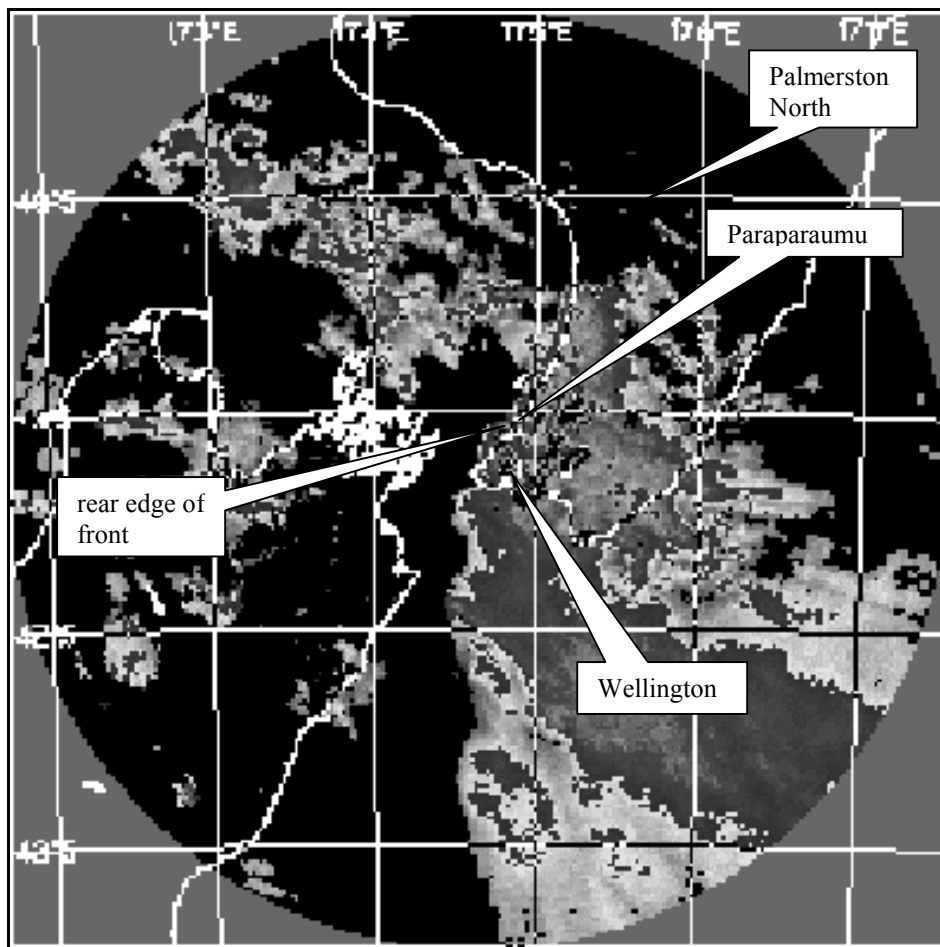
Figure 2
Radar weather map for 2130 on 3 October 2003)
(courtesy of MetService New Zealand)

This enhanced precipitation may indicate a concentration of large supercooled water droplets at this height. The temperature at this height was of the order of -15° C to -18° C. The freezing level in the vicinity would have been close to 9500 ft. These conditions combined would be conducive to aircraft icing above the freezing level.

Doppler radar velocity data indicated the presence of a wind convergence line in the vicinity of Paraparaumu between 2115 and 2130 at an altitude of about 16 400 ft extending down to lower levels.

Radar data between 2100 and 2200 indicated that the rain over Wellington and Kapiti was primarily from stratiform cloud with no significant embedded convection (no thunderstorms). This is consistent with no lightning being detected by any of the detection equipment available.

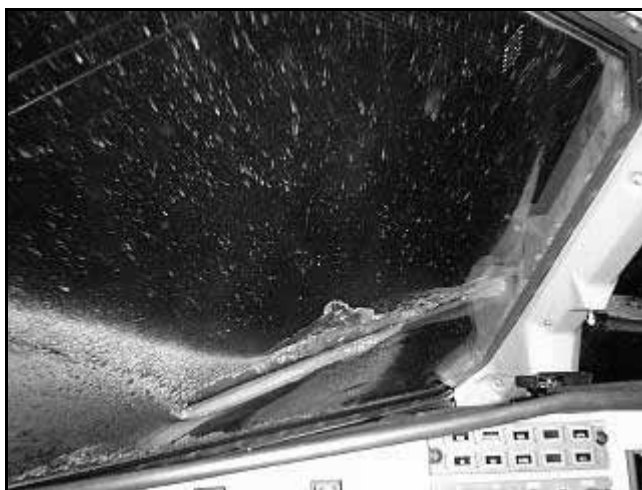
Figure 3
Icing encountered by aircraft west of Otaki

- 1.7.10 On the day of the accident, MetService received several pilot reports concerning weather conditions. One report, made at 1947, advised of moderate to severe turbulence in the vicinity of Wanganui below FL220. After the accident involving ZK-KFU a report was received of a severe ice encounter at about 1940 “just west of Otaki”. The aircraft concerned was in descent and heading towards Wellington when, between 13 000 ft and 8000 ft, it encountered severe icing. One of the pilots on board the aircraft took photographs of the ice accruing on the window (see Figure 3).

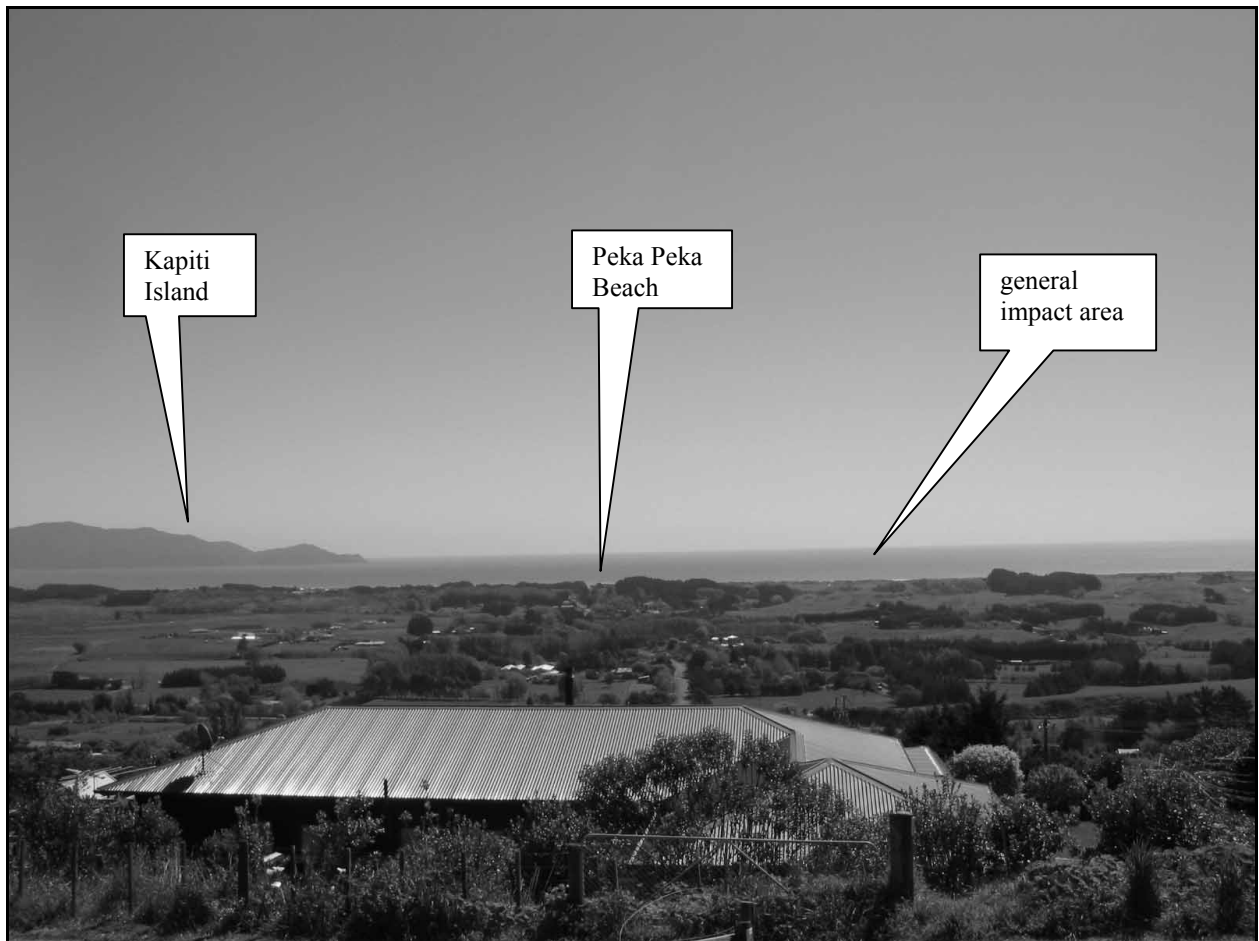
Figure 6
General view of accident site looking west

- 1.11.2 Four pieces of aircraft fuselage panelling were found inland, running about in line with Peka Peka Road in about a northwest to southeast direction. The first piece was found near the beach and was the heaviest and most distorted of the 4 pieces. A lighter but larger item, measuring about 1.35 m by 750 mm, was found about one km inland. The item found the furthest inland, at about 3 km, was the lightest and smallest, measuring about 200 mm by 200 mm. The pieces matched each other and were identified as wing to fuselage fairing from the right upper wing area.

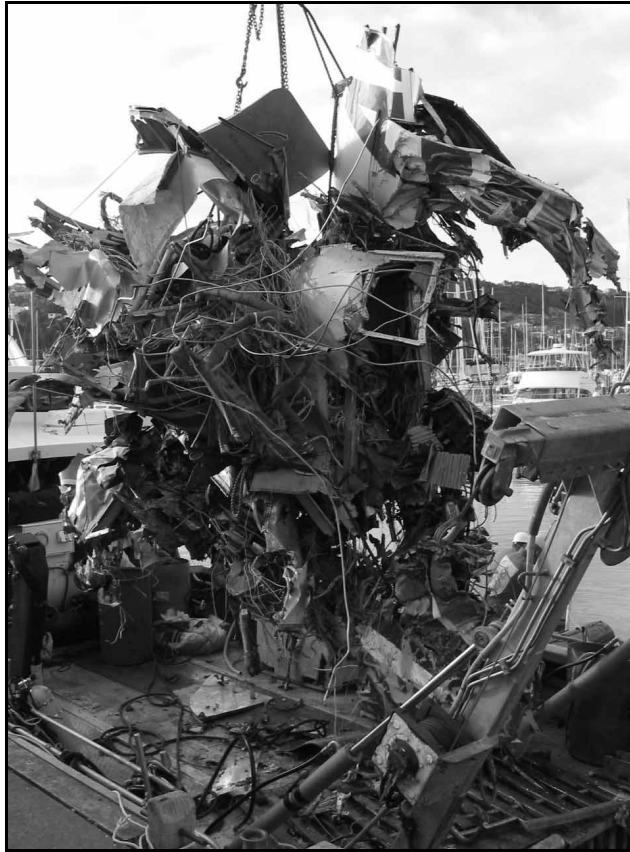
Figure 7
Forward section of ZK-KFU

- 1.11.10 The forward section of the aircraft contained much of the aircraft cockpit and extended back to nearly the wing attachment area (see Figure 7). The section was severely deformed and cutters were used to gain access for examination. The crew access door, located on the left side of the aircraft just aft of the cockpit, the door opposite and the belly hold door were still attached. The crew door and frame displayed compression lines consistent with a large rearwards force being applied. The door opposite was not deformed to the same extent and the belly hold door was essentially undamaged.
