## AVIATION OCCURRENCE REPORT

03-007

Hughes 369HS, ZK-HCC, in-flight power loss and emergency landing, Fox Glacier

30 November 2003

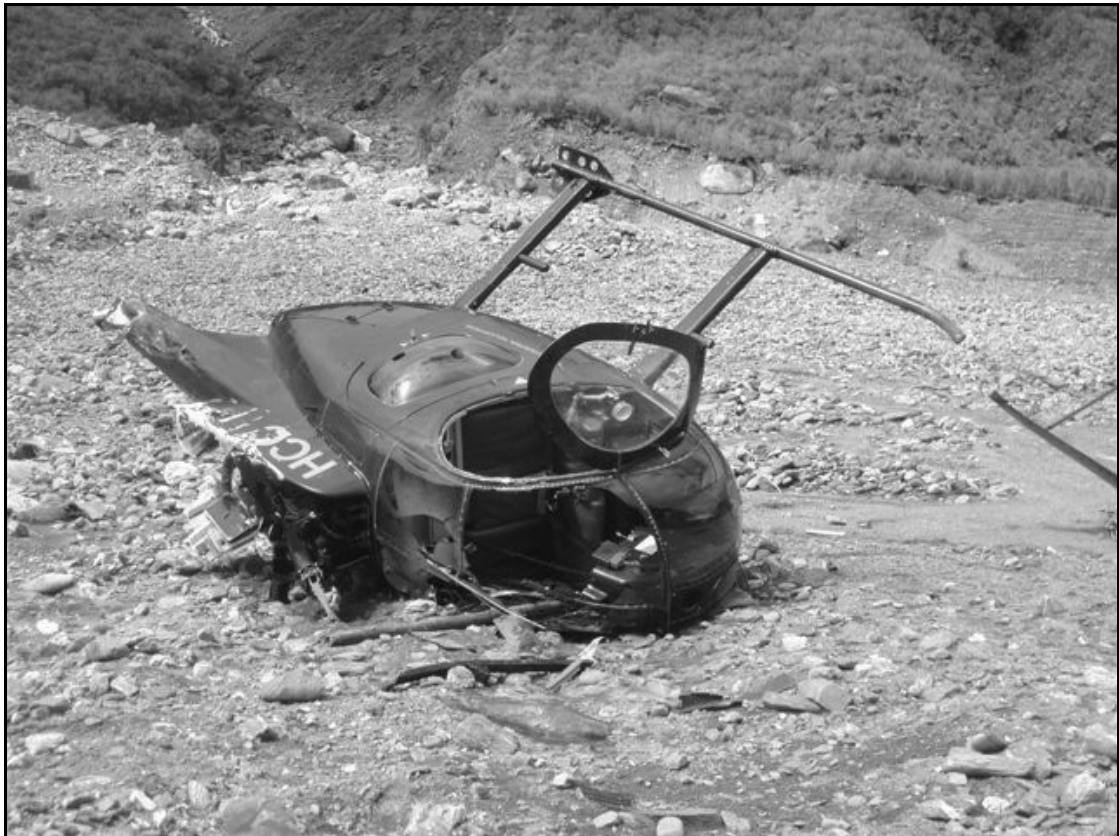
The pilot descended the helicopter to 6500 feet where power was restored. Several minutes later a second power loss occurred so he carried out an emergency landing at the base of Fox Glacier. The right rear skid broke when it struck a large rock during the landing, and the helicopter consequently rolled onto its right side. No one was seriously injured in the accident.

**ZK-HCC after the accident**

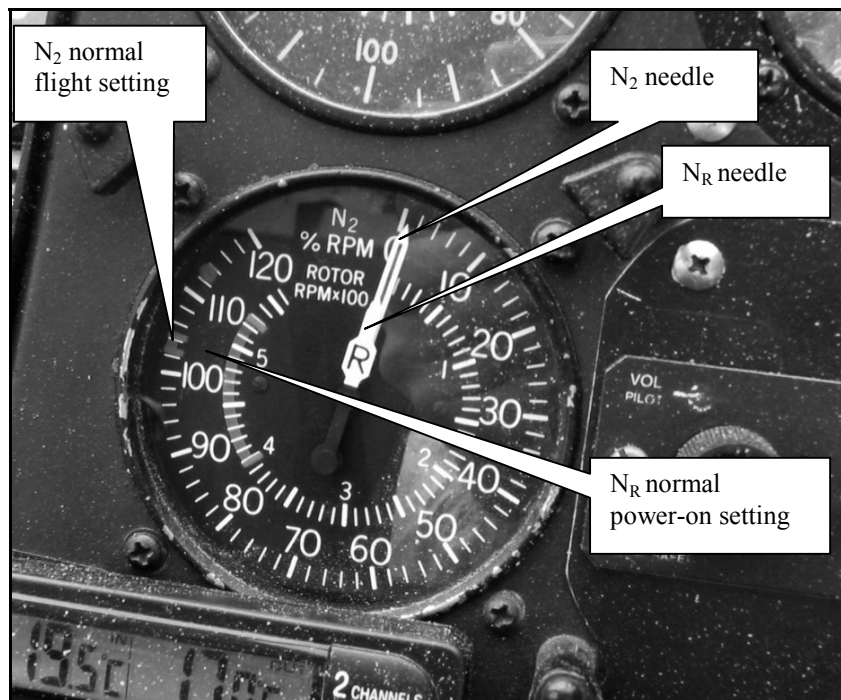
**Figure 1**  
**Dual N<sub>2</sub> N<sub>R</sub> tachometer**

- 1.7.2 The results showed that the tape was not a continuous recording of the entire flight, but on the portions analysed the N<sub>2</sub> decreased 3 separate times to 98%. The first N<sub>2</sub> reduction occurred after about 7 minutes of video recording at a time when a lake across the main divide of the Southern Alps could be seen. This corresponded to a photograph taken by a passenger in the centre front seat showing the time on the helicopter clock as 1015, and the airspeed indicator reading about 30 miles per hour (about 25 knots).

- 1.7.3 The first recorded N<sub>2</sub> reduction to 98% (460 RPM N<sub>R</sub>) was followed later by momentary N<sub>2</sub> increases to 107%, and 104.5%. Another recording showed an N<sub>2</sub> speed reduction again to 98%, followed by a momentary increase to 106%, then a reduction again to 98%.
