## RAILWAY OCCURRENCE REPORT

03-101      express freight Train 226, person injured while stepping down      7 January 2003  
from wagon, Paekakariki

TRANSPORT ACCIDENT INVESTIGATION COMMISSION  
NEW ZEALAND

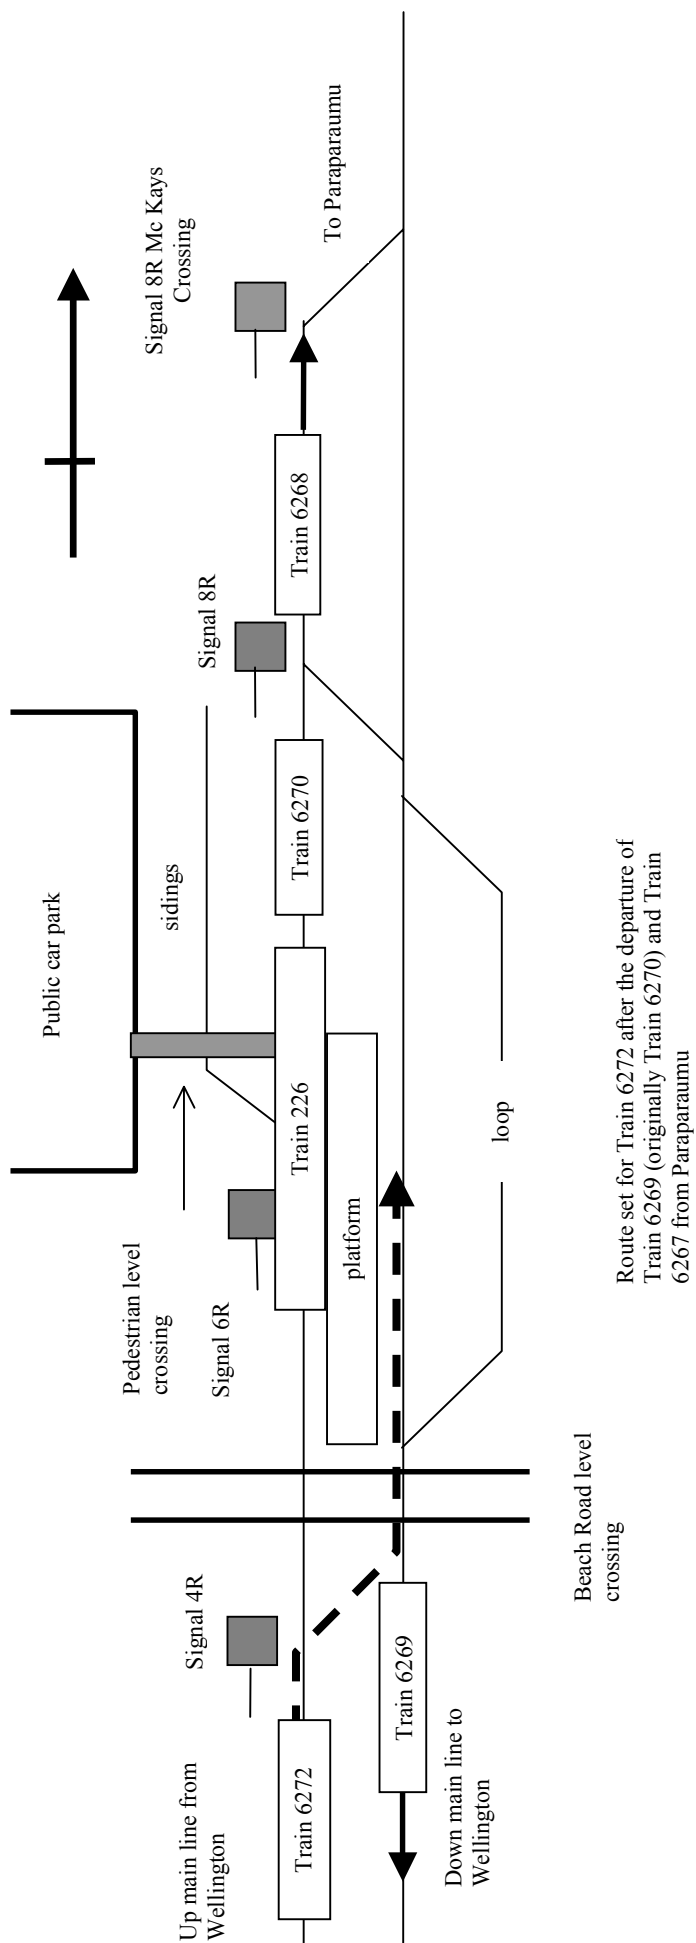
**Figure 1**  
Site plan of Paekakariki (not to scale)

- 1.1.3 At about 1825 a signalling equipment fault between McKays Crossing and Paraparaumu caused Signal 8R<sup>3</sup> at McKays Crossing to become defective. Because of the congestion caused by the signal failure, the train controller decided to terminate Train 6270 at Paekakariki, bus the passengers to Paraparaumu, and return the service to Wellington as Train 6269. Train 6270 was waiting at Signal 8R at Paekakariki prior to crossing over to the down main line, when Train 226 arrived and stopped at Signal 6R (see Figure 1).

- 1.1.4 The crew of Train 226 conversed by radio with the train controller, and were given a signal indication permitting Train 226 to enter, at low speed, the section which was occupied by Train 6270. The locomotive of Train 226 stopped about 400 m past Signal 6R, but the length of the train was such that there was insufficient room for all the wagons to be clear of the platform and several flat deck wagons were left straddling the pedestrian crossing.

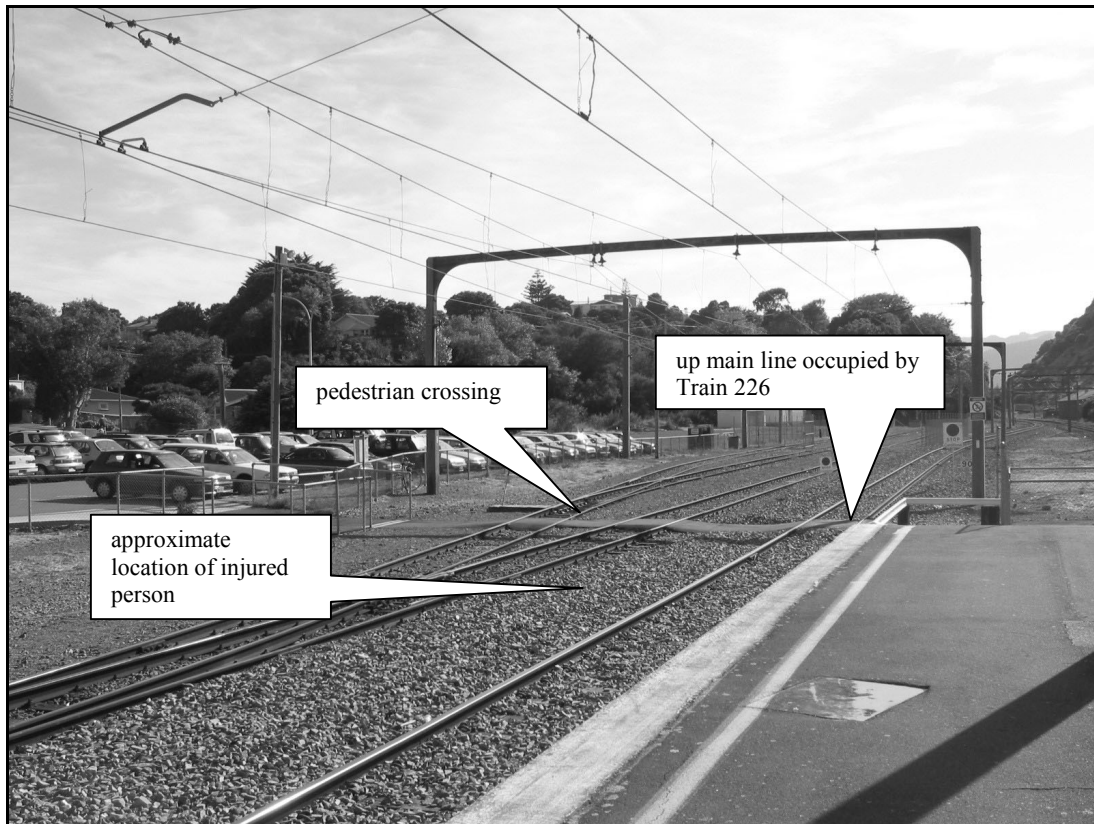
**Figure 2**  
**Approximate location of the injured person**

- 1.1.7 The height between the wagon deck and the ground on the off-platform side was about one metre, so the passenger sat on the edge of the wagon and lowered herself down but as she made contact with the ground she twisted her ankle and rolled in the ballast, finishing up lying between the up main line, and the tracks leading to the sidings (see Figure 2).

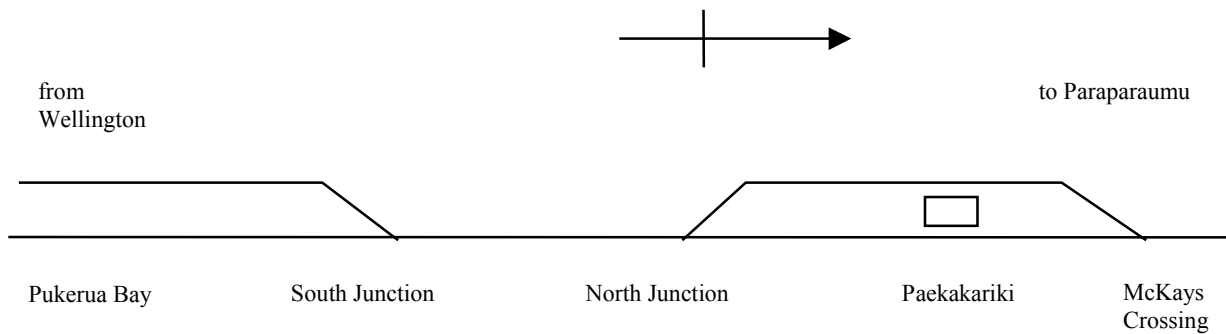
**Figure 3**  
**Route from Pukerua Bay to McKays Crossing (not to scale)**

- 1.2.3 Northbound trains approaching South Junction on the up main line became visible on the VDU at Pukerua Bay, about 2 kms before South Junction, to indicate their approach. After clearing the single line section at North Junction, northbound trains were no longer visible on the VDU until they reappeared again on the VDU about one kilometre south of Paekakariki. Apart from these locations, double line track within the Wellington metro area was not generally monitored on the VDU.

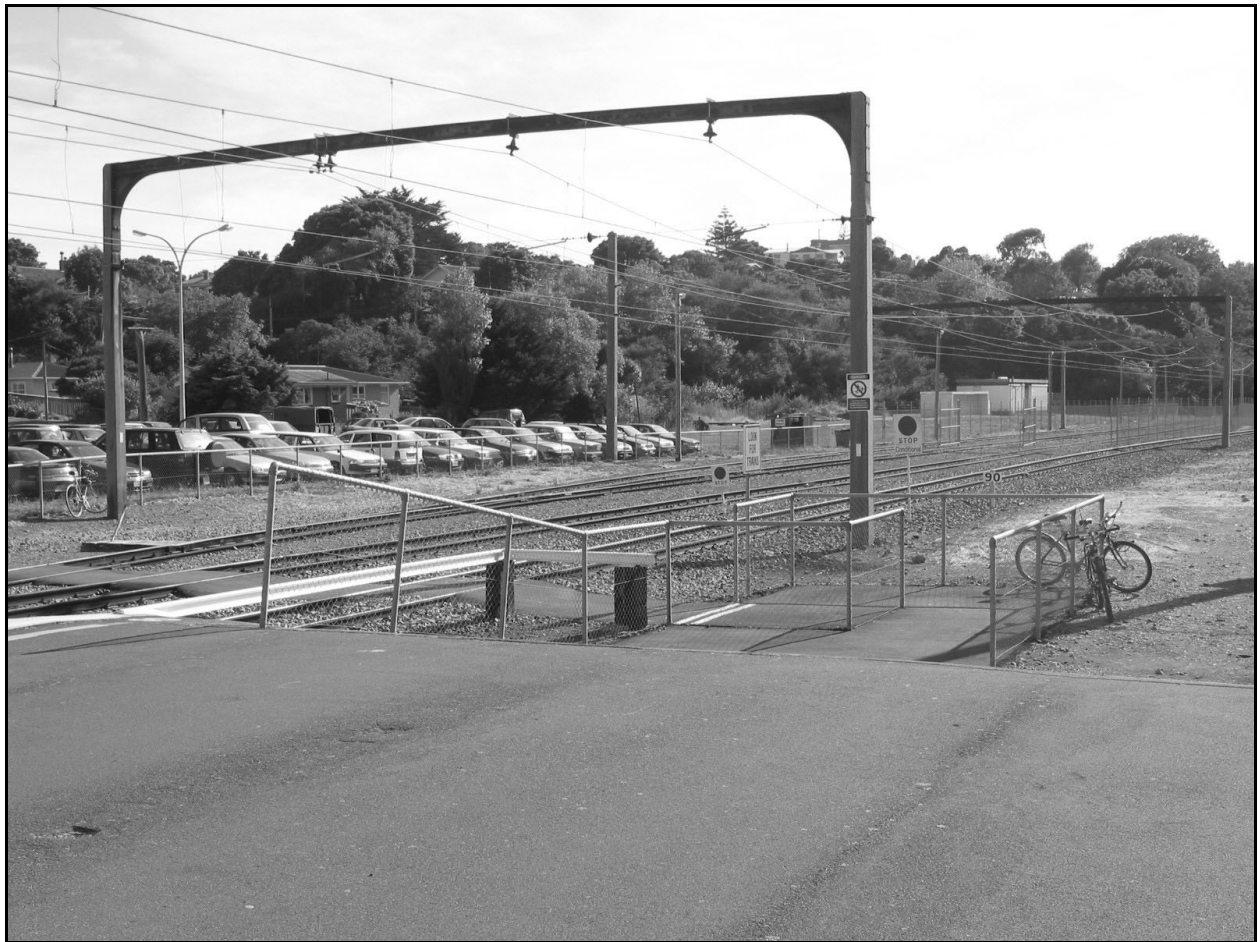
**Figure 4**  
**The pedestrian level crossing at the north end of the Paekakariki platform**

- 1.2.7 Pedestrian access to the public car park was from the north end of the platform via a pedestrian level crossing (see Figures 2 and 4). This crossing was also regularly used when passengers were transferred from trains to buses. There was no signage in place directing passengers to an alternative level crossing at the south end of the platform if the pedestrian crossing at the north end was obstructed. From the south end of the platform a pedestrian access way ran from the end of the platform for about 40 m to where it connected with Beach Road level crossing.

- 2.12 The pedestrian level crossing met all code requirements and guidelines, was fit for purpose and did not contribute to the accident. However, this accident has raised the issue of freight trains stopping and obstructing pedestrian level crossings, particularly in the Auckland and Wellington metropolitan areas, and it is considered that the siting of such level crossings in relation to signals etc, should be included in an independent review of pedestrian level crossings recommended to the Director of Land Transport Safety.

- 4.1 Tranz Rail advised that signage was installed on 10 February 2003 at the pedestrian crossing at the north end of Paekakariki directing passengers to Beach Road level crossing should the pedestrian crossing be obstructed.
- 4.2 Tranz Rail advised that from 28 February 2003 berthing arrangements had been altered at Paekakariki so that freight trains would not be routed via the up main line when passengers were using the north end pedestrian crossing to transfer from trains to buses.
- 4.3 In view of these actions no safety recommendations regarding these issues are made to the Chief Executive Officer of Tranz Rail.
