## MARINE OCCURRENCE REPORT

03-201

passenger ferry *Harbour Cat*, engine room fire, Auckland Harbour

16 January 2003

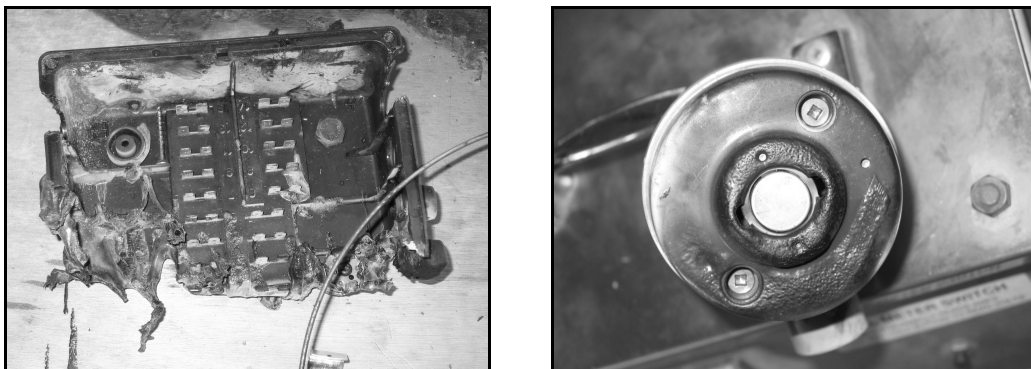
- 1.2.6 The auto ignition temperature<sup>2</sup> of diesel fuel is 257°C. The engine manufacturer indicated that with the engine operating at normal operating speed the exhaust gas temperature would have been up to about 490°C. The engine was water-cooled and so the exhaust pipe itself would have been at a lower temperature; probably between 300° and 400°C.
- 1.2.7 The air filter was a standard Scania spare part constructed of plastic with a concertinaed paper element. The outer casing and paper element both showed signs of having been on fire.
- 1.2.8 The junction box for the engine electrics was found to have melted. Fire damage was also apparent to some of the wiring entering it, the fluorescent light diffuser also melted. The fire detector head above the engine was also fire damaged (see Figure 4).

**Figure 3**  
**Damage to electrical junction box and fire detector head**

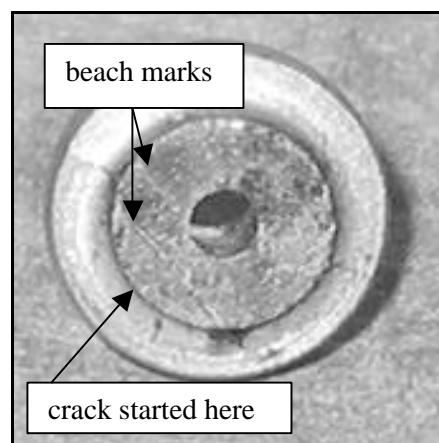
- 1.8.8 The operator had the fractured fuel pipe and nipple examined by a metallurgist. The metallurgist found that the failure as evidenced by beach marks was because of metal fatigue. The metal fatigue involved gradual crack growth under pulsing during each fuel injection, which possibly induced a slight cyclic flexing of the pipe (see Figure 4).

**Figure 4**  
**Fracture surface on the nipple, showing the extent of the slow cyclic crack fatigue growth (beach marks) perpendicular to the tubes' natural flex**

- 2.16 The metallurgist reported that the fracture was possibly due to vibration cracking. As No. 6 cylinder is the furthest away from the fuel pump and consequently has the longest fuel pipe length, it is possible that a vibration was set up due to the length of pipe.

- 3.10 The fracture that occurred on 20 June 2003 was probably caused by vibration, and it is possible that the fracture on 16 January 2003 was also caused by vibration. The source of the vibration could not be conclusively determined.

- 1.8.9 The metallurgist suggested that, if possible, to reduce the stresses, raise the endurance limit and increase the usable life of the fuel pipe, heavier pipe with a greater cross sectional area and possibly constructed out of higher strength steel be used.

- 2.17 As the operator was unable to fit a larger fuel pipe to the engine due to physical constraints the addition of an extra bracket on the fuel pipe line may serve to dampen any localised vibrations that caused the pipe to fracture.

- 3.11 The addition of an extra bracket on the fuel pipe line may alleviate the localised vibration problem.
