## M A R I N E   O C C U R R E N C E   R E P O R T

Report 03-204, restricted limit passenger vessel *Tiger III*,  
passenger injury, Cape Brett

TRANSPORT ACCIDENT INVESTIGATION COMMISSION  
NEW ZEALAND

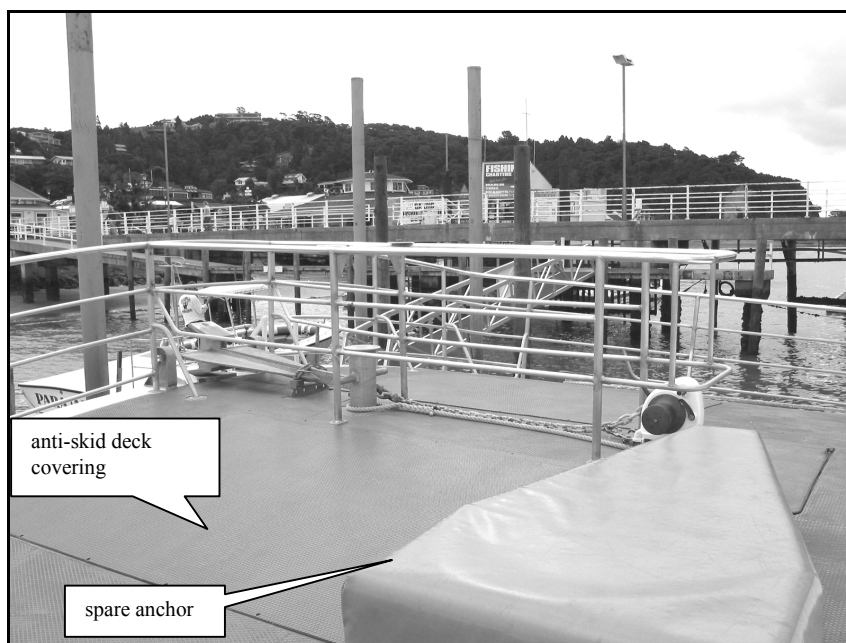
- 1.2.4 The foredeck was mostly clear of obstacles with the anchor and windlass in the centre of the deck, surrounded by railings (see Figures 3 and 4). The only other encumbrance was the spare anchor that was covered by a box with a padded top, which could be, and often was, used as a seat. The railings were stainless steel and of welded construction. The foredeck of the *Tiger III* was covered in a non-slip matting to assist the passengers and crew maintain their footing.

**Figure 3**  
**Foredeck of the *Tiger III* showing the windlass, anchor and spare anchor**

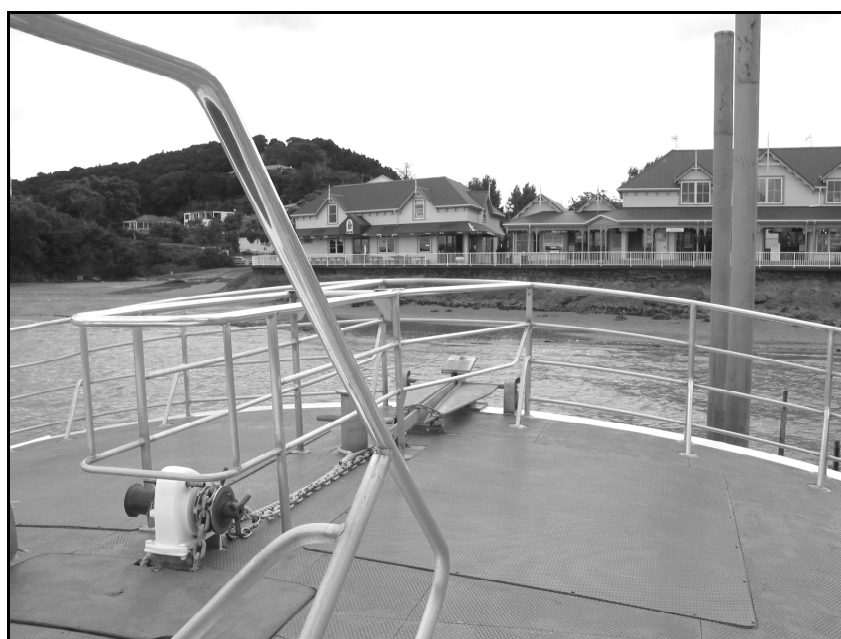
**Figure 4**  
**Foredeck of the *Tiger III* from the access to the passenger cabin**

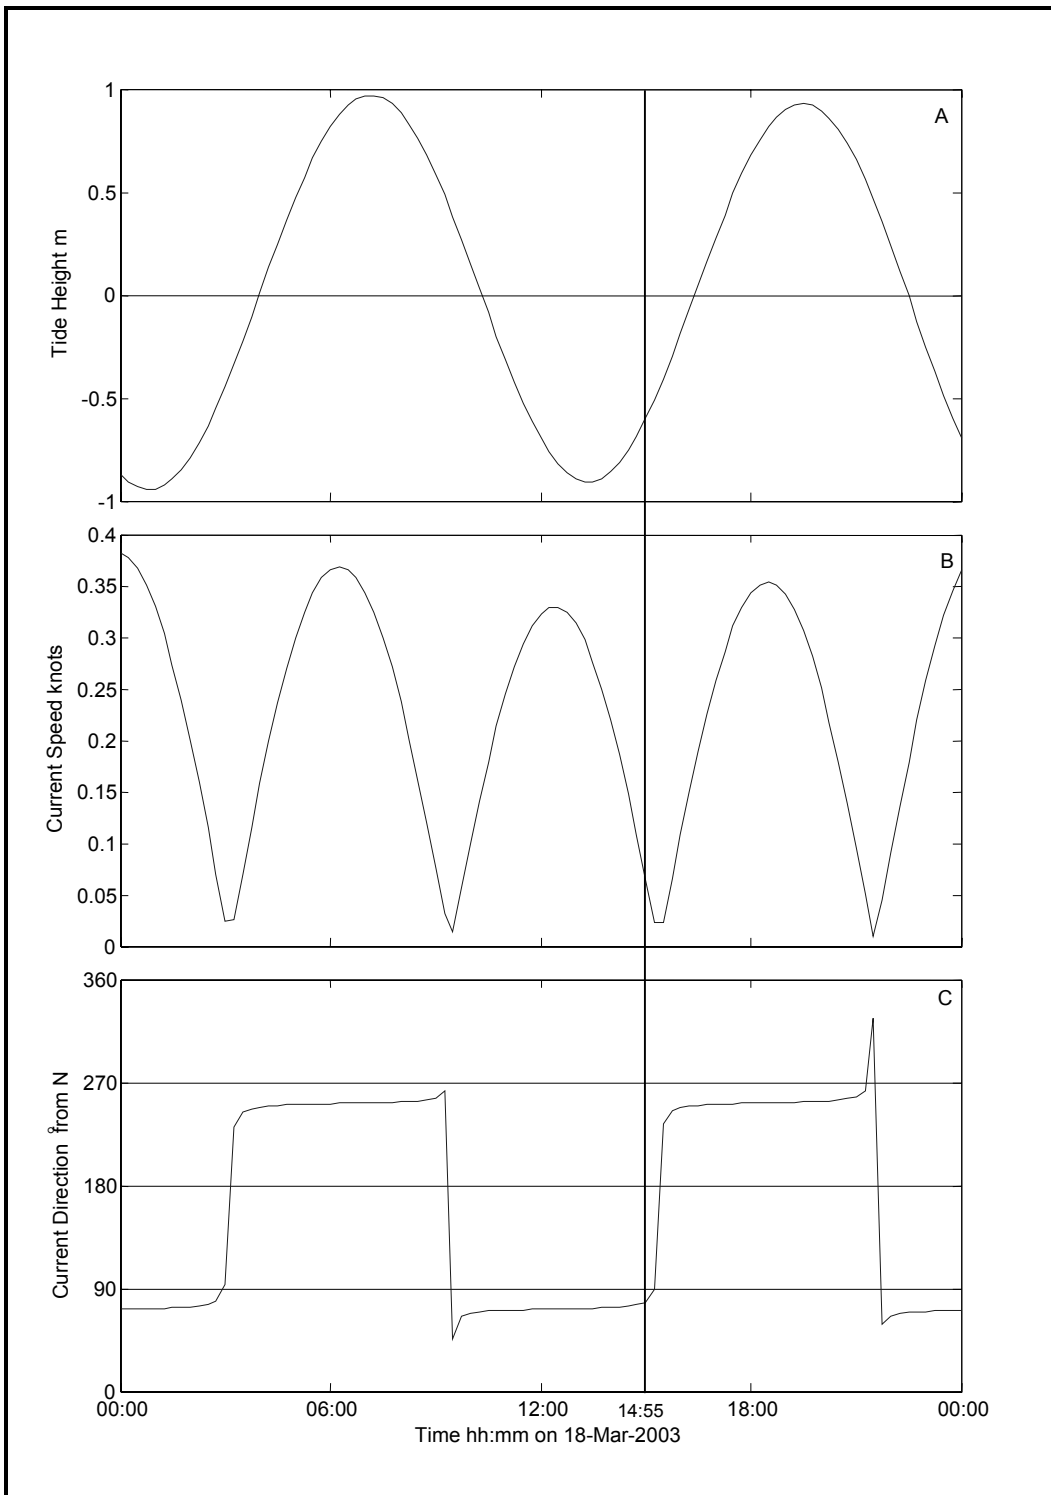
1.7.2 NIWA were commissioned to supply tidal data for the Cape Brett area for the time of the accident from a computer model. The graph of that data is contained in Figure 5. From the upper graph it can be seen that the accident occurred shortly after low water. At that time the current was flowing towards the east at a rate of less than 0.1 knots.

**Figure 5**  
**Tide height, current speed, and current direction for position of the accident.**  
**The vertical line indicates the time of the accident**

- 2.4 The current at the time of the accident was negligible and was unlikely to have had any effect on the sea conditions.
- 2.5 The accident happened soon after the vessel had departed the landing and was altering course around the northern end on Otuwhanga Island. It was not travelling particularly fast, between 10 and 12 knots, which might have been a reasonable speed for such a vessel in the prevailing sea conditions, but not with people on the foredeck.

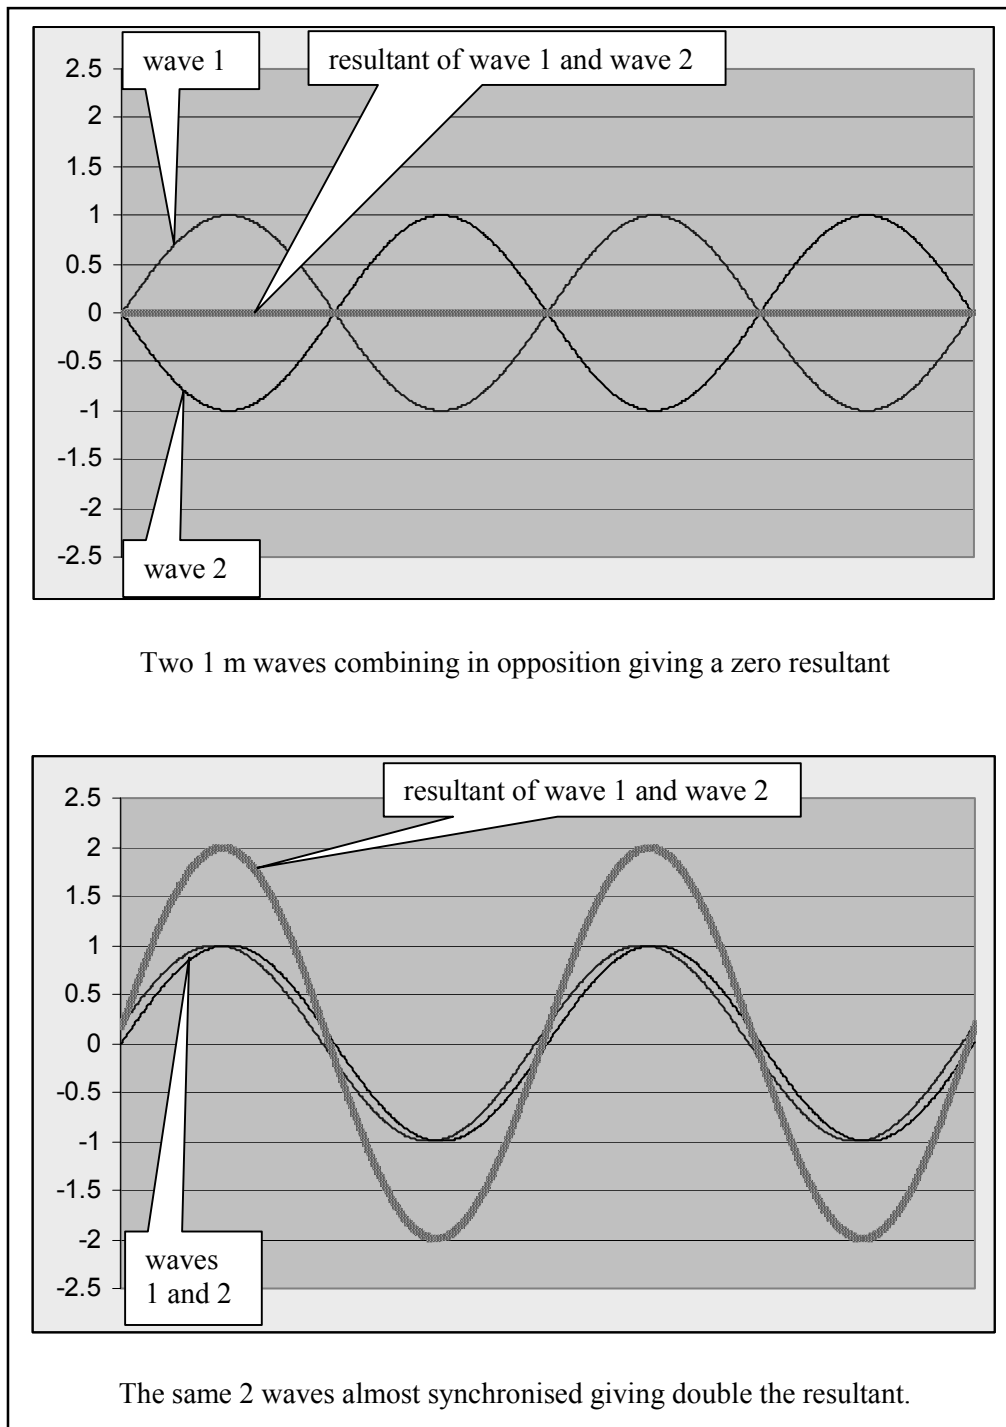
- 1.9.6 When talking about waves it is normal to focus on the height of the crest of a wave but because of their sinusoidal form, each crest must have a corresponding trough, which will be of similar depth to the height of the crest. However, where an unusually high crest can be seen easily at a distance an unusually deep trough may not be seen until it is imminent.

**Figure 7**  
**Diagram to show the minimum and maximum resultant**  
**of 2 waves combining**

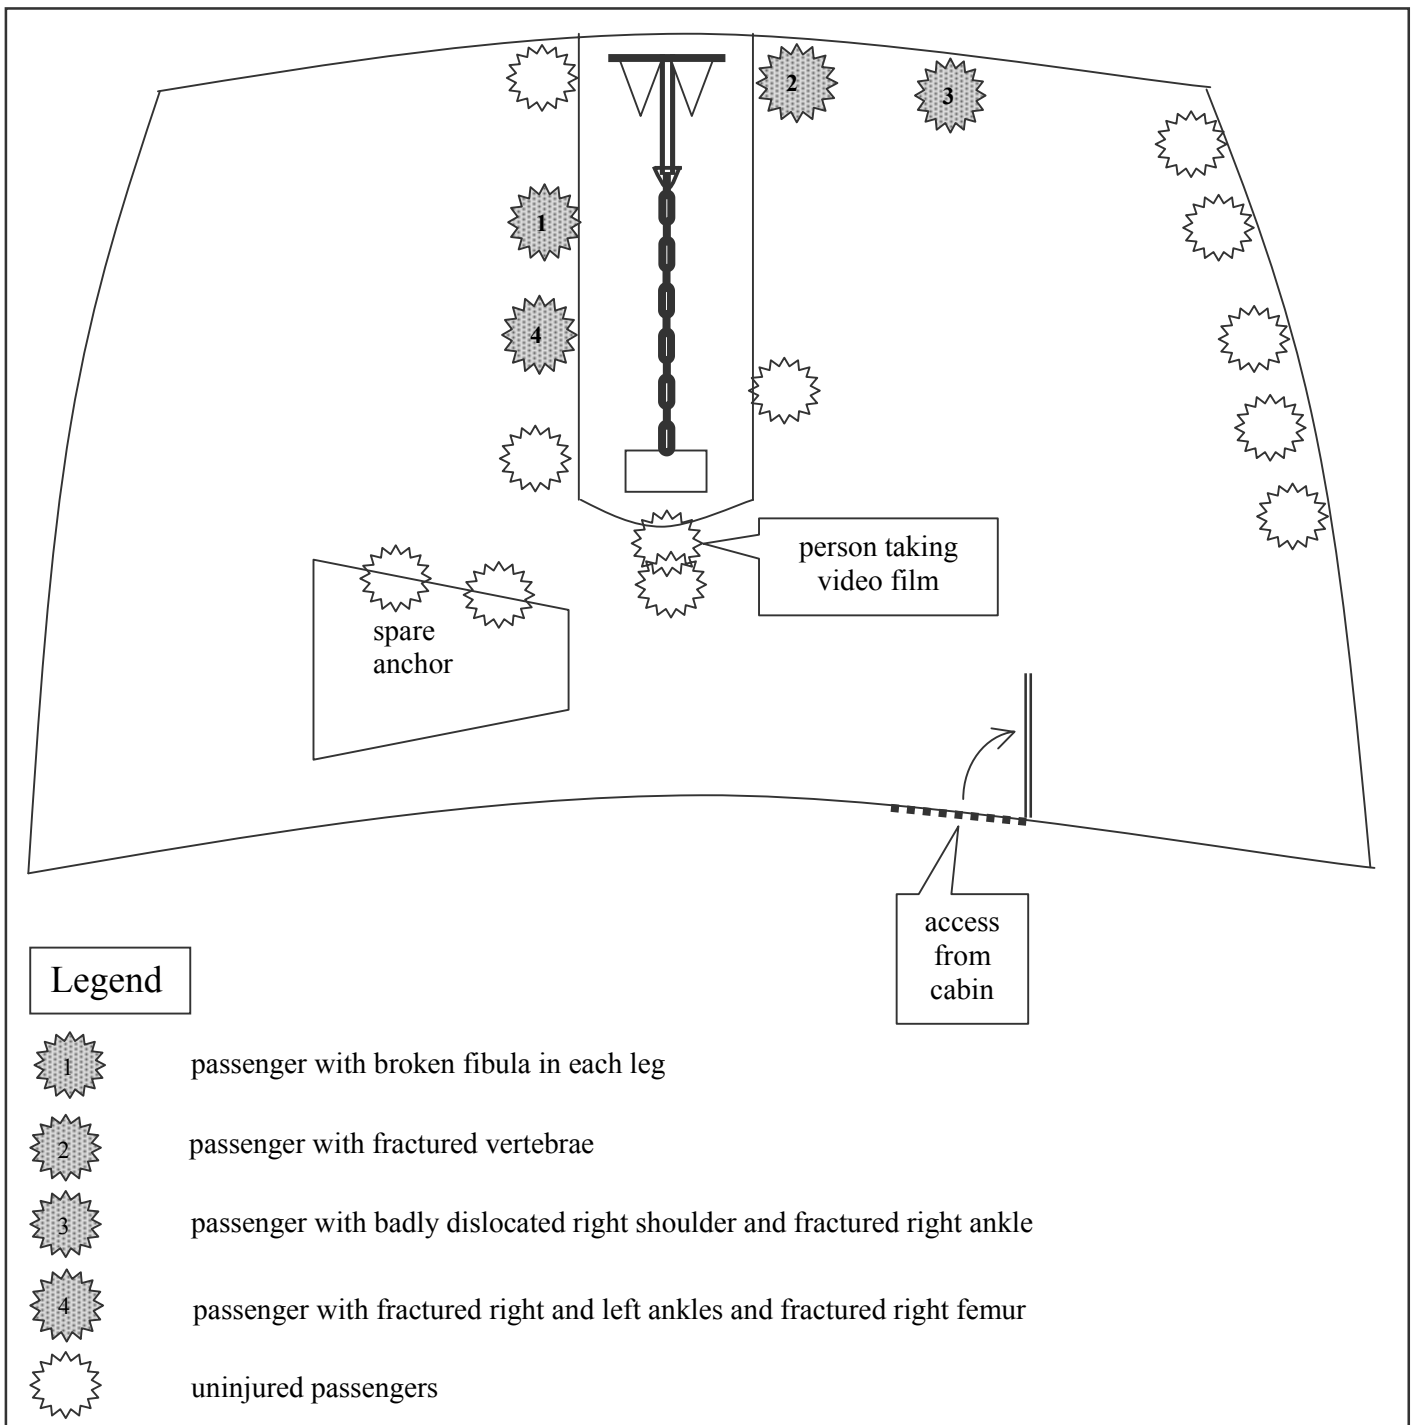
1.10.1 Four passengers on the foredeck (see Figure 8) sustained serious injuries. They were:

- broken fibula in each leg
- fractured vertebrae
- badly dislocated right shoulder and fractured right ankle
- fractured right and left ankles and fractured right femur.

**Figure 8**  
**Foredeck of the *Tiger III* showing position of injured passengers**

- 2.6 The injuries sustained by the passengers were consistent with the vertical and horizontal impact forces sustained when they hit the foredeck. The compression forces of impact caused one vertebral fracture, and there were a number of limb injuries caused either by compression or flailing. The dislocated right shoulder was consistent with the person being violently swung around while holding on with that arm.

All skippers must employ extreme caution before allowing passengers to travel on the foredeck of our vessels. Flat water or a low evenly spread swell are generally acceptable conditions but at all times good seamanship and a vigilant lookout MUST be maintained. In any other conditions the foredeck will be closed to passengers.
